Profile/Photo Observation Report

Street:	OFF W 61ST AVE	Flow Control:	Not Controlled
City:	Hobart, IN	Year Renewed:	
Location:	Yard	Tape/Media #:	
Purpose:	Routine Assessment	Dia/Height:	8"
Use:	Sanitary	Material:	PVC
Drain Area:	NA	Lining:	
Category:	NA		
Comment:	Flow direction is marked wrong.		
Location Details:		Direction of Survey:	Upstream
US MH:	M-608-009	DS MH:	M-608-008
		Total Length Surveyed (ft):	87.6

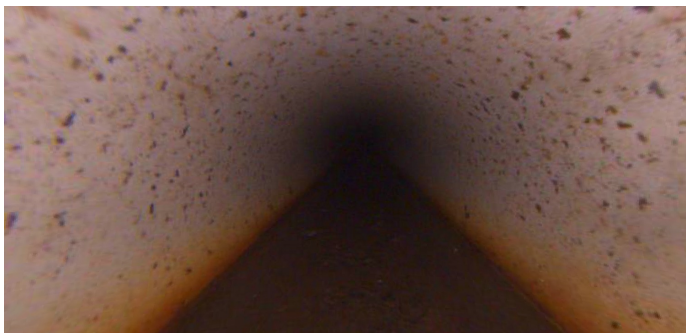
Code: **AMH**
Description: **Manhole**

Distance (ft): **.0**
Structural Grade: **0**
O&M Grade: **0**
Clock Start/From:
Clock To:
1st Value:
2nd Value:
Value Percent:
Continuous Index:
Within 8" of Joint: **NO**
Remarks: **M-608-008**

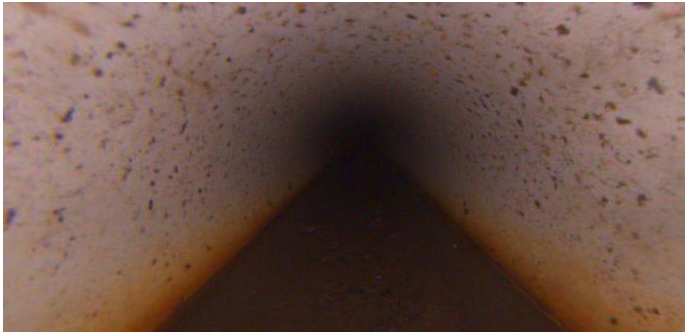
Code:	MWL
Description:	Water Level

Distance (ft):	.0
Structural Grade:	0
O&M Grade:	0
Clock Start/From:	
Clock To:	
1st Value:	
2nd Value:	
Value Percent:	10.000
Continuous Index:	
Within 8" of Joint:	NO
Remarks:

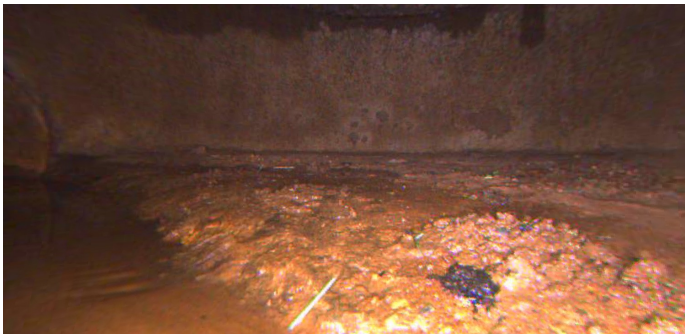
Code:	AMH
Description:	Manhole

Distance (ft):	87.6
Structural Grade:	0
O&M Grade:	0
Clock Start/From:	
Clock To:	
1st Value:	
2nd Value:	
Value Percent:	
Continuous Index:	
Within 8" of Joint:	NO
Remarks:	M-608-009
