Profile/Photo Observation Report

Street:	FOXCROFT STREET	Flow Control:	Not Controlled
City:	Hobart, IN	Year Renewed:	
Location:	Yard	Tape/Media #:	
Purpose:	Routine Assessment	Dia/Height:	8"
Use:	Sanitary	Material:	PVC
Drain Area:	NA	Lining:	
Category:	NA		
Comment:

Location Details:		Direction of Survey:	Upstream
US MH:	M-608-010	DS MH:	M-608-009
		Total Length Surveyed (ft):	224.2

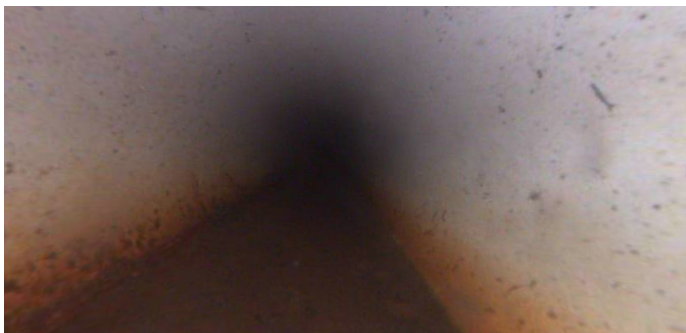
Code: **AMH**
Description: **Manhole**

Distance (ft): **.0**
Structural Grade: **0**
O&M Grade: **0**
Clock Start/From:
Clock To:
1st Value:
2nd Value:
Value Percent:
Continuous Index:
Within 8" of Joint: **NO**
Remarks: **M-608-009**

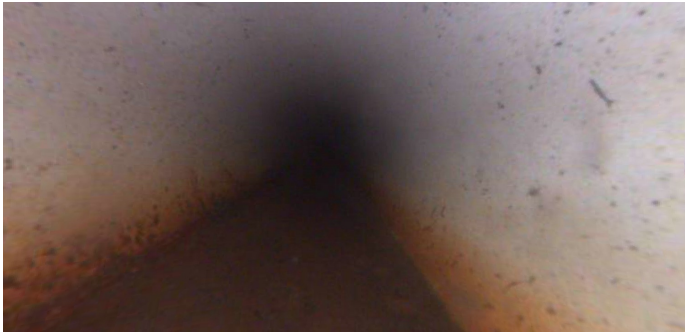
Code:	MWL
Description:	Water Level

Distance (ft):	.0
Structural Grade:	0
O&M Grade:	0
Clock Start/From:	
Clock To:	
1st Value:	
2nd Value:	
Value Percent:	5.000
Continuous Index:	
Within 8" of Joint:	NO
Remarks:

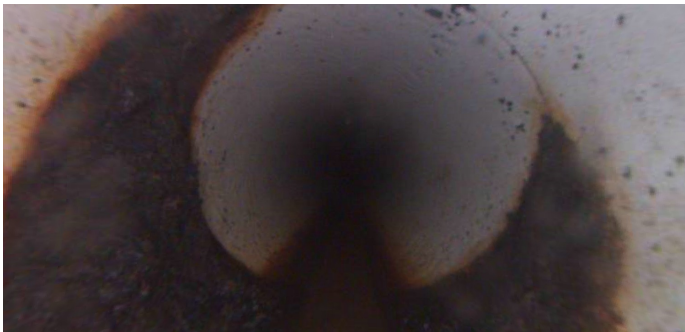
Code:	DAE
Description:	Deposits Attached Encrustation

Distance (ft):	37.4
Structural Grade:	0
O&M Grade:	2
Clock Start/From:	7
Clock To:	5
1st Value:	
2nd Value:	
Value Percent:	10.000
Continuous Index:	
Within 8" of Joint:	YES
Remarks:

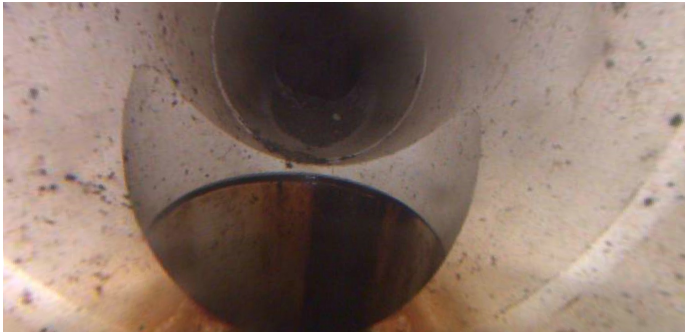
Code: **TF**
Description: **Tap Factory**

Distance (ft): **222.9**
Structural Grade: **0**
O&M Grade: **0**
Clock Start/From: **6**
Clock To:
1st Value: **6.000**
2nd Value:
Value Percent:
Continuous Index:
Within 8" of Joint:
Remarks: **drop connection**

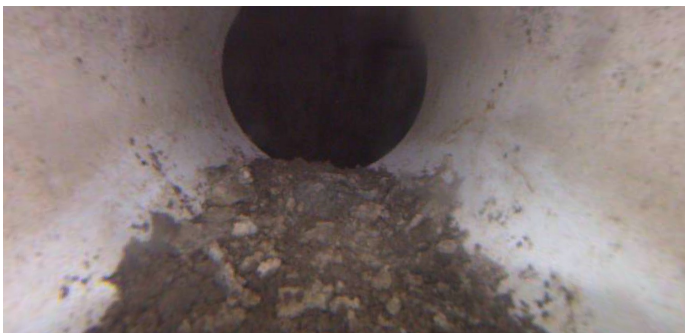
Code: **DSF**
Description: **Deposits Settled Fine**

Distance (ft): **224.2**
Structural Grade: **0**
O&M Grade: **2**
Clock Start/From: **5**
Clock To: **7**
1st Value:
2nd Value:
Value Percent: **5.000**
Continuous Index:
Within 8" of Joint: **NO**
Remarks:

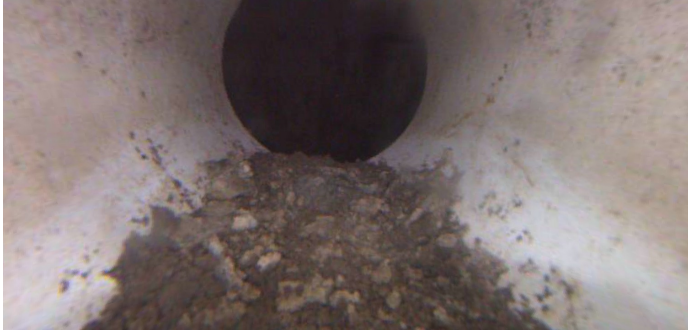
Code:	AMH
Description:	Manhole
Distance (ft):	224.2
Structural Grade:	0
O&M Grade:	0
Clock Start/From:	
Clock To:	
1st Value:	
2nd Value:	
Value Percent:	
Continuous Index:	
Within 8" of Joint:	NO
Remarks:	M-608-010 in drop
