Profile/Photo Observation Report

Date:	10/11/2018	Weather:		Coding:	PACP 6.0
Pipe Length (ft):	170.3	Owner:	NA	Pre Clean:	Not Known
P.O.#:		Surveyor:	Selasie Honu	PSR:	P-608-013-014
Customer:		Clean Date:	01/01/1900	Shape:	C

Street:	OFF S ASH ST	Flow Control:	Not Controlled
City:	Hobart, IN	Year Renewed:	
Location:	Light Highway	Tape/Media #:	
Purpose:	Routine Assessment	Dia/Height:	10"
Use:	Sanitary	Material:	PVC
Drain Area:	NA	Lining:	
Category:	NA		
Comment:

Location Details:		Direction of Survey:	Upstream
US MH:	M-608-014	DS MH:	M-608-013
		Total Length Surveyed (ft):	93.1

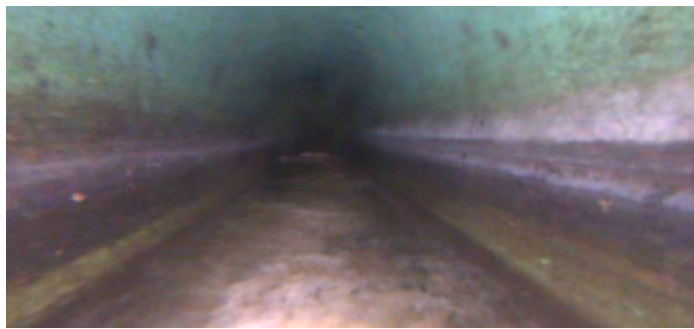
Code: **AMH**
Description: **Manhole**

Distance (ft): **.0**
Structural Grade: **0**
O&M Grade: **0**
Clock Start/From:
Clock To:
1st Value:
2nd Value:
Value Percent:
Continuous Index:
Within 8" of Joint: **NO**
Remarks: **M-608-013**

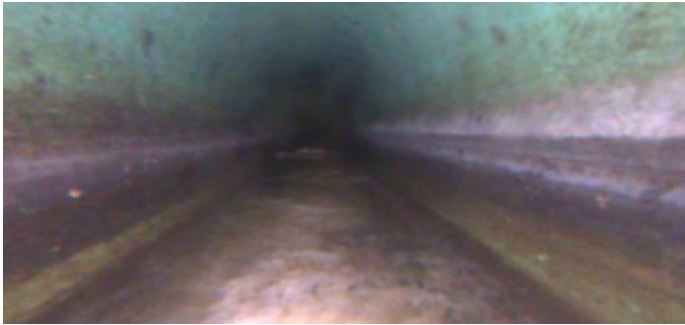
Code:	MWL
Description:	Water Level

Distance (ft):	.0
Structural Grade:	0
O&M Grade:	0
Clock Start/From:	
Clock To:	
1st Value:	
2nd Value:	
Value Percent:	5.000
Continuous Index:	
Within 8" of Joint:	NO
Remarks:

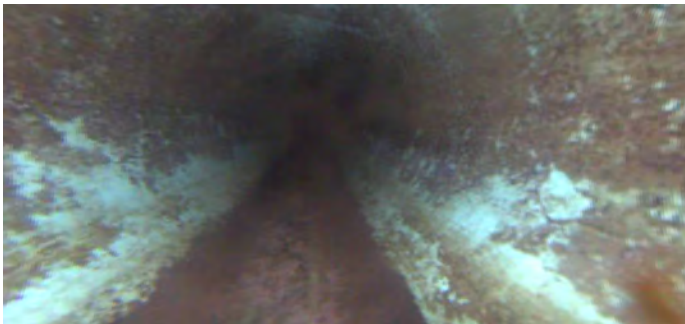
Code:	MSA
Description:	Abandoned Survey

Distance (ft):	93.1
Structural Grade:	0
O&M Grade:	0
Clock Start/From:	
Clock To:	
1st Value:	
2nd Value:	
Value Percent:	
Continuous Index:	
Within 8" of Joint:	NO
Remarks:	camera stopped
