Profile/Photo Observation Report

Date:	10/11/2018	Weather:		Coding:	PACP 6.0
Pipe Length (ft):	170.3	Owner:	NA	Pre Clean:	Not Known
P.O.#:		Surveyor:	Selasie Honu	PSR:	P-608-013-014
Customer:		Clean Date:	01/01/1900	Shape:	C

Location Details:		Direction of Survey:	Upstream
US MH:	M-608-014	DS MH:	M-608-013
		Total Length Surveyed (ft):	93.1

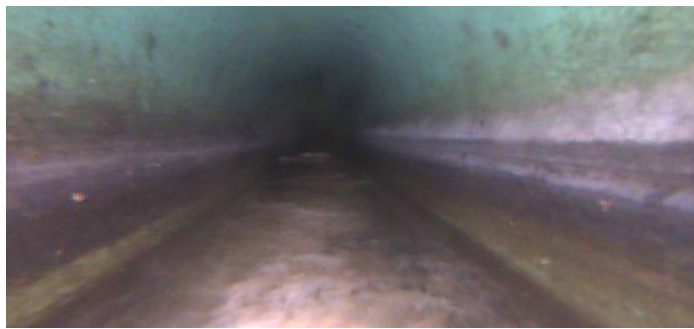
Code: **AMH**
Description: **Manhole**

Distance (ft): **.0**
Structural Grade: **0**
O&M Grade: **0**
Clock Start/From:
Clock To:
1st Value:
2nd Value:
Value Percent:
Continuous Index:
Within 8" of Joint: **NO**
Remarks: **M-608-013**

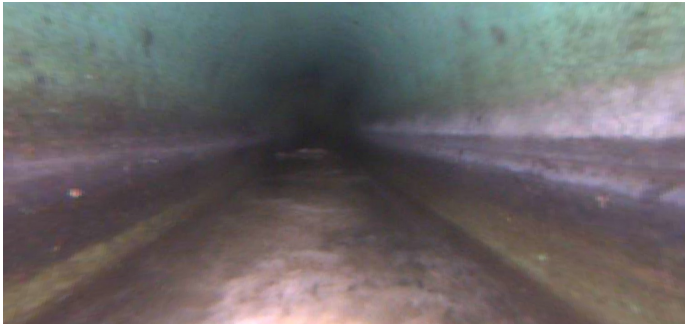
Code:	MWL
Description:	Water Level

Distance (ft):	.0
Structural Grade:	0
O&M Grade:	0
Clock Start/From:	
Clock To:	
1st Value:	
2nd Value:	
Value Percent:	5.000
Continuous Index:	
Within 8" of Joint:	NO
Remarks:

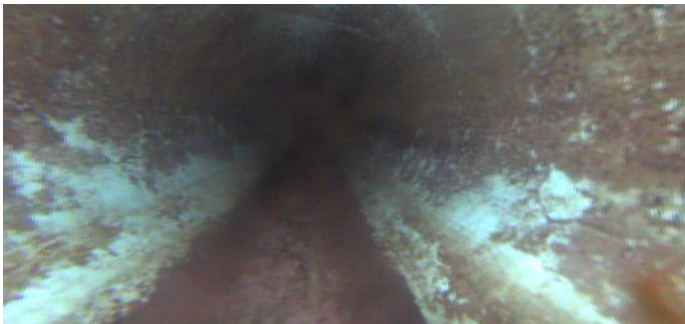
Code:	MSA
Description:	Abandoned Survey

Distance (ft):	93.1
Structural Grade:	0
O&M Grade:	0
Clock Start/From:	
Clock To:	
1st Value:	
2nd Value:	
Value Percent:	
Continuous Index:	
Within 8" of Joint:	NO
Remarks:	camera stopped
