## Profile/Photo Observation Report

Street:	<b>FOXCROFT STREET</b>	Flow Control:	<b>Not Controlled</b>
City:	<b>Hobart, IN</b>	Year Renewed:	
Location:	<b>Yard</b>	Tape/Media #:	
Purpose:	<b>Routine Assessment</b>	Dia/Height:	<b>8"</b>
Use:	<b>Sanitary</b>	Material:	<b>PVC</b>
Drain Area:	<b>NA</b>	Lining:	
Category:	<b>NA</b>		
Comment:

Location Details:		Direction of Survey:	<b>Upstream</b>
US MH:	<b>M-608-019</b>	DS MH:	<b>M-608-019A</b>
		Total Length Surveyed (ft):	<b>3.2</b>

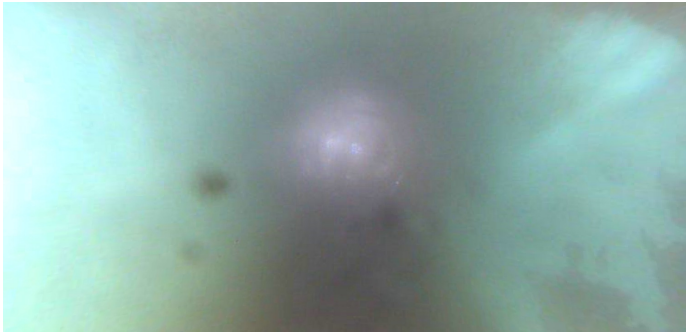
Code:	<b>MWL</b>
Description:	<b>Water Level</b>

Distance (ft):	<b>.0</b>
Structural Grade:	<b>0</b>
O&M Grade:	<b>0</b>
Clock Start/From:	
Clock To:	
1st Value:	
2nd Value:	
Value Percent:	<b>5.000</b>
Continuous Index:	
Within 8" of Joint:	<b>NO</b>
Remarks:

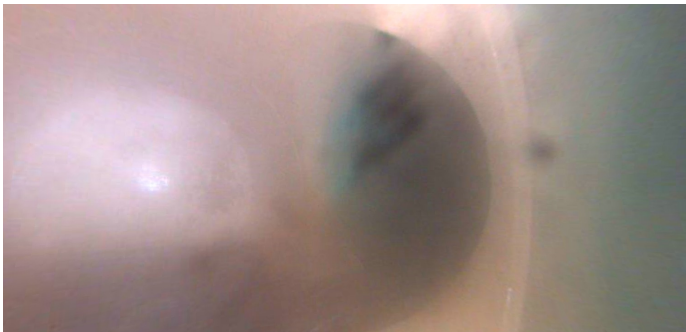
Code:	<b>TF</b>
Description:	<b>Tap Factory</b>

Distance (ft):	<b>2.5</b>
Structural Grade:	<b>0</b>
O&M Grade:	<b>0</b>
Clock Start/From:	<b>3</b>
Clock To:	
1st Value:	<b>4.000</b>
2nd Value:	
Value Percent:	
Continuous Index:	
Within 8" of Joint:	
Remarks:

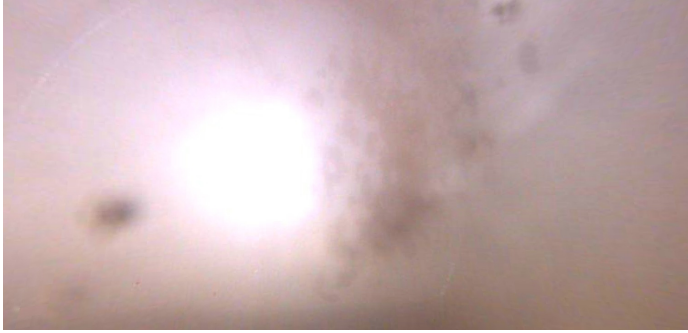
Code:	<b>AEP</b>
Description:	<b>End of Pipe</b>
Distance (ft):	<b>3.2</b>
Structural Grade:	<b>0</b>
O&M Grade:	<b>0</b>
Clock Start/From:	
Clock To:	
1st Value:	
2nd Value:	
Value Percent:	
Continuous Index:	
Within 8" of Joint:	<b>NO</b>
Remarks:	<b>M-608-019</b>
