Profile/Photo Observation Report

Street:	FOXCROFT STREET	Flow Control:	Not Controlled
City:	Hobart, IN	Year Renewed:	
Location:	Yard	Tape/Media #:	
Purpose:	Routine Assessment	Dia/Height:	8"
Use:	Sanitary	Material:	PVC
Drain Area:	NA	Lining:	
Category:	NA		
Comment:	New MH_F, M-608-019A. Flow direction is marked wrong.		
Location Details:		Direction of Survey:	Upstream
US MH:	M-608-019A	DS MH:	M-608-018
		Total Length Surveyed (ft):	179.2

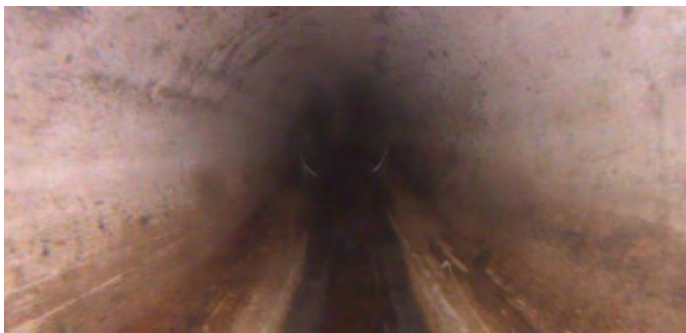
Code: **AMH**
Description: **Manhole**

Distance (ft): **.0**
Structural Grade: **0**
O&M Grade: **0**
Clock Start/From:
Clock To:
1st Value:
2nd Value:
Value Percent:
Continuous Index:
Within 8" of Joint: **NO**
Remarks: **M-608-018**

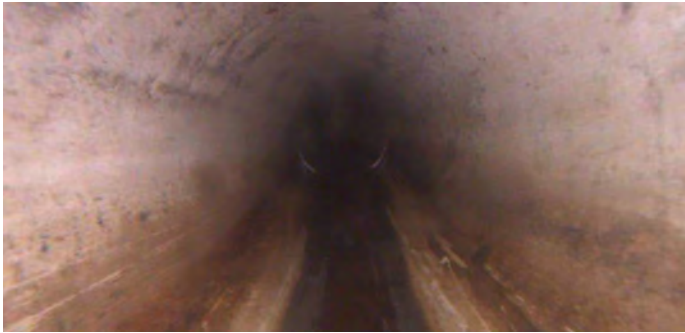
Code:	MWL
Description:	Water Level

Distance (ft):	.0
Structural Grade:	0
O&M Grade:	0
Clock Start/From:	
Clock To:	
1st Value:	
2nd Value:	
Value Percent:	5.000
Continuous Index:	
Within 8" of Joint:	NO
Remarks:

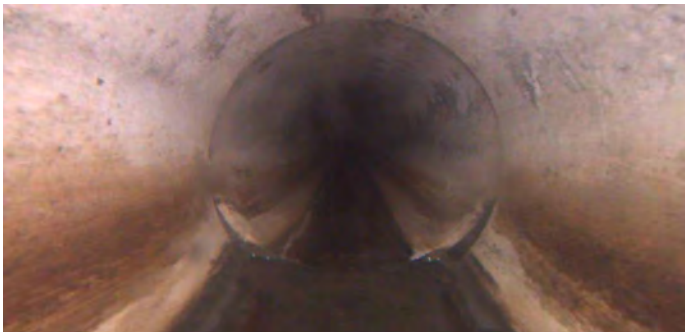
Code:	JOM
Description:	Joint Offset Medium

Distance (ft):	2.4
Structural Grade:	1
O&M Grade:	0
Clock Start/From:	
Clock To:	
1st Value:	
2nd Value:	
Value Percent:	
Continuous Index:	
Within 8" of Joint:	NO
Remarks:

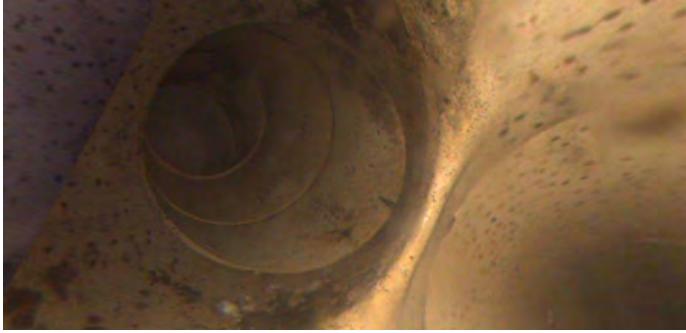
Code: **TF**
Description: **Tap Factory**

Distance (ft): **172.9**
Structural Grade: **0**
O&M Grade: **0**
Clock Start/From: **2**
Clock To:
1st Value: **4.000**
2nd Value:
Value Percent:
Continuous Index:
Within 8" of Joint:
Remarks:

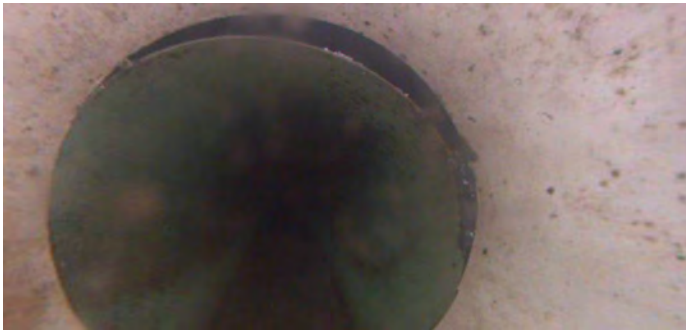
Code: **JOM**
Description: **Joint Offset Medium**

Distance (ft): **174.1**
Structural Grade: **1**
O&M Grade: **0**
Clock Start/From:
Clock To:
1st Value:
2nd Value:
Value Percent:
Continuous Index:
Within 8" of Joint: **NO**
Remarks:
