## Profile/Photo Observation Report

Street:	<b>FOXCROFT STREET</b>	Flow Control:	<b>Not Controlled</b>
City:	<b>Hobart, IN</b>	Year Renewed:	
Location:	<b>Yard</b>	Tape/Media #:	
Purpose:	<b>Routine Assessment</b>	Dia/Height:	<b>8"</b>
Use:	<b>Sanitary</b>	Material:	<b>PVC</b>
Drain Area:	<b>NA</b>	Lining:	
Category:	<b>NA</b>		
Comment:	<b>New MH_F, M-608-019A. Flow direction is marked wrong.</b>		
Location Details:		Direction of Survey:	<b>Upstream</b>
US MH:	<b>M-608-019A</b>	DS MH:	<b>M-608-018</b>
		Total Length Surveyed (ft):	<b>179.2</b>

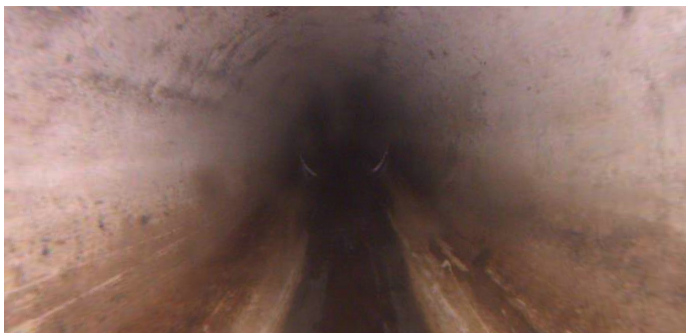
Code: **AMH**  
Description: **Manhole**

Distance (ft): **.0**  
Structural Grade: **0**  
O&M Grade: **0**  
Clock Start/From:  
Clock To:  
1st Value:  
2nd Value:  
Value Percent:  
Continuous Index:  
Within 8" of Joint: **NO**  
Remarks: **M-608-018**

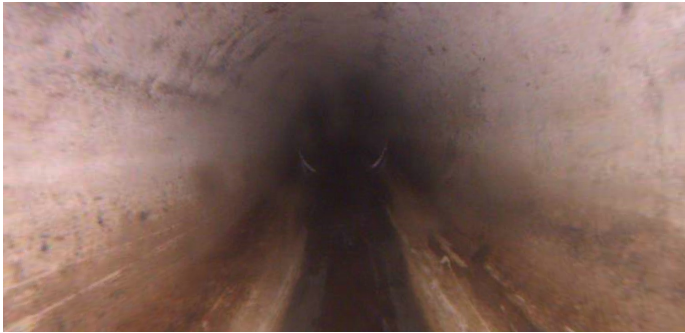
Code:	<b>MWL</b>
Description:	<b>Water Level</b>

Distance (ft):	<b>.0</b>
Structural Grade:	<b>0</b>
O&M Grade:	<b>0</b>
Clock Start/From:	
Clock To:	
1st Value:	
2nd Value:	
Value Percent:	<b>5.000</b>
Continuous Index:	
Within 8" of Joint:	<b>NO</b>
Remarks:

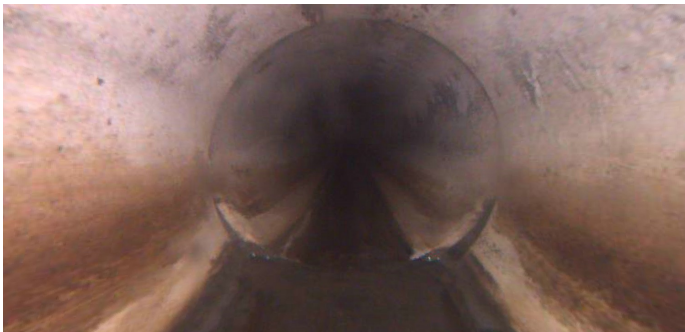
Code:	<b>JOM</b>
Description:	<b>Joint Offset Medium</b>

Distance (ft):	<b>2.4</b>
Structural Grade:	<b>1</b>
O&M Grade:	<b>0</b>
Clock Start/From:	
Clock To:	
1st Value:	
2nd Value:	
Value Percent:	
Continuous Index:	
Within 8" of Joint:	<b>NO</b>
Remarks:

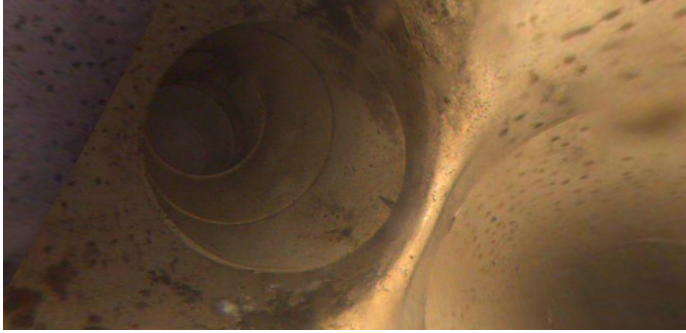
Code: **TF**  
Description: **Tap Factory**

Distance (ft): **172.9**  
Structural Grade: **0**  
O&M Grade: **0**  
Clock Start/From: **2**  
Clock To:  
1st Value: **4.000**  
2nd Value:  
Value Percent:  
Continuous Index:  
Within 8" of Joint:  
Remarks:

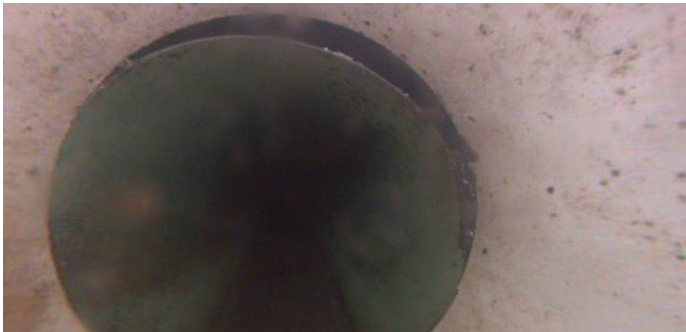
Code: **JOM**  
Description: **Joint Offset Medium**

Distance (ft): **174.1**  
Structural Grade: **1**  
O&M Grade: **0**  
Clock Start/From:  
Clock To:  
1st Value:  
2nd Value:  
Value Percent:  
Continuous Index:  
Within 8" of Joint: **NO**  
Remarks:
