Profile/Photo Observation Report

Date:	10/12/2018	Weather:		Coding:	PACP 6.0
Pipe Length (ft):	107.4	Owner:	NA	Pre Clean:	Not Known
P.O.#:		Surveyor:	Selasie Honu	PSR:	P-608-020-021
Customer:		Clean Date:	01/01/1900	Shape:	C

Street:	OFF S ASH ST	Flow Control:	Not Controlled
City:	Hobart, IN	Year Renewed:	
Location:	Light Highway	Tape/Media #:	
Purpose:	Routine Assessment	Dia/Height:	8"
Use:	Sanitary	Material:	VCP
Drain Area:	NA	Lining:	
Category:	NA		
Comment:

Location Details:		Direction of Survey:	Upstream
US MH:	M-608-021	DS MH:	M-608-020
		Total Length Surveyed (ft):	108.0

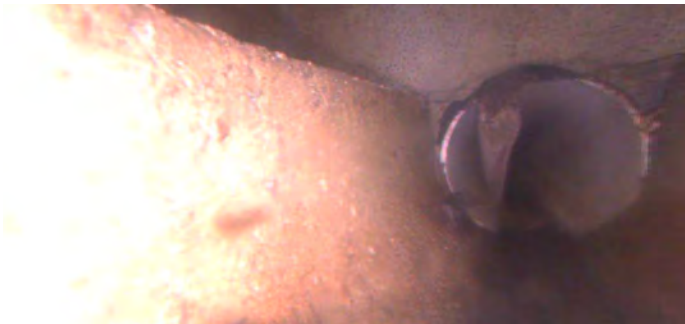
Code:	AMH
Description:	Manhole

Distance (ft):	108.0
Structural Grade:	0
O&M Grade:	0
Clock Start/From:	
Clock To:	
1st Value:	
2nd Value:	
Value Percent:	
Continuous Index:	
Within 8" of Joint:	NO
Remarks:	M-608-021
