Profile/Photo Observation Report

Street:	OFF S ASH ST	Flow Control:	Not Controlled
City:	Hobart, IN	Year Renewed:	
Location:	Yard	Tape/Media #:	
Purpose:	Routine Assessment	Dia/Height:	12"
Use:	Sanitary	Material:	PVC
Drain Area:	NA	Lining:	
Category:	NA		
Comment:

Location Details:		Direction of Survey:	Downstream
US MH:	M-608-025	DS MH:	M-608-024
		Total Length Surveyed (ft):	141.1

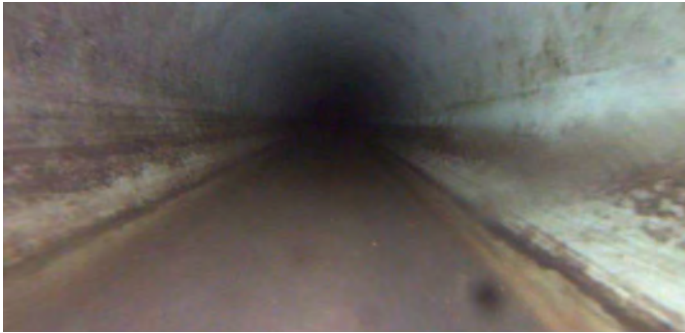
Code:	MWL
Description:	Water Level

Distance (ft):	.0
Structural Grade:	0
O&M Grade:	0
Clock Start/From:	
Clock To:	
1st Value:	
2nd Value:	
Value Percent:	20.000
Continuous Index:	
Within 8" of Joint:	NO
Remarks:

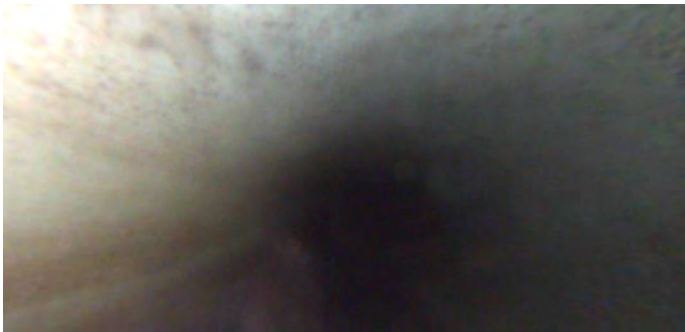
Code:	MSA
Description:	Abandoned Survey

Distance (ft):	141.1
Structural Grade:	0
O&M Grade:	0
Clock Start/From:	
Clock To:	
1st Value:	
2nd Value:	
Value Percent:	
Continuous Index:	
Within 8" of Joint:	NO
Remarks:	OVERTURNED
