Profile/Photo Observation Report

Street:	FOXCROFT STREET	Flow Control:	Not Controlled
City:	Hobart, IN	Year Renewed:	
Location:	Yard	Tape/Media #:	
Purpose:	Routine Assessment	Dia/Height:	12"
Use:	Sanitary	Material:	PVC
Drain Area:	NA	Lining:	
Category:	NA		
Comment:

Location Details:		Direction of Survey:	Downstream
US MH:	M-608-025	DS MH:	M-608-024
		Total Length Surveyed (ft):	141.1

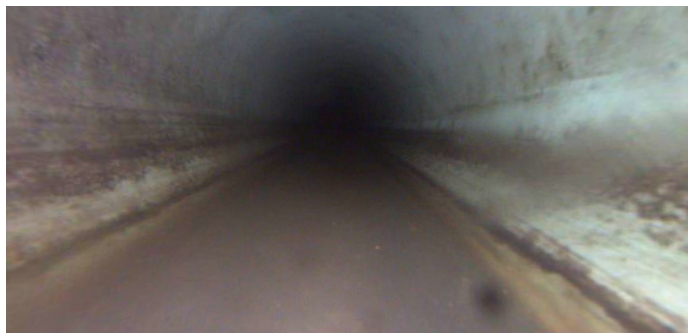
Code: **AMH**
 Description: **Manhole**
 Distance (ft): **.0**
 Structural Grade: **0**
 O&M Grade: **0**
 Clock Start/From:
 Clock To:
 1st Value:
 2nd Value:
 Value Percent:
 Continuous Index:
 Within 8" of Joint: **NO**
 Remarks: **M-608-025**

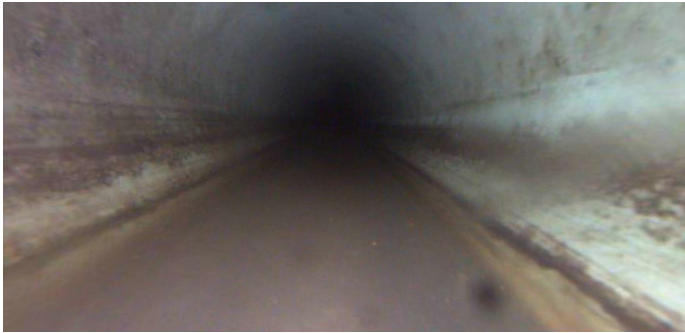
Code:	MWL
Description:	Water Level

Distance (ft):	.0
Structural Grade:	0
O&M Grade:	0
Clock Start/From:	
Clock To:	
1st Value:	
2nd Value:	
Value Percent:	20.000
Continuous Index:	
Within 8" of Joint:	NO
Remarks:

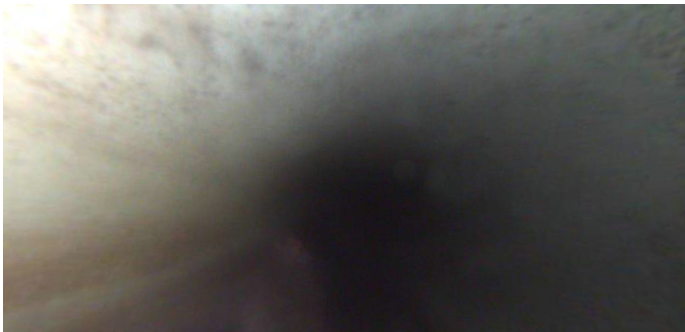
Code:	MSA
Description:	Abandoned Survey

Distance (ft):	141.1
Structural Grade:	0
O&M Grade:	0
Clock Start/From:	
Clock To:	
1st Value:	
2nd Value:	
Value Percent:	
Continuous Index:	
Within 8" of Joint:	NO
Remarks:	OVERTURNED
