Profile/Photo Observation Report

Street:	FOXCROFT STREET	Flow Control:	Not Controlled
City:	Hobart, IN	Year Renewed:	
Location:	Yard	Tape/Media #:	
Purpose:	Routine Assessment	Dia/Height:	12"
Use:	Sanitary	Material:	PVC
Drain Area:	NA	Lining:	
Category:	NA		
Comment:

Location Details:		Direction of Survey:	Upstream
US MH:	M-608-025	DS MH:	M-608-024
		Total Length Surveyed (ft):	151.9

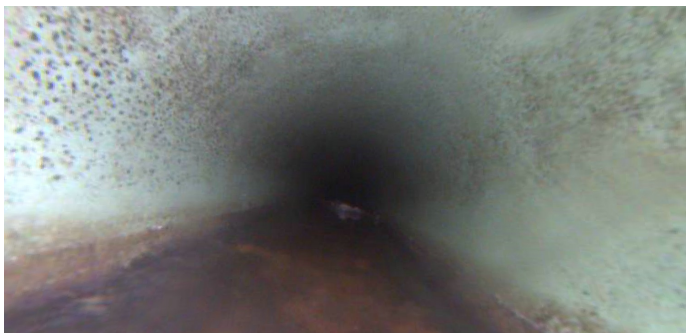
Code: **AMH**
Description: **Manhole**

Distance (ft): **.0**
Structural Grade: **0**
O&M Grade: **0**
Clock Start/From:
Clock To:
1st Value:
2nd Value:
Value Percent:
Continuous Index:
Within 8" of Joint: **NO**
Remarks: **M-608-024**

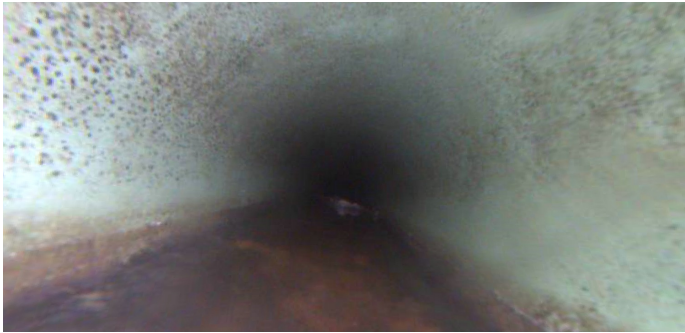
Code:	MWL
Description:	Water Level

Distance (ft):	.0
Structural Grade:	0
O&M Grade:	0
Clock Start/From:	
Clock To:	
1st Value:	
2nd Value:	
Value Percent:	20.000
Continuous Index:	
Within 8" of Joint:	NO
Remarks:

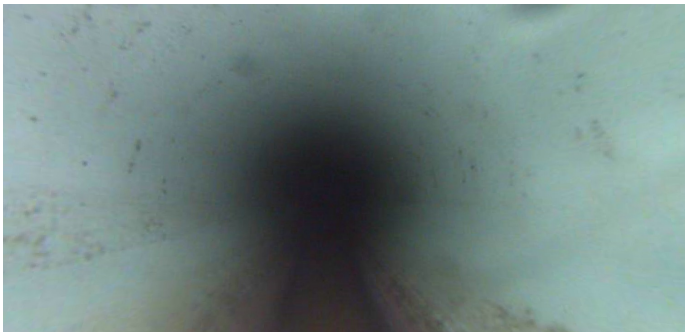
Code:	MWL
Description:	Water Level

Distance (ft):	30.6
Structural Grade:	0
O&M Grade:	0
Clock Start/From:	
Clock To:	
1st Value:	
2nd Value:	
Value Percent:	5.000
Continuous Index:	
Within 8" of Joint:	NO
Remarks:

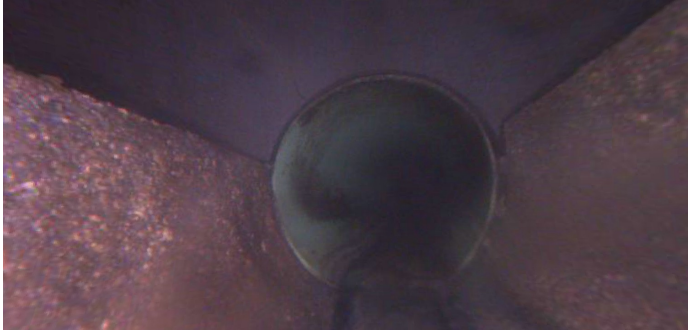
Code:	AMH
Description:	Manhole
Distance (ft):	151.9
Structural Grade:	0
O&M Grade:	0
Clock Start/From:	
Clock To:	
1st Value:	
2nd Value:	
Value Percent:	
Continuous Index:	
Within 8" of Joint:	NO
Remarks:	M-608-025
