Profile/Photo Observation Report

Date:	04/04/2018	Weather:		Coding:	PACP 6.0
Pipe Length (ft):	240.2	Owner:	NA	Pre Clean:	No Pre-Cleaning
P.O.#:		Surveyor:	Jen Costello	PSR:	P-608-025-026
Customer:		Clean Date:	01/01/1900	Shape:	C

Street:	FOXCROFT STREET	Flow Control:	Not Controlled
City:	Hobart, IN	Year Renewed:	
Location:	Yard	Tape/Media #:	
Purpose:	Routine Assessment	Dia/Height:	12"
Use:	Sanitary	Material:	PVC
Drain Area:	NA	Lining:	
Category:	NA		
Comment:

Location Details:		Direction of Survey:	Upstream
US MH:	M-608-026	DS MH:	M-608-025
		Total Length Surveyed (ft):	239.3

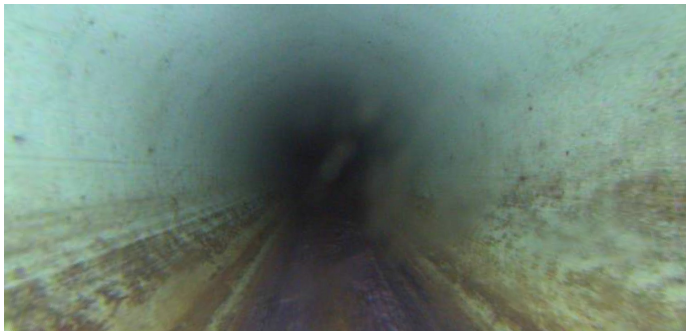
Code: **AMH**
Description: **Manhole**

Distance (ft): **.0**
Structural Grade: **0**
O&M Grade: **0**
Clock Start/From:
Clock To:
1st Value:
2nd Value:
Value Percent:
Continuous Index:
Within 8" of Joint: **NO**
Remarks: **M-608-025**

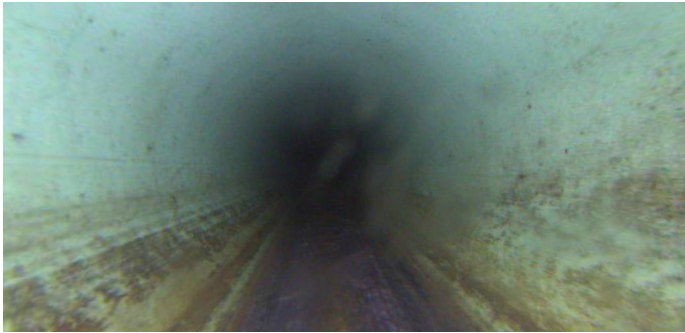
Code:	MWL
Description:	Water Level

Distance (ft):	.0
Structural Grade:	0
O&M Grade:	0
Clock Start/From:	
Clock To:	
1st Value:	
2nd Value:	
Value Percent:	5.000
Continuous Index:	
Within 8" of Joint:	NO
Remarks:

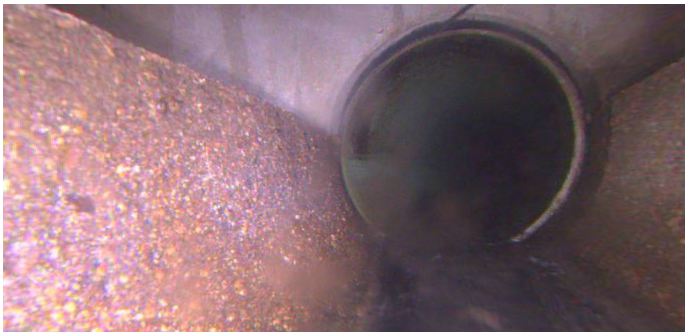
Code:	AMH
Description:	Manhole

Distance (ft):	239.3
Structural Grade:	0
O&M Grade:	0
Clock Start/From:	
Clock To:	
1st Value:	
2nd Value:	
Value Percent:	
Continuous Index:	
Within 8" of Joint:	NO
Remarks:	M-608-026
