Profile/Photo Observation Report

Street:	OFF W 14TH ST	Flow Control:	Not Controlled
City:	Hobart, IN	Year Renewed:	
Location:	Yard	Tape/Media #:	
Purpose:	Routine Assessment	Dia/Height:	12"
Use:	Sanitary	Material:	PVC
Drain Area:	NA	Lining:	
Category:	NA		
Comment:	Flow direction marked wrong.

Location Details:		Direction of Survey:	Downstream
US MH:	M-608-027	DS MH:	M-608-026
		Total Length Surveyed (ft):	63.0

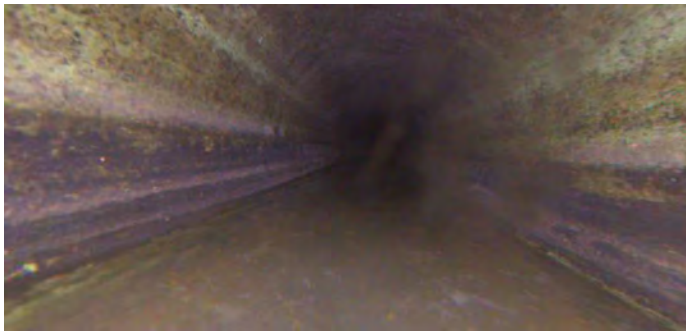
Code: **AMH**
Description: **Manhole**

Distance (ft): **.0**
Structural Grade: **0**
O&M Grade: **0**
Clock Start/From:
Clock To:
1st Value:
2nd Value:
Value Percent:
Continuous Index:
Within 8" of Joint: **NO**
Remarks: **M-608-027**

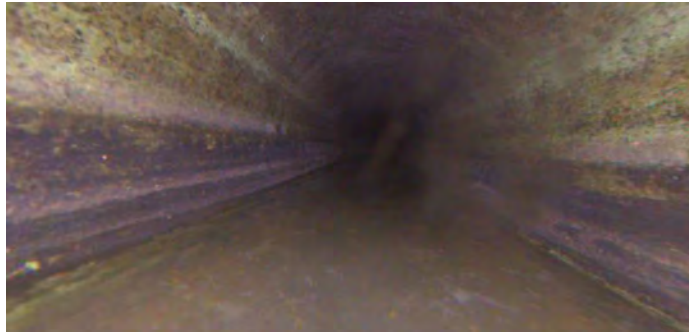
Code:	MWL
Description:	Water Level
Distance (ft):	.0
Structural Grade:	0
O&M Grade:	0
Clock Start/From:	
Clock To:	
1st Value:	
2nd Value:	
Value Percent:	30.000
Continuous Index:	
Within 8" of Joint:	NO
Remarks:

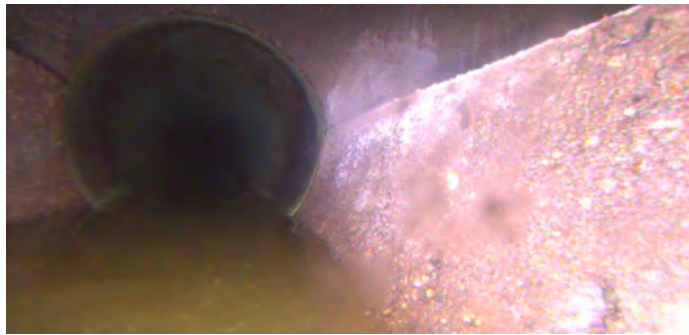
Code:	AMH
Description:	Manhole
Distance (ft):	63.0
Structural Grade:	0
O&M Grade:	0
Clock Start/From:	
Clock To:	
1st Value:	
2nd Value:	
Value Percent:	
Continuous Index:	
Within 8" of Joint:	NO
Remarks:	M-608-026
