Profile/Photo Observation Report

Date:	04/05/2018	Weather:		Coding:	PACP 6.0
Pipe Length (ft):	133.3	Owner:	NA	Pre Clean:	No Pre-Cleaning
P.O.#:		Surveyor:	Jen Costello	PSR:	P-608-032-033
Customer:		Clean Date:	01/01/1900	Shape:	C

Street:	OFF W 14TH ST	Flow Control:	Not Controlled
City:	Hobart, IN	Year Renewed:	
Location:	Yard	Tape/Media #:	
Purpose:	Routine Assessment	Dia/Height:	12"
Use:	Sanitary	Material:	PVC
Drain Area:	NA	Lining:	
Category:	NA		
Comment:	Flow direction is marked wrong.		
Location Details:		Direction of Survey:	Upstream
US MH:	M-608-033	DS MH:	M-608-032
		Total Length Surveyed (ft):	6.7

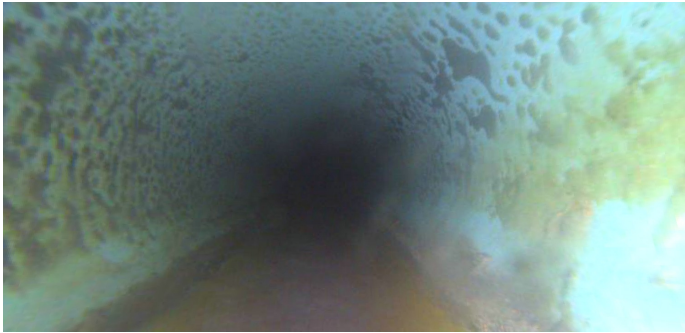
Code:	MWL
Description:	Water Level

Distance (ft):	.0
Structural Grade:	0
O&M Grade:	0
Clock Start/From:	
Clock To:	
1st Value:	
2nd Value:	
Value Percent:	10.000
Continuous Index:	
Within 8" of Joint:	NO
Remarks:

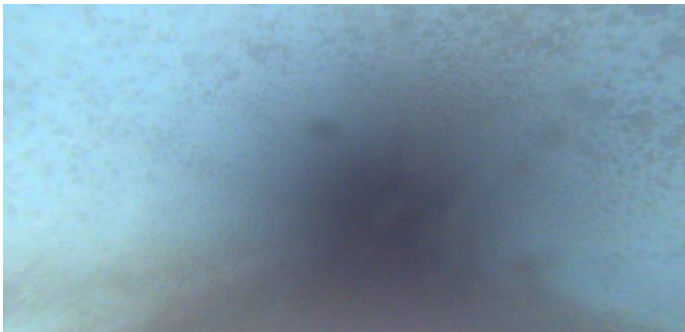
Code:	MSA
Description:	Abandoned Survey

Distance (ft):	6.7
Structural Grade:	0
O&M Grade:	0
Clock Start/From:	
Clock To:	
1st Value:	
2nd Value:	
Value Percent:	
Continuous Index:	
Within 8" of Joint:	NO
Remarks:	unknown
