Profile/Photo Observation Report

Street:	OFF W 14TH ST	Flow Control:	Not Controlled
City:	Hobart, IN	Year Renewed:	
Location:	Yard	Tape/Media #:	
Purpose:	Routine Assessment	Dia/Height:	12"
Use:	Sanitary	Material:	PVC
Drain Area:	NA	Lining:	
Category:	NA		
Comment:	Flow direction is wrong.

Location Details:		Direction of Survey:	Upstream
US MH:	M-608-034	DS MH:	M-608-033
		Total Length Surveyed (ft):	120.7

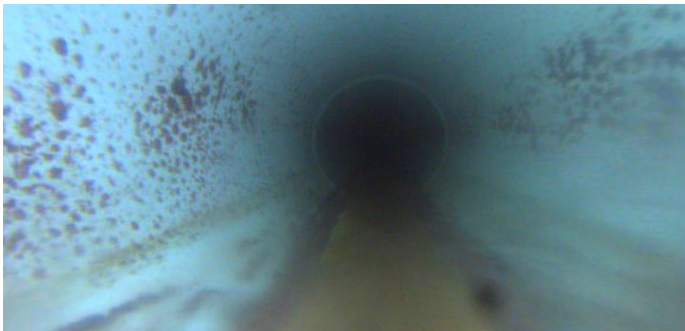
Code: **AMH**
Description: **Manhole**

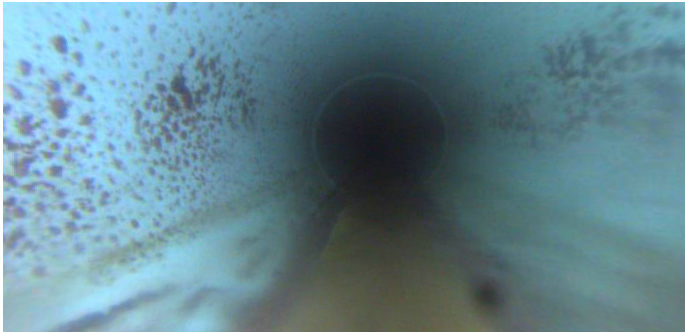
Code:	MWL
Description:	Water Level

Distance (ft):	.0
Structural Grade:	0
O&M Grade:	0
Clock Start/From:	
Clock To:	
1st Value:	
2nd Value:	
Value Percent:	5.000
Continuous Index:	
Within 8" of Joint:	NO
Remarks:

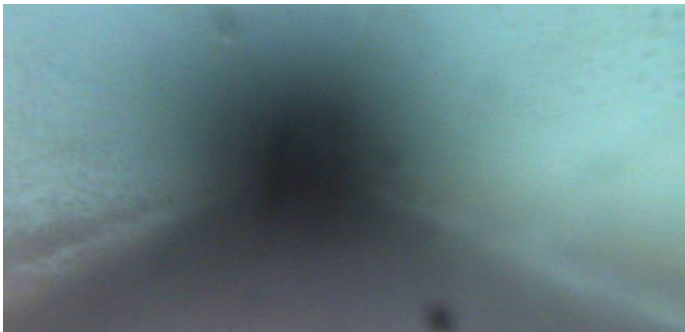
Code:	MWL
Description:	Water Level

Distance (ft):	67.6
Structural Grade:	0
O&M Grade:	0
Clock Start/From:	
Clock To:	
1st Value:	
2nd Value:	
Value Percent:	20.000
Continuous Index:	
Within 8" of Joint:	NO
Remarks:

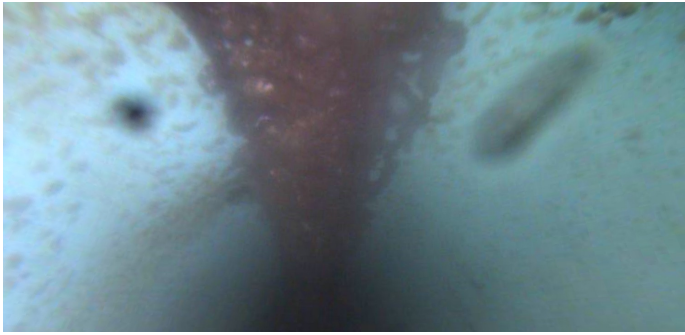
Code: **DAGS**
Description: **Deposits Attached Grease**

Distance (ft): **73.9**
Structural Grade: **0**
O&M Grade: **2**
Clock Start/From: **11**
Clock To: **1**
1st Value:
2nd Value:
Value Percent: **5.000**
Continuous Index: **S01**
Within 8" of Joint: **NO**
Remarks:

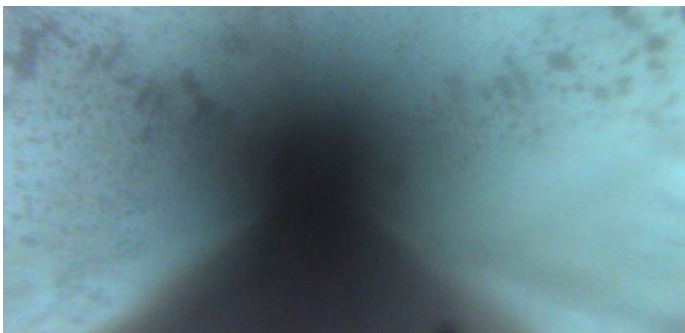
Code: **DAGS**
Description: **Deposits Attached Grease**

Distance (ft): **87.2**
Structural Grade: **0**
O&M Grade: **2**
Clock Start/From: **11**
Clock To: **1**
1st Value:
2nd Value:
Value Percent: **5.000**
Continuous Index: **F01**
Within 8" of Joint: **NO**
Remarks:

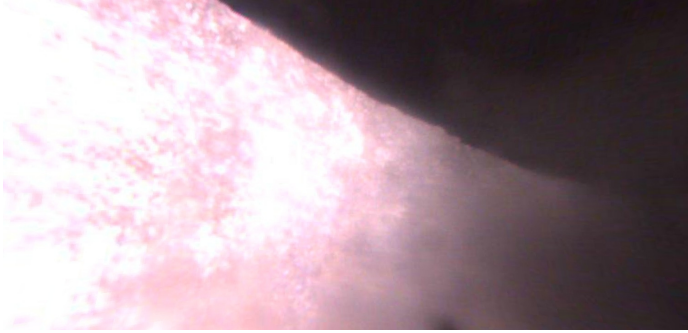
Code:	AMH
Description:	Manhole
Distance (ft):	120.7
Structural Grade:	0
O&M Grade:	0
Clock Start/From:	
Clock To:	
1st Value:	
2nd Value:	
Value Percent:	
Continuous Index:	
Within 8" of Joint:	NO
Remarks:	M-608-034
