Profile/Photo Observation Report

Date:	04/05/2018	Weather:		Coding:	PACP 6.0
Pipe Length (ft):	118.2	Owner:	NA	Pre Clean:	No Pre-Cleaning
P.O.#:		Surveyor:	Jen Costello	PSR:	P-608-033-034
Customer:		Clean Date:	01/01/1900	Shape:	C

Street:	FOXCROFT STREET	Flow Control:	Not Controlled
City:	Hobart, IN	Year Renewed:	
Location:	Yard	Tape/Media #:	
Purpose:	Routine Assessment	Dia/Height:	12"
Use:	Sanitary	Material:	PVC
Drain Area:	NA	Lining:	
Category:	NA		
Comment:	Flow direction is wrong.		
Location Details:		Direction of Survey:	Upstream
US MH:	M-608-034	DS MH:	M-608-033
		Total Length Surveyed (ft):	120.7

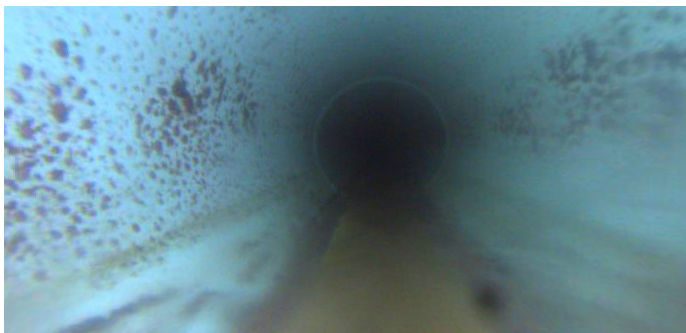
Code: **AMH**
Description: **Manhole**

Distance (ft): **.0**
Structural Grade: **0**
O&M Grade: **0**
Clock Start/From:
Clock To:
1st Value:
2nd Value:
Value Percent:
Continuous Index:
Within 8" of Joint: **NO**
Remarks: **M-608-033**

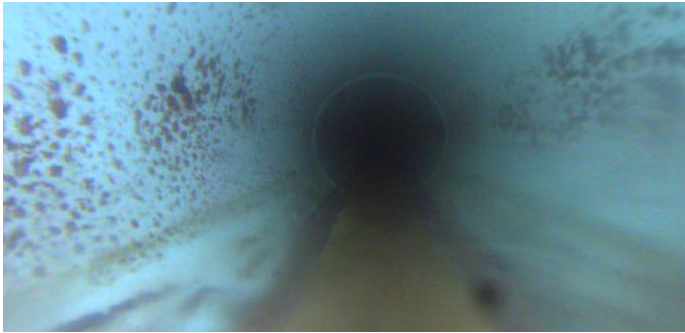
Code:	MWL
Description:	Water Level

Distance (ft):	.0
Structural Grade:	0
O&M Grade:	0
Clock Start/From:	
Clock To:	
1st Value:	
2nd Value:	
Value Percent:	5.000
Continuous Index:	
Within 8" of Joint:	NO
Remarks:

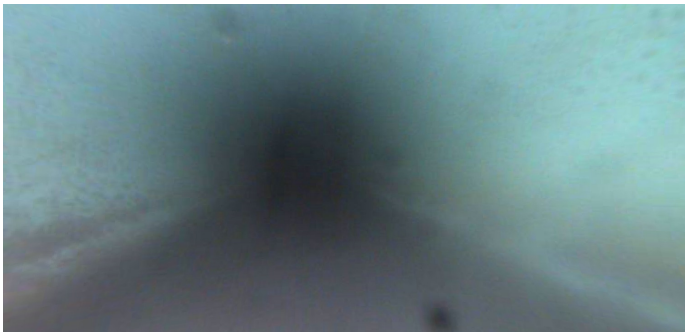
Code:	MWL
Description:	Water Level

Distance (ft):	67.6
Structural Grade:	0
O&M Grade:	0
Clock Start/From:	
Clock To:	
1st Value:	
2nd Value:	
Value Percent:	20.000
Continuous Index:	
Within 8" of Joint:	NO
Remarks:

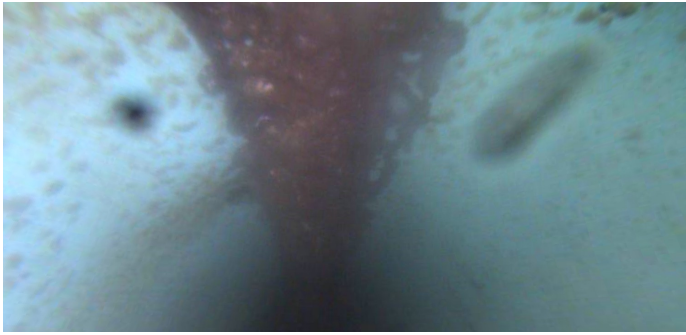
Code: **DAGS**
Description: **Deposits Attached Grease**

Distance (ft): **73.9**
Structural Grade: **0**
O&M Grade: **2**
Clock Start/From: **11**
Clock To: **1**
1st Value:
2nd Value:
Value Percent: **5.000**
Continuous Index: **S01**
Within 8" of Joint: **NO**
Remarks:

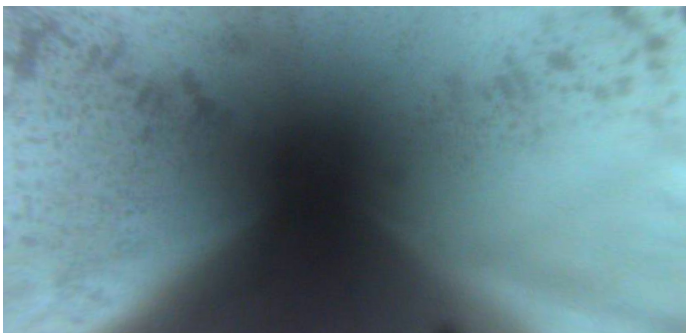
Code: **DAGS**
Description: **Deposits Attached Grease**

Distance (ft): **87.2**
Structural Grade: **0**
O&M Grade: **2**
Clock Start/From: **11**
Clock To: **1**
1st Value:
2nd Value:
Value Percent: **5.000**
Continuous Index: **F01**
Within 8" of Joint: **NO**
Remarks:

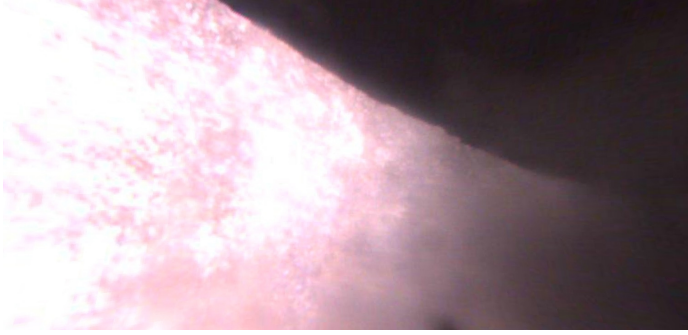
Code:	AMH
Description:	Manhole
Distance (ft):	120.7
Structural Grade:	0
O&M Grade:	0
Clock Start/From:	
Clock To:	
1st Value:	
2nd Value:	
Value Percent:	
Continuous Index:	
Within 8" of Joint:	NO
Remarks:	M-608-034
