Profile/Photo Observation Report

Street:	FOXCROFT STREET	Flow Control:	Not Controlled
City:	Hobart, IN	Year Renewed:	
Location:	Yard	Tape/Media #:	
Purpose:	Routine Assessment	Dia/Height:	8"
Use:	Sanitary	Material:	PVC
Drain Area:	NA	Lining:	
Category:	NA		
Comment:	Flow direction wrong

Location Details:		Direction of Survey:	Downstream
US MH:	M-608-037	DS MH:	M-608-036
		Total Length Surveyed (ft):	196.6

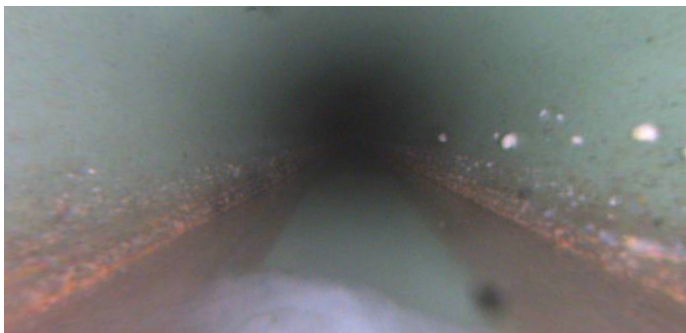
Code: **AMH**
Description: **Manhole**

Distance (ft): **.0**
Structural Grade: **0**
O&M Grade: **0**
Clock Start/From:
Clock To:
1st Value:
2nd Value:
Value Percent:
Continuous Index:
Within 8" of Joint: **NO**
Remarks: **M-608-037**

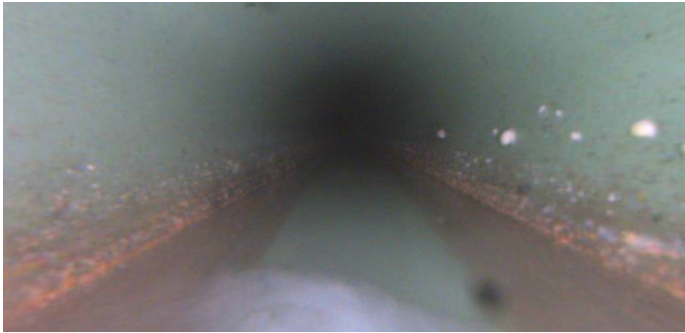
Code:	MWL
Description:	Water Level

Distance (ft):	.0
Structural Grade:	0
O&M Grade:	0
Clock Start/From:	
Clock To:	
1st Value:	
2nd Value:	
Value Percent:	30.000
Continuous Index:	
Within 8" of Joint:	NO
Remarks:

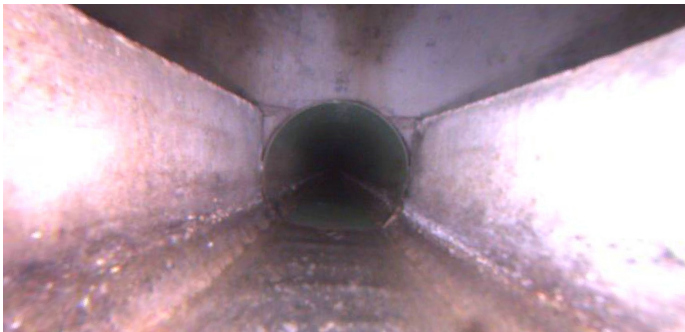
Code:	AMH
Description:	Manhole

Distance (ft):	196.6
Structural Grade:	0
O&M Grade:	0
Clock Start/From:	
Clock To:	
1st Value:	
2nd Value:	
Value Percent:	
Continuous Index:	
Within 8" of Joint:	NO
Remarks:	M-608-036
