Profile/Photo Observation Report

Street:	OFF WASHINGTON ST	Flow Control:	Not Controlled
City:	Hobart, IN	Year Renewed:	
Location:	Yard	Tape/Media #:	
Purpose:	Routine Assessment	Dia/Height:	8"
Use:	Sanitary	Material:	PVC
Drain Area:	NA	Lining:	
Category:	NA		
Comment:	Flow direction wrong		
Location Details:		Direction of Survey:	Upstream
US MH:	M-608-038	DS MH:	M-608-037
		Total Length Surveyed (ft):	104.5

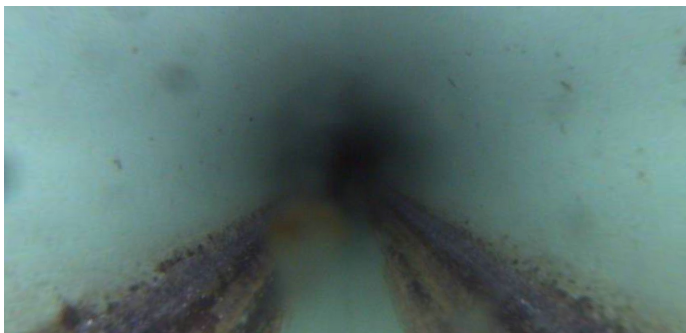
Code: **AMH**
Description: **Manhole**

Distance (ft): **.0**
Structural Grade: **0**
O&M Grade: **0**
Clock Start/From:
Clock To:
1st Value:
2nd Value:
Value Percent:
Continuous Index:
Within 8" of Joint: **NO**
Remarks: **M-608-037**

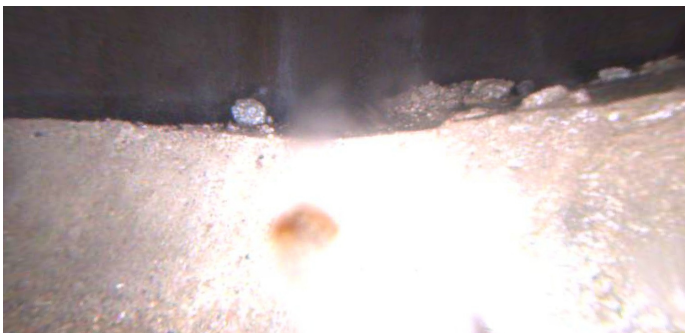
Code: **AMH**
Description: **Manhole**

Distance (ft): **104.5**
Structural Grade: **0**
O&M Grade: **0**
Clock Start/From:
Clock To:
1st Value:
2nd Value:
Value Percent:
Continuous Index:
Within 8" of Joint: **NO**
Remarks: **M-608-038**
