Profile/Photo Observation Report

Date:	03/30/2018	Weather:		Coding:	PACP 6.0
Pipe Length (ft):	106.1	Owner:	NA	Pre Clean:	No Pre-Cleaning
P.O.#:		Surveyor:	Jen Costello	PSR:	P-608-037-038
Customer:		Clean Date:	01/01/1900	Shape:	C

Street:	FOXCROFT STREET	Flow Control:	Not Controlled
City:	Hobart, IN	Year Renewed:	
Location:	Yard	Tape/Media #:	
Purpose:	Routine Assessment	Dia/Height:	8"
Use:	Sanitary	Material:	PVC
Drain Area:	NA	Lining:	
Category:	NA		
Comment:	Flow direction wrong

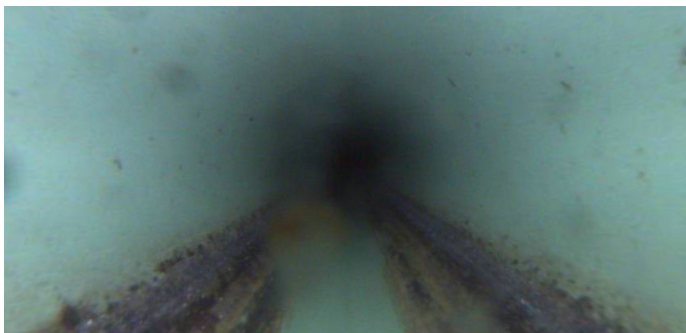
Code: **AMH**
Description: **Manhole**

Distance (ft): **.0**
Structural Grade: **0**
O&M Grade: **0**
Clock Start/From:
Clock To:
1st Value:
2nd Value:
Value Percent:
Continuous Index:
Within 8" of Joint: **NO**
Remarks: **M-608-037**

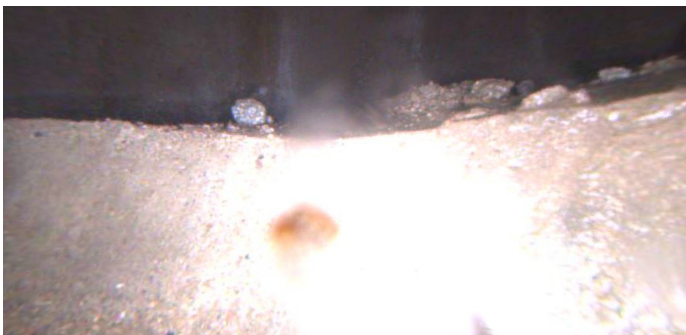
Code: **AMH**
Description: **Manhole**

Distance (ft): **104.5**
Structural Grade: **0**
O&M Grade: **0**
Clock Start/From:
Clock To:
1st Value:
2nd Value:
Value Percent:
Continuous Index:
Within 8" of Joint: **NO**
Remarks: **M-608-038**
