Profile/Photo Observation Report

Date:	03/30/2018	Weather:		Coding:	PACP 6.0
Pipe Length (ft):	363.6	Owner:	NA	Pre Clean:	No Pre-Cleaning
P.O.#:		Surveyor:	Jen Costello	PSR:	P-608-039-040
Customer:		Clean Date:	01/01/1900	Shape:	C

Street:	WASHINGTON ST & ST MARY CIR	Flow Control:	Not Controlled
City:	Hobart, IN	Year Renewed:	
Location:	Light Highway	Tape/Media #:	
Purpose:	Routine Assessment	Dia/Height:	8"
Use:	Sanitary	Material:	PVC
Drain Area:	NA	Lining:	
Category:	NA		
Comment:	Flow direction wrong

Location Details:		Direction of Survey:	Upstream
US MH:	M-608-040	DS MH:	M-608-039
		Total Length Surveyed (ft):	360.5

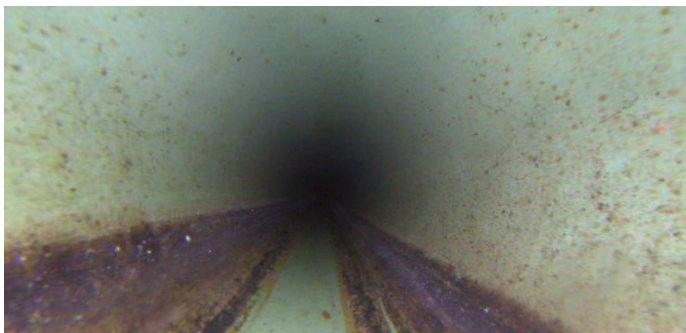
Code: **AMH**
Description: **Manhole**

Distance (ft): **.0**
Structural Grade: **0**
O&M Grade: **0**
Clock Start/From:
Clock To:
1st Value:
2nd Value:
Value Percent:
Continuous Index:
Within 8" of Joint: **NO**
Remarks: **M-608-039**

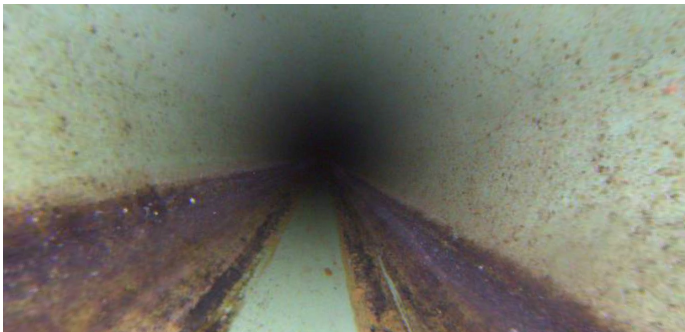
Code:	DAGS
Description:	Deposits Attached Grease

Distance (ft):	.0
Structural Grade:	0
O&M Grade:	2
Clock Start/From:	7
Clock To:	5
1st Value:	
2nd Value:	
Value Percent:	5.000
Continuous Index:	S01
Within 8" of Joint:	NO
Remarks:

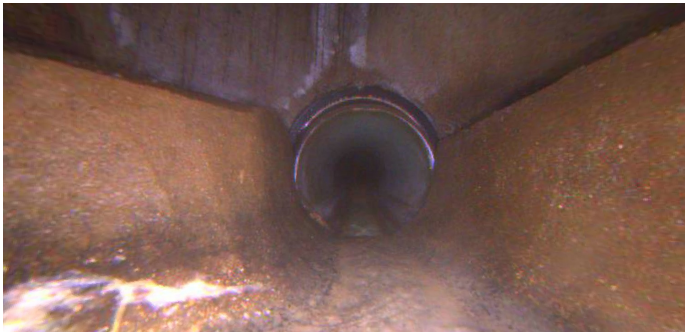
Code: **AMH**
Description: **Manhole**

Distance (ft): **360.5**
Structural Grade: **0**
O&M Grade: **0**
Clock Start/From:
Clock To:
1st Value:
2nd Value:
Value Percent:
Continuous Index:
Within 8" of Joint: **NO**
Remarks: **M-608-040**
