Profile/Photo Observation Report

Date:	03/30/2018	Weather:		Coding:	PACP 6.0
Pipe Length (ft):	363.6	Owner:	NA	Pre Clean:	No Pre-Cleaning
P.O.#:		Surveyor:	Jen Costello	PSR:	P-608-039-040
Customer:		Clean Date:	01/01/1900	Shape:	C

Street:	FOXCROFT STREET	Flow Control:	Not Controlled
City:	Hobart, IN	Year Renewed:	
Location:	Light Highway	Tape/Media #:	
Purpose:	Routine Assessment	Dia/Height:	8"
Use:	Sanitary	Material:	PVC
Drain Area:	NA	Lining:	
Category:	NA		
Comment:	Flow direction wrong		
Location Details:		Direction of Survey:	Upstream
US MH:	M-608-040	DS MH:	M-608-039
		Total Length Surveyed (ft):	360.5

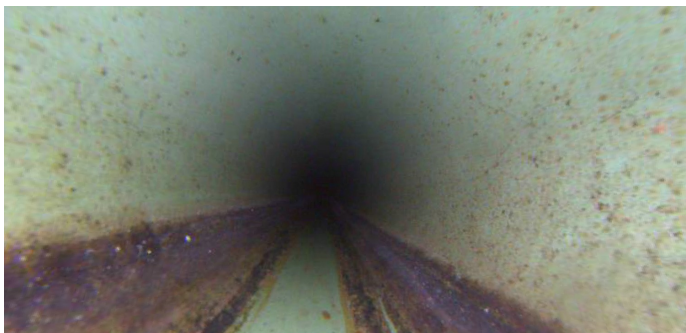
Code: **AMH**
Description: **Manhole**

Distance (ft): **.0**
Structural Grade: **0**
O&M Grade: **0**
Clock Start/From:
Clock To:
1st Value:
2nd Value:
Value Percent:
Continuous Index:
Within 8" of Joint: **NO**
Remarks: **M-608-039**

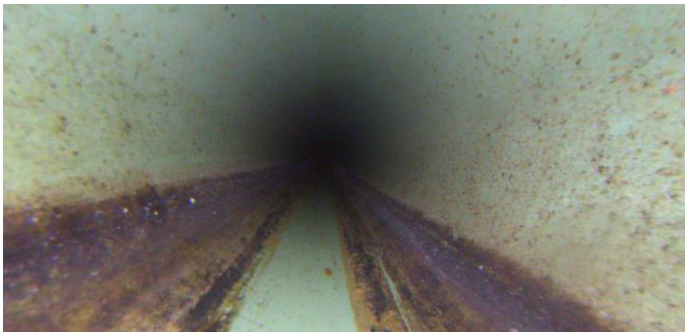
Code:	DAGS
Description:	Deposits Attached Grease

Distance (ft):	.0
Structural Grade:	0
O&M Grade:	2
Clock Start/From:	7
Clock To:	5
1st Value:	
2nd Value:	
Value Percent:	5.000
Continuous Index:	S01
Within 8" of Joint:	NO
Remarks:

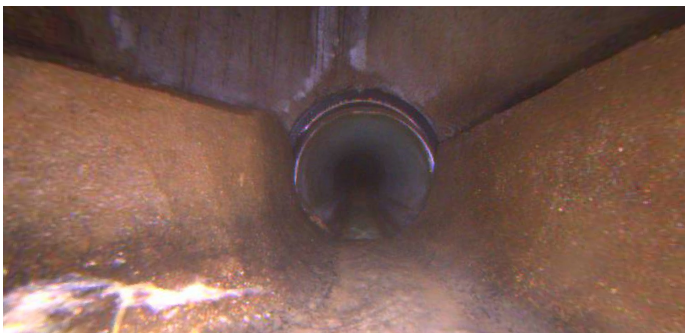
Code: **AMH**
Description: **Manhole**

Distance (ft): **360.5**
Structural Grade: **0**
O&M Grade: **0**
Clock Start/From:
Clock To:
1st Value:
2nd Value:
Value Percent:
Continuous Index:
Within 8" of Joint: **NO**
Remarks: **M-608-040**
