Profile/Photo Observation Report

Street:	FOXCROFT STREET	Flow Control:	Not Controlled
City:	Hobart, IN	Year Renewed:	
Location:	Light Highway	Tape/Media #:	
Purpose:	Routine Assessment	Dia/Height:	10"
Use:	Sanitary	Material:	PVC
Drain Area:	NA	Lining:	
Category:	NA		
Comment:	Flow direction wrong

Location Details:		Direction of Survey:	Downstream
US MH:	M-608-041	DS MH:	M-608-040
		Total Length Surveyed (ft):	337.8

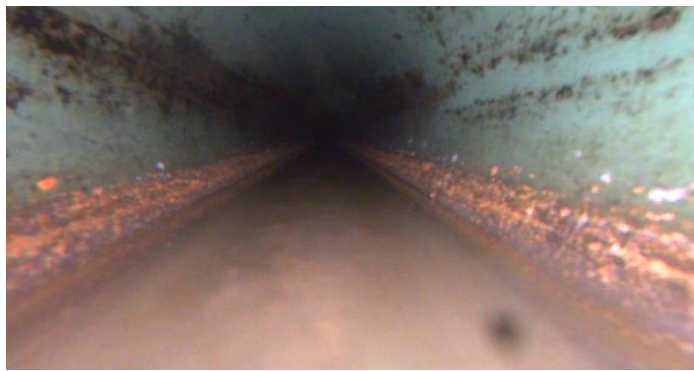
Code: **AMH**
 Description: **Manhole**

Distance (ft): **.0**
 Structural Grade: **0**
 O&M Grade: **0**
 Clock Start/From:
 Clock To:
 1st Value:
 2nd Value:
 Value Percent:
 Continuous Index:
 Within 8" of Joint: **NO**
 Remarks: **M-608-041**

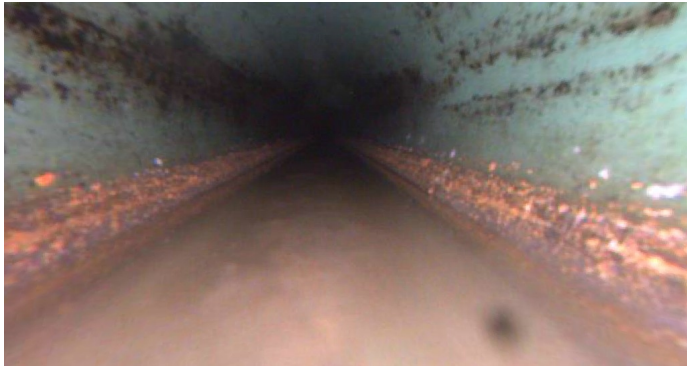
Code:	MWL
Description:	Water Level
Distance (ft):	.0
Structural Grade:	0
O&M Grade:	0
Clock Start/From:	
Clock To:	
1st Value:	
2nd Value:	
Value Percent:	10.000
Continuous Index:	
Within 8" of Joint:	NO
Remarks:

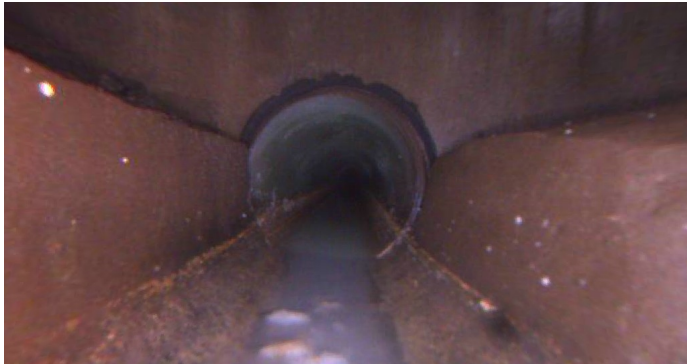
Code:	AMH
Description:	Manhole
Distance (ft):	337.8
Structural Grade:	0
O&M Grade:	0
Clock Start/From:	
Clock To:	
1st Value:	
2nd Value:	
Value Percent:	
Continuous Index:	
Within 8" of Joint:	NO
Remarks:	M-608-040
