Profile/Photo Observation Report

Street:	PHEASANT RUN DR	Flow Control:	Not Controlled
City:	Hobart, IN	Year Renewed:	
Location:	Other	Tape/Media #:	
Purpose:	Not Known	Dia/Height:	10"
Use:	Sanitary	Material:	PVC
Drain Area:	NA	Lining:	
Category:	NA		
Comment:

Location Details:		Direction of Survey:	Upstream
US MH:	M-703-003	DS MH:	M-703-002
		Total Length Surveyed (ft):	181.2

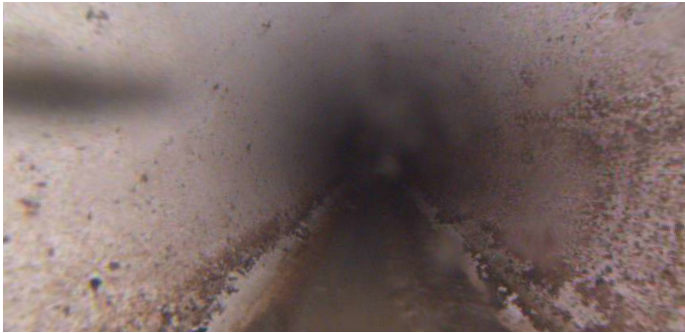
Code:	MWL
Description:	Water Level

Distance (ft):	.0
Structural Grade:	0
O&M Grade:	0
Clock Start/From:	
Clock To:	
1st Value:	
2nd Value:	
Value Percent:	5.000
Continuous Index:	
Within 8" of Joint:	NO
Remarks:

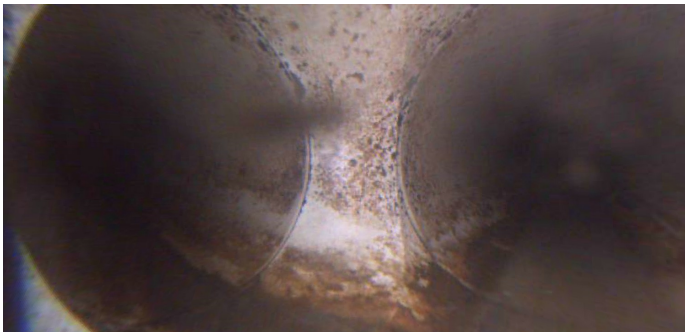
Code:	TFA
Description:	Tap Factory Active

Distance (ft):	8.5
Structural Grade:	0
O&M Grade:	0
Clock Start/From:	9
Clock To:	
1st Value:	4.000
2nd Value:	
Value Percent:	
Continuous Index:	
Within 8" of Joint:	
Remarks:

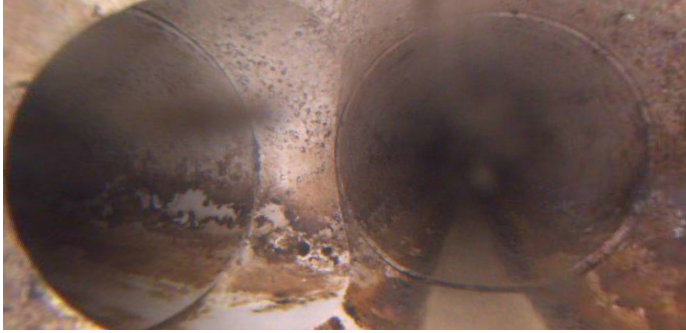
Code: **TF**
Description: **Tap Factory**

Distance (ft): **83.1**
Structural Grade: **0**
O&M Grade: **0**
Clock Start/From: **9**
Clock To:
1st Value: **4.000**
2nd Value:
Value Percent:
Continuous Index:
Within 8" of Joint:
Remarks:

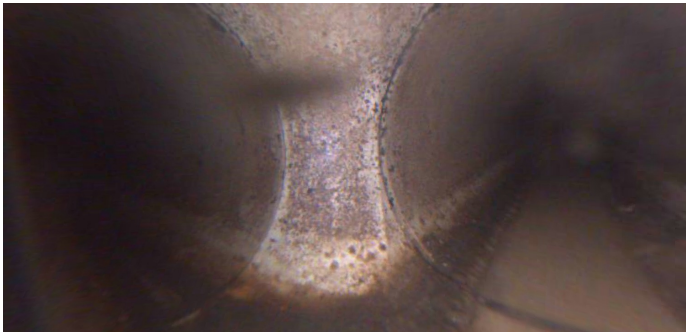
Code: **TFA**
Description: **Tap Factory Active**

Distance (ft): **147.8**
Structural Grade: **0**
O&M Grade: **0**
Clock Start/From: **9**
Clock To:
1st Value: **4.000**
2nd Value:
Value Percent:
Continuous Index:
Within 8" of Joint:
Remarks:

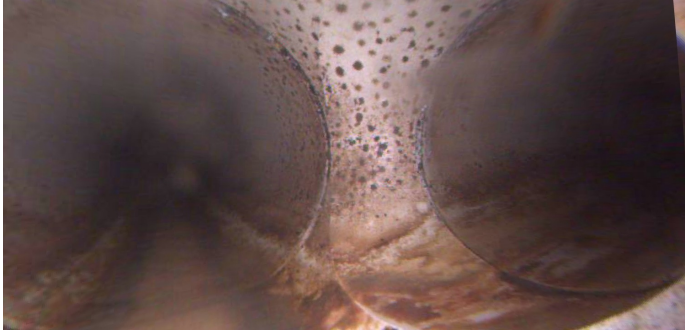
Code: **TFA**
Description: **Tap Factory Active**

Distance (ft): **158.3**
Structural Grade: **0**
O&M Grade: **0**
Clock Start/From: **3**
Clock To:
1st Value: **4.000**
2nd Value:
Value Percent:
Continuous Index:
Within 8" of Joint:
Remarks:

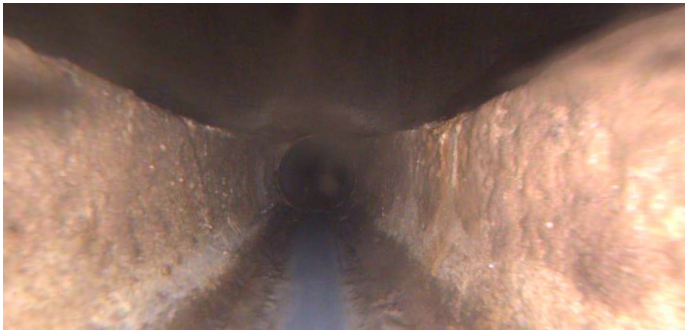
Code: **AMH**
Description: **Manhole**

Distance (ft): **181.2**
Structural Grade: **0**
O&M Grade: **0**
Clock Start/From:
Clock To:
1st Value:
2nd Value:
Value Percent:
Continuous Index:
Within 8" of Joint: **NO**
Remarks: **M-703-003**
