Profile/Photo Observation Report

Date:	03/27/2018	Weather:		Coding:	PACP 6.0
Pipe Length (ft):	303.5	Owner:	NA	Pre Clean:	Not Known
P.O.#:		Surveyor:	Jen Costello	PSR:	P-703-002-003
Customer:		Clean Date:	01/01/1900	Shape:	C

Street:	pheasant run dr	Flow Control:	Not Controlled
City:	Hobart, IN	Year Renewed:	
Location:	Other	Tape/Media #:	
Purpose:	Not Known	Dia/Height:	10"
Use:	Sanitary	Material:	PVC
Drain Area:	NA	Lining:	
Category:	NA		
Comment:

Location Details:		Direction of Survey:	Upstream
US MH:	M-703-003	DS MH:	M-703-002
		Total Length Surveyed (ft):	181.2

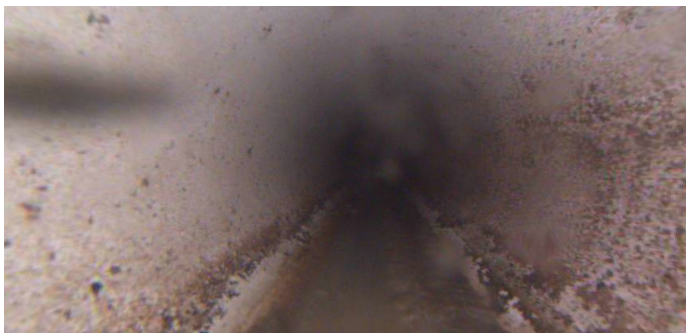
Code: **AMH**
Description: **Manhole**

Distance (ft): **.0**
Structural Grade: **0**
O&M Grade: **0**
Clock Start/From:
Clock To:
1st Value:
2nd Value:
Value Percent:
Continuous Index:
Within 8" of Joint: **NO**
Remarks: **M-703-002**

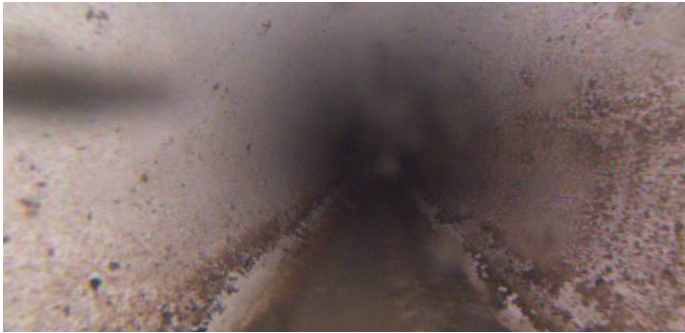
Code:	MWL
Description:	Water Level

Distance (ft):	.0
Structural Grade:	0
O&M Grade:	0
Clock Start/From:	
Clock To:	
1st Value:	
2nd Value:	
Value Percent:	5.000
Continuous Index:	
Within 8" of Joint:	NO
Remarks:

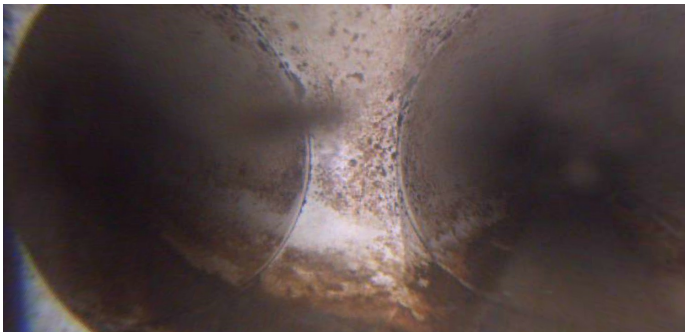
Code:	TFA
Description:	Tap Factory Active

Distance (ft):	8.5
Structural Grade:	0
O&M Grade:	0
Clock Start/From:	9
Clock To:	
1st Value:	4.000
2nd Value:	
Value Percent:	
Continuous Index:	
Within 8" of Joint:	
Remarks:

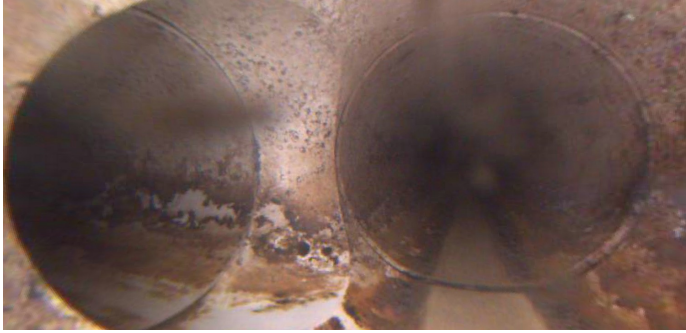
Code: **TF**
Description: **Tap Factory**

Distance (ft): **83.1**
Structural Grade: **0**
O&M Grade: **0**
Clock Start/From: **9**
Clock To:
1st Value: **4.000**
2nd Value:
Value Percent:
Continuous Index:
Within 8" of Joint:
Remarks:

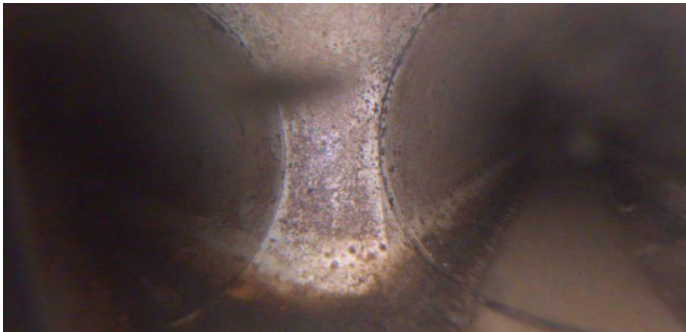
Code: **TFA**
Description: **Tap Factory Active**

Distance (ft): **147.8**
Structural Grade: **0**
O&M Grade: **0**
Clock Start/From: **9**
Clock To:
1st Value: **4.000**
2nd Value:
Value Percent:
Continuous Index:
Within 8" of Joint:
Remarks:

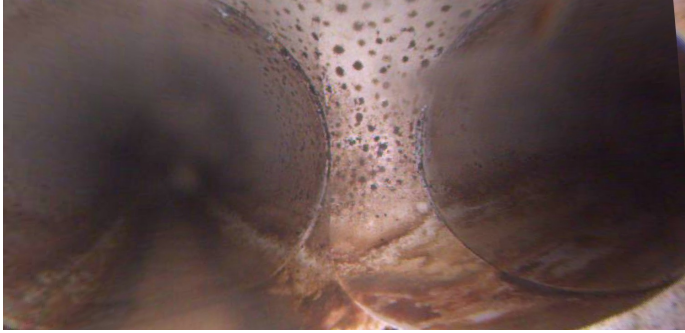
Code: **TFA**
Description: **Tap Factory Active**

Distance (ft): **158.3**
Structural Grade: **0**
O&M Grade: **0**
Clock Start/From: **3**
Clock To:
1st Value: **4.000**
2nd Value:
Value Percent:
Continuous Index:
Within 8" of Joint:
Remarks:

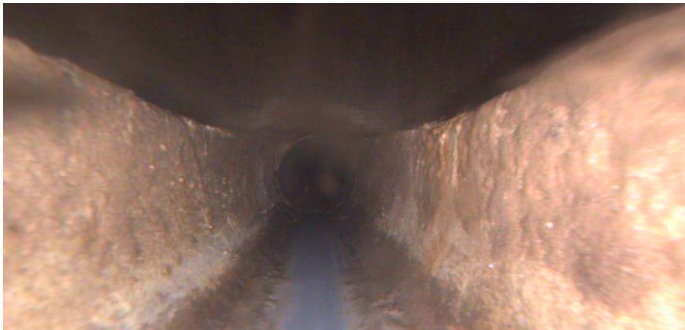
Code: **AMH**
Description: **Manhole**

Distance (ft): **181.2**
Structural Grade: **0**
O&M Grade: **0**
Clock Start/From:
Clock To:
1st Value:
2nd Value:
Value Percent:
Continuous Index:
Within 8" of Joint: **NO**
Remarks: **M-703-003**
