## Profile/Photo Observation Report

Street:	<b>PHEASANT RUN DR</b>	Flow Control:	<b>Not Controlled</b>
City:	<b>Hobart, IN</b>	Year Renewed:	
Location:	<b>Other</b>	Tape/Media #:	
Purpose:	<b>Not Known</b>	Dia/Height:	<b>10"</b>
Use:	<b>Sanitary</b>	Material:	<b>PVC</b>
Drain Area:	<b>NA</b>	Lining:	
Category:	<b>NA</b>		
Comment:

Location Details:		Direction of Survey:	<b>Upstream</b>
US MH:	<b>M-703-004</b>	DS MH:	<b>M-703-003</b>
		Total Length Surveyed (ft):	<b>294.1</b>

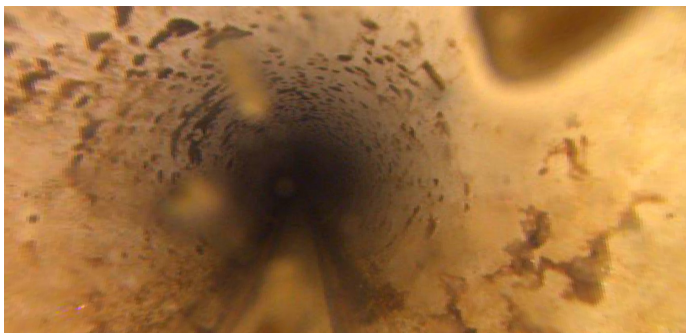
Code: **AMH**  
Description: **Manhole**

Distance (ft): **.0**  
Structural Grade: **0**  
O&M Grade: **0**  
Clock Start/From:  
Clock To:  
1st Value:  
2nd Value:  
Value Percent:  
Continuous Index:  
Within 8" of Joint: **NO**  
Remarks: **M-703-003**

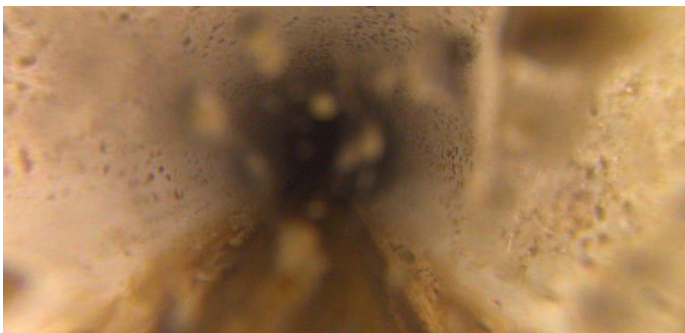
Code: **MWL**  
Description: **Water Level**

Distance (ft): **86.4**  
Structural Grade: **0**  
O&M Grade: **0**  
Clock Start/From:  
Clock To:  
1st Value:  
2nd Value:  
Value Percent: **5.000**  
Continuous Index:  
Within 8" of Joint: **NO**  
Remarks:

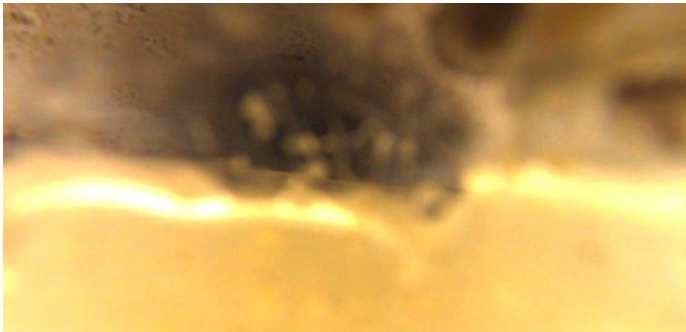
Code: **MWL**  
Description: **Water Level**

Distance (ft): **111.6**  
Structural Grade: **0**  
O&M Grade: **0**  
Clock Start/From:  
Clock To:  
1st Value:  
2nd Value:  
Value Percent: **40.000**  
Continuous Index:  
Within 8" of Joint: **NO**  
Remarks:

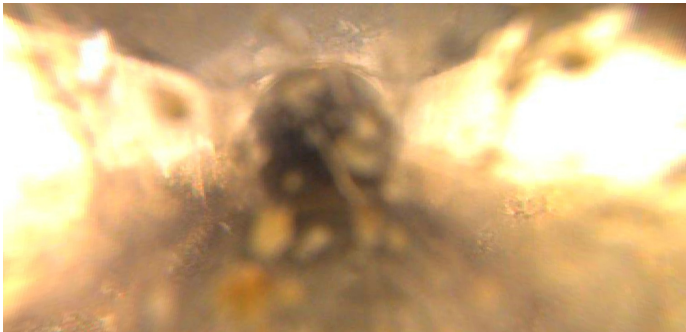
Code: **AMH**  
Description: **Manhole**

Distance (ft): **294.1**  
Structural Grade: **0**  
O&M Grade: **0**  
Clock Start/From:  
Clock To:  
1st Value:  
2nd Value:  
Value Percent:  
Continuous Index:  
Within 8" of Joint: **NO**  
Remarks: **M-703-004**
