Profile/Photo Observation Report

Date:	03/26/2018	Weather:		Coding:	PACP 6.0
Pipe Length (ft):	298.8	Owner:	NA	Pre Clean:	Not Known
P.O.#:		Surveyor:	Justin Gonzales	PSR:	P-703-003-004
Customer:		Clean Date:	01/01/1900	Shape:	C

Street:	pheasant run dr	Flow Control:	Not Controlled
City:	Hobart, IN	Year Renewed:	
Location:	Other	Tape/Media #:	
Purpose:	Not Known	Dia/Height:	10"
Use:	Sanitary	Material:	PVC
Drain Area:	NA	Lining:	
Category:	NA		
Comment:

Location Details:		Direction of Survey:	Upstream
US MH:	M-703-004	DS MH:	M-703-003
		Total Length Surveyed (ft):	294.1

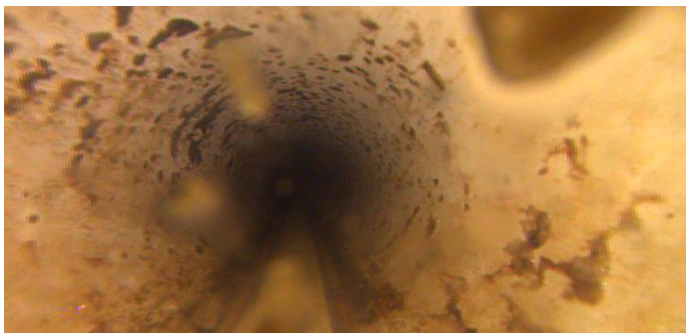
Code: **AMH**
Description: **Manhole**

Distance (ft): **.0**
Structural Grade: **0**
O&M Grade: **0**
Clock Start/From:
Clock To:
1st Value:
2nd Value:
Value Percent:
Continuous Index:
Within 8" of Joint: **NO**
Remarks: **M-703-003**

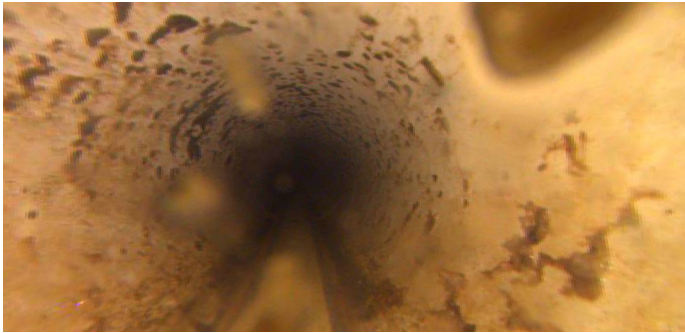
Code:	MWL
Description:	Water Level

Distance (ft):	.0
Structural Grade:	0
O&M Grade:	0
Clock Start/From:	
Clock To:	
1st Value:	
2nd Value:	
Value Percent:	5.000
Continuous Index:	
Within 8" of Joint:	NO
Remarks:

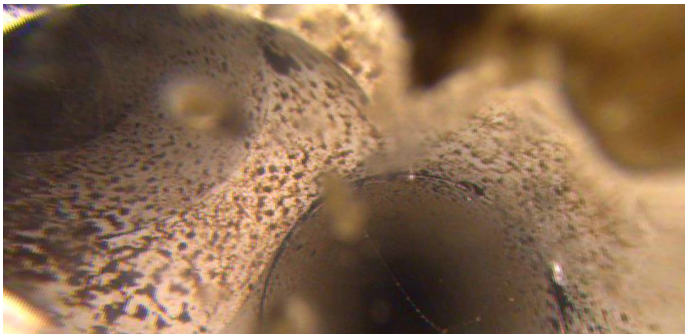
Code:	TF
Description:	Tap Factory

Distance (ft):	27.8
Structural Grade:	0
O&M Grade:	0
Clock Start/From:	10
Clock To:	
1st Value:	4.000
2nd Value:	
Value Percent:	
Continuous Index:	
Within 8" of Joint:	
Remarks:

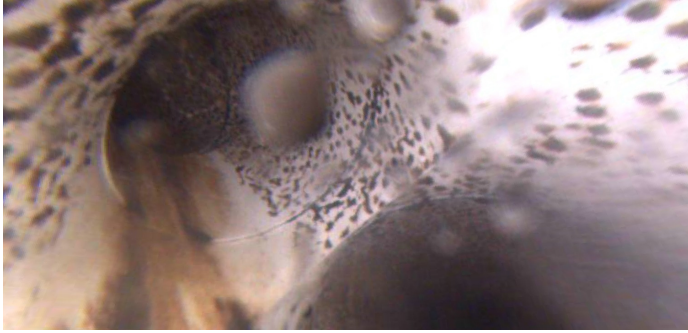
Code: **TF**
Description: **Tap Factory**

Distance (ft): **79.2**
Structural Grade: **0**
O&M Grade: **0**
Clock Start/From: **2**
Clock To:
1st Value: **4.000**
2nd Value:
Value Percent:
Continuous Index:
Within 8" of Joint:
Remarks:

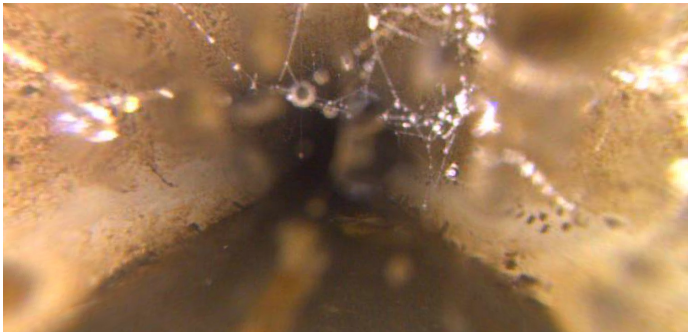
Code: **MWL**
Description: **Water Level**

Distance (ft): **80.0**
Structural Grade: **0**
O&M Grade: **0**
Clock Start/From:
Clock To:
1st Value:
2nd Value:
Value Percent: **20.000**
Continuous Index:
Within 8" of Joint: **NO**
Remarks:

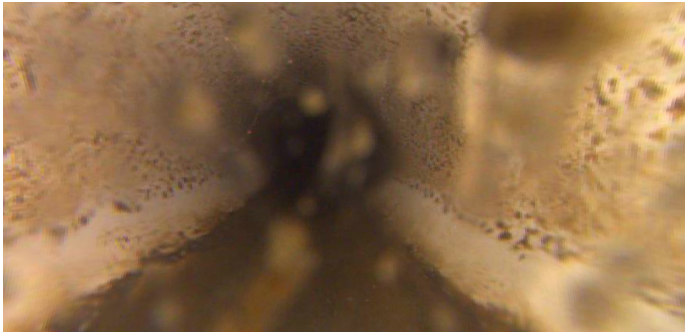
Code: **MGO**
Description: **General Observation**

Distance (ft): **82.1**
Structural Grade: **0**
O&M Grade: **0**
Clock Start/From:
Clock To:
1st Value:
2nd Value:
Value Percent:
Continuous Index:
Within 8" of Joint: **NO**
Remarks: **LARVAE OBSTRUCTING LENS**

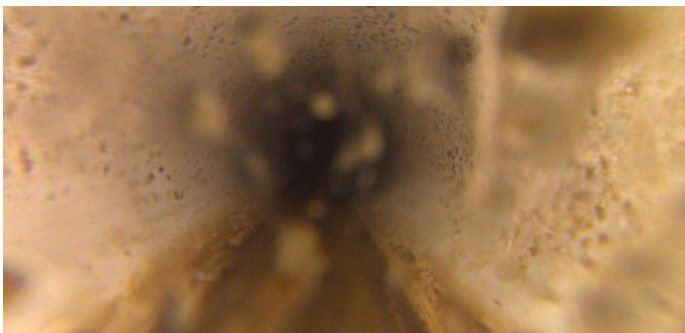
Code: **MWL**
Description: **Water Level**

Distance (ft): **86.4**
Structural Grade: **0**
O&M Grade: **0**
Clock Start/From:
Clock To:
1st Value:
2nd Value:
Value Percent: **5.000**
Continuous Index:
Within 8" of Joint: **NO**
Remarks:

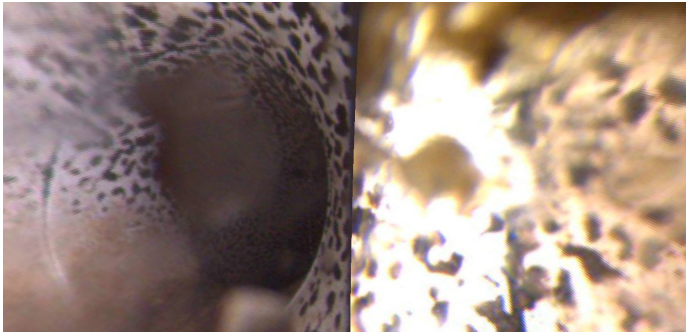
Code: **TF**
Description: **Tap Factory**

Distance (ft): **111.4**
Structural Grade: **0**
O&M Grade: **0**
Clock Start/From: **10**
Clock To:
1st Value: **4.000**
2nd Value:
Value Percent:
Continuous Index:
Within 8" of Joint:
Remarks:

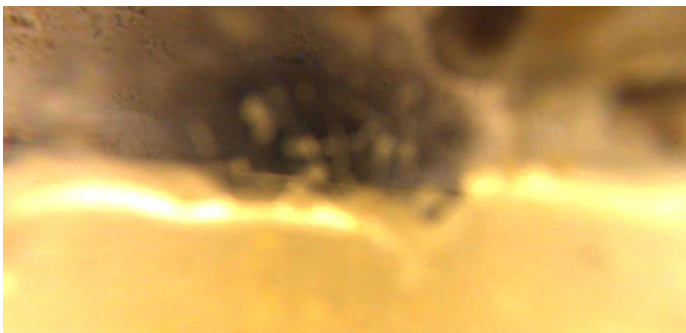
Code: **MWL**
Description: **Water Level**

Distance (ft): **111.6**
Structural Grade: **0**
O&M Grade: **0**
Clock Start/From:
Clock To:
1st Value:
2nd Value:
Value Percent: **40.000**
Continuous Index:
Within 8" of Joint: **NO**
Remarks:

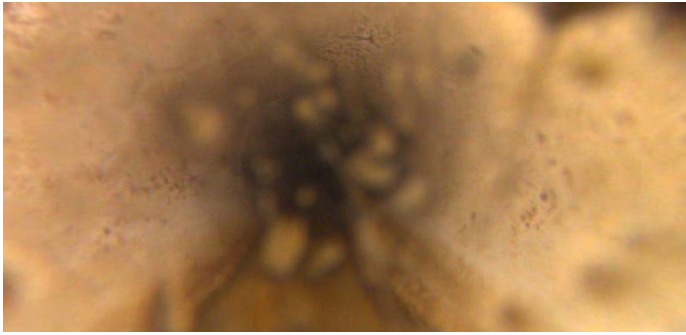
Code: **MWL**
Description: **Water Level**

Distance (ft): **122.6**
Structural Grade: **0**
O&M Grade: **0**
Clock Start/From:
Clock To:
1st Value:
2nd Value:
Value Percent: **5.000**
Continuous Index:
Within 8" of Joint: **NO**
Remarks:

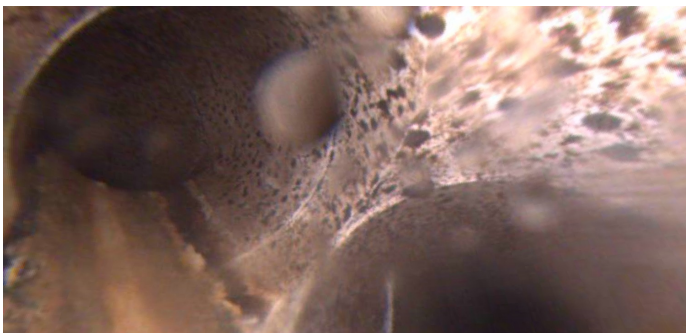
Code: **TF**
Description: **Tap Factory**

Distance (ft): **162.7**
Structural Grade: **0**
O&M Grade: **0**
Clock Start/From: **2**
Clock To:
1st Value: **4.000**
2nd Value:
Value Percent:
Continuous Index:
Within 8" of Joint:
Remarks:

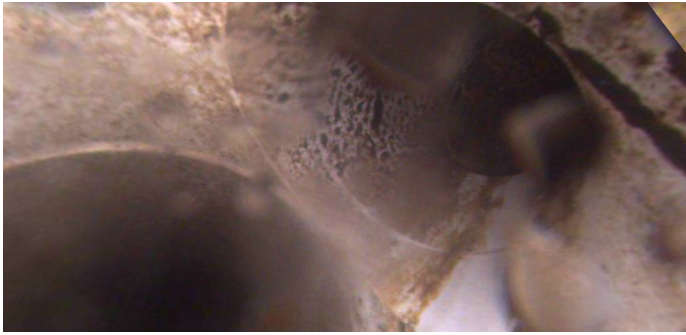
Code: **TF**
Description: **Tap Factory**

Distance (ft): **188.7**
Structural Grade: **0**
O&M Grade: **0**
Clock Start/From: **10**
Clock To:
1st Value: **4.000**
2nd Value:
Value Percent:
Continuous Index:
Within 8" of Joint:
Remarks:

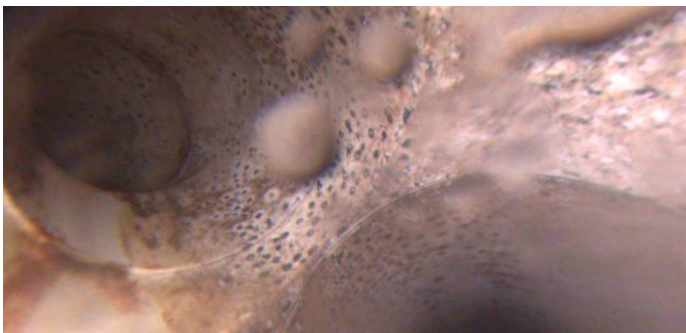
Code: **TF**
Description: **Tap Factory**

Distance (ft): **234.2**
Structural Grade: **0**
O&M Grade: **0**
Clock Start/From: **2**
Clock To:
1st Value: **4.000**
2nd Value:
Value Percent:
Continuous Index:
Within 8" of Joint:
Remarks:

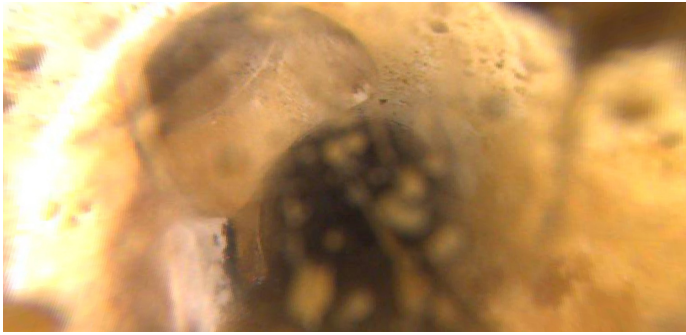
Code: **TF**
Description: **Tap Factory**

Distance (ft): **256.7**
Structural Grade: **0**
O&M Grade: **0**
Clock Start/From: **10**
Clock To:
1st Value: **4.000**
2nd Value:
Value Percent:
Continuous Index:
Within 8" of Joint:
Remarks:

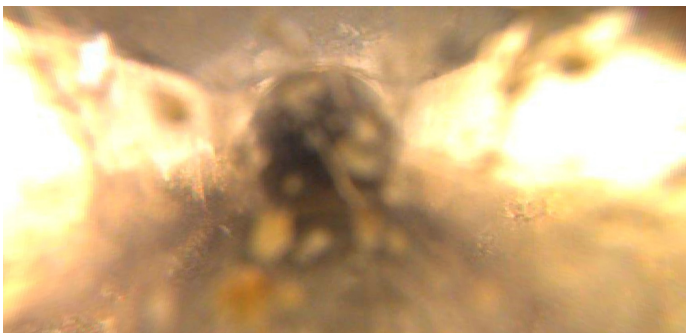
Code: **AMH**
Description: **Manhole**

Distance (ft): **294.1**
Structural Grade: **0**
O&M Grade: **0**
Clock Start/From:
Clock To:
1st Value:
2nd Value:
Value Percent:
Continuous Index:
Within 8" of Joint: **NO**
Remarks: **M-703-004**
