Profile/Photo Observation Report

| P.O.#: | | Surveyor: | JUSTIN GONZALES | PSR: | P-703-004-006 |

| Street: | PHEASANT RUN DR & EDGEWATER | Flow Control: | Not Controlled |
| City: | Hobart, IN | Year Renewed: | |

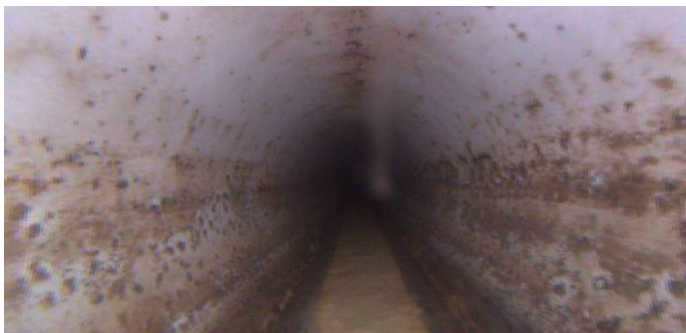
Code: **AMH**
Description: **Manhole**

Distance (ft): **.0**
Structural Grade: **0**
O&M Grade: **0**
Clock Start/From:
Clock To:
1st Value:
2nd Value:
Value Percent:
Continuous Index:
Within 8" of Joint: **NO**
Remarks: **M-703-004**

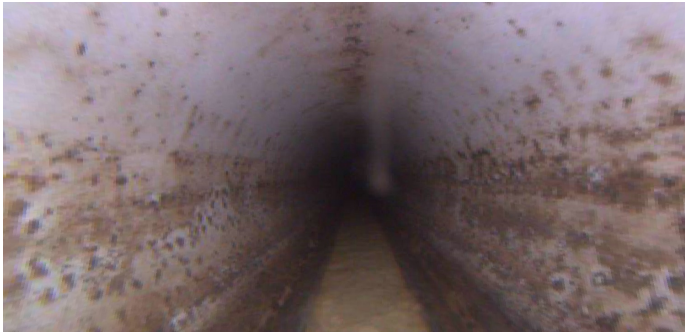
| Code: | MWL |
| Description: | Water Level |

| Distance (ft): | .0 |
| Value Percent: | 5.000 |

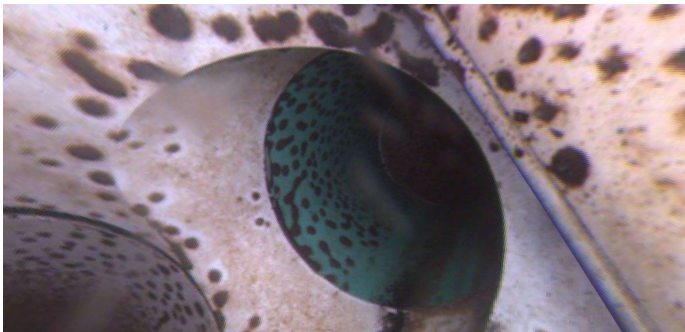
| Code: | TF |
| Description: | Tap Factory |

| Distance (ft): | 20.5 |
| Clock Start/From: | 2 |
| 1st Value: | 4.000 |

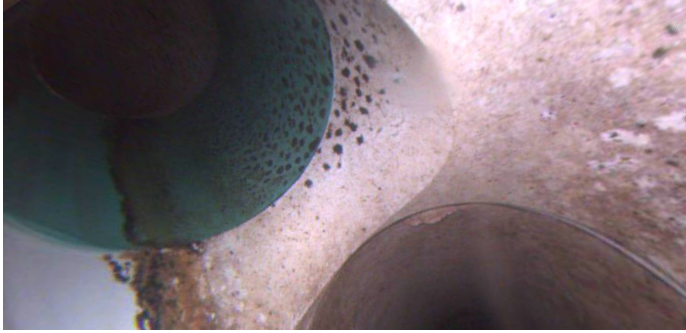
Code: **TF**
Description: **Tap Factory**

Distance (ft): **33.7**
Structural Grade: **0**
O&M Grade: **0**
Clock Start/From: **10**
Clock To:
1st Value: **4.000**
2nd Value:
Value Percent:
Continuous Index:
Within 8" of Joint:
Remarks:

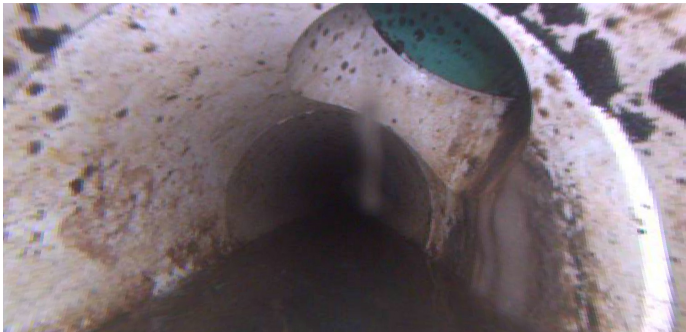
Code: **TF**
Description: **Tap Factory**

Distance (ft): **97.2**
Structural Grade: **0**
O&M Grade: **0**
Clock Start/From: **2**
Clock To:
1st Value: **4.000**
2nd Value:
Value Percent:
Continuous Index:
Within 8" of Joint:
Remarks:

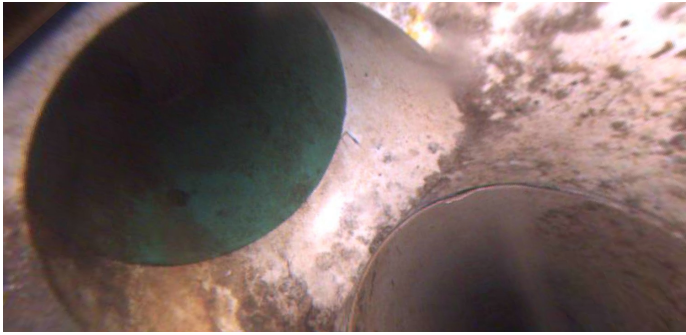
Code: **TF**
Description: **Tap Factory**

Distance (ft): **110.0**
Structural Grade: **0**
O&M Grade: **0**
Clock Start/From: **10**
Clock To:
1st Value: **4.000**
2nd Value:
Value Percent:
Continuous Index:
Within 8" of Joint:
Remarks:

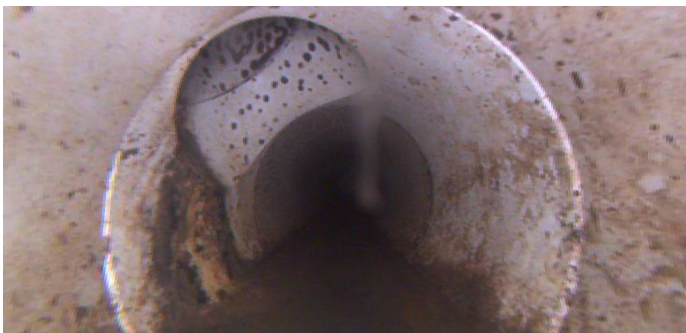
Code: **TF**
Description: **Tap Factory**

Distance (ft): **192.7**
Structural Grade: **0**
O&M Grade: **0**
Clock Start/From: **10**
Clock To:
1st Value: **4.000**
2nd Value:
Value Percent:
Continuous Index:
Within 8" of Joint:
Remarks:

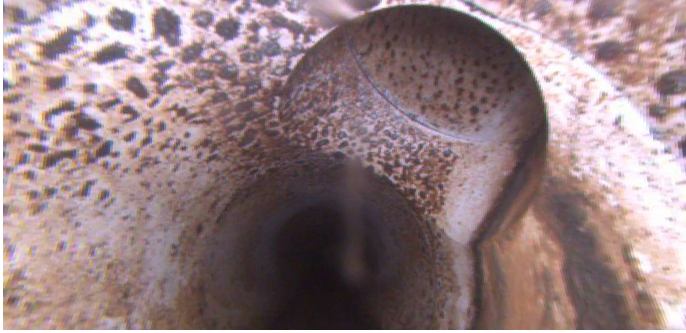
Code: **TF**
Description: **Tap Factory**

Distance (ft): **195.9**
Structural Grade: **0**
O&M Grade: **0**
Clock Start/From: **2**
Clock To:
1st Value: **4.000**
2nd Value:
Value Percent:
Continuous Index:
Within 8" of Joint:
Remarks:

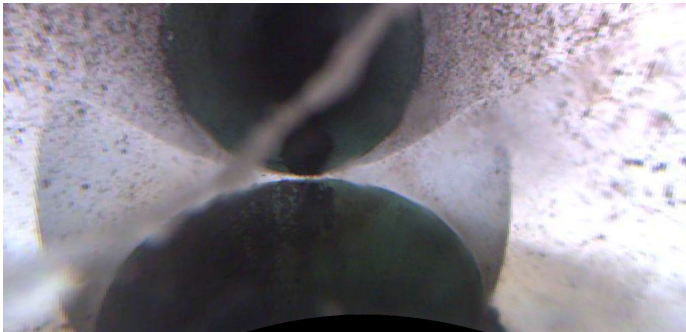
Code: **TF**
Description: **Tap Factory**

Distance (ft): **308.5**
Structural Grade: **0**
O&M Grade: **0**
Clock Start/From: **6**
Clock To:
1st Value: **6.000**
2nd Value:
Value Percent:
Continuous Index:
Within 8" of Joint:
Remarks: **DROP CONNECTION**

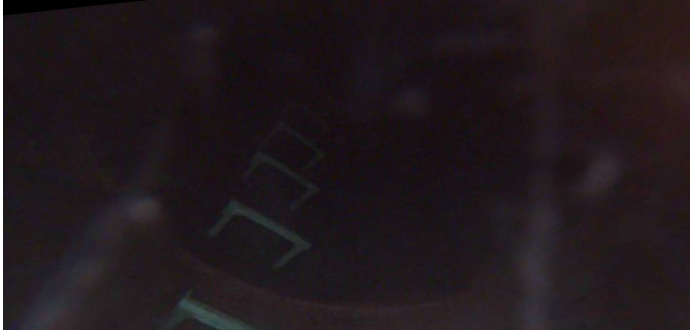
| Code: | AMH |
| Description: | Manhole |
| Distance (ft): | 311.4 |
| Remarks: | M-703-006 |
