Profile/Photo Observation Report

Street:	pheasant run dr	Flow Control:	Not Controlled
City:	Hobart, IN	Year Renewed:	
Location:	Other	Tape/Media #:	
Purpose:	Not Known	Dia/Height:	10"
Use:	Sanitary	Material:	PVC
Drain Area:	NA	Lining:	
Category:	NA		
Comment:

Location Details:		Direction of Survey:	Downstream
US MH:	M-703-004	DS MH:	M-703-006
		Total Length Surveyed (ft):	311.4

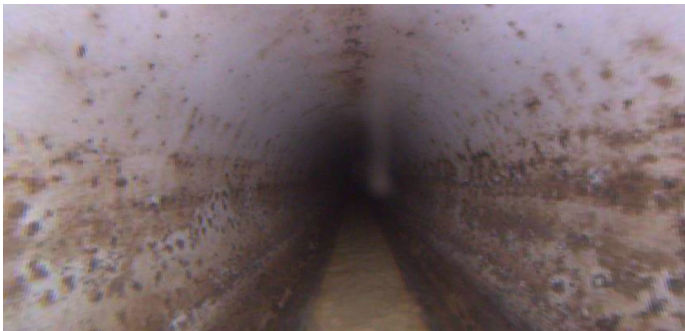
Code: **AMH**
Description: **Manhole**

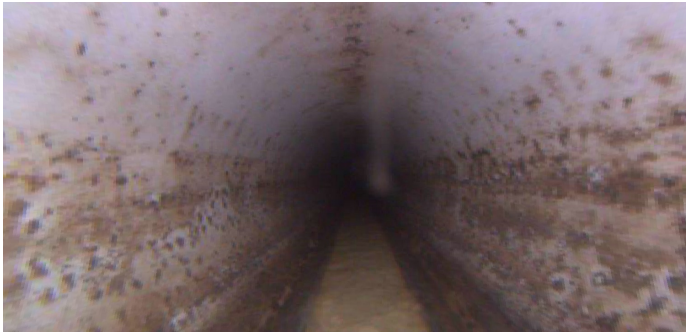
Code:	MWL
Description:	Water Level

Distance (ft):	.0
Structural Grade:	0
O&M Grade:	0
Clock Start/From:	
Clock To:	
1st Value:	
2nd Value:	
Value Percent:	5.000
Continuous Index:	
Within 8" of Joint:	NO
Remarks:

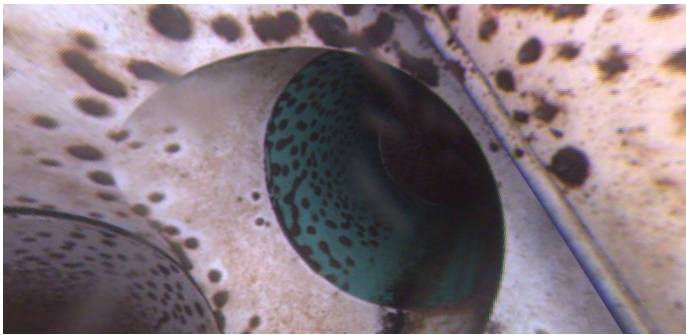
Code:	TF
Description:	Tap Factory

Distance (ft):	20.5
Structural Grade:	0
O&M Grade:	0
Clock Start/From:	2
Clock To:	
1st Value:	4.000
2nd Value:	
Value Percent:	
Continuous Index:	
Within 8" of Joint:	
Remarks:

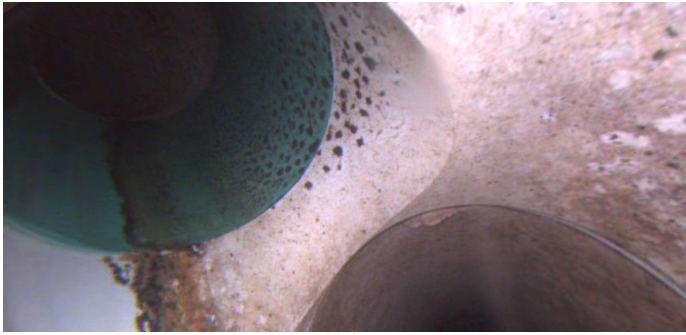
Code: **TF**
Description: **Tap Factory**

Distance (ft): **33.7**
Structural Grade: **0**
O&M Grade: **0**
Clock Start/From: **10**
Clock To:
1st Value: **4.000**
2nd Value:
Value Percent:
Continuous Index:
Within 8" of Joint:
Remarks:

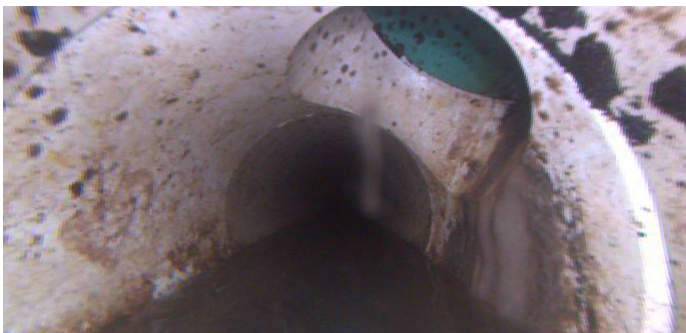
Code: **TF**
Description: **Tap Factory**

Distance (ft): **97.2**
Structural Grade: **0**
O&M Grade: **0**
Clock Start/From: **2**
Clock To:
1st Value: **4.000**
2nd Value:
Value Percent:
Continuous Index:
Within 8" of Joint:
Remarks:

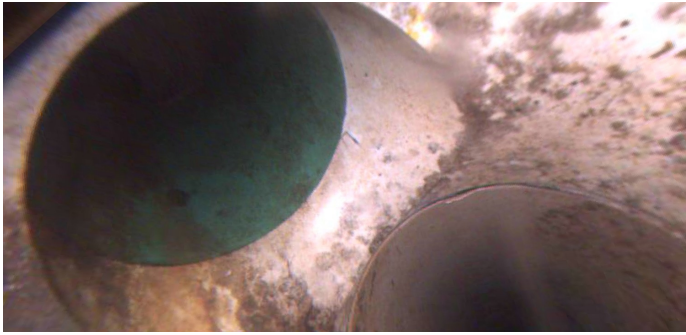
Code: **TF**
Description: **Tap Factory**

Distance (ft): **110.0**
Structural Grade: **0**
O&M Grade: **0**
Clock Start/From: **10**
Clock To:
1st Value: **4.000**
2nd Value:
Value Percent:
Continuous Index:
Within 8" of Joint:
Remarks:

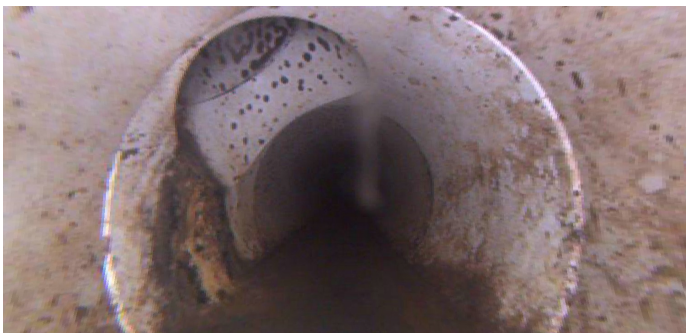
Code: **TF**
Description: **Tap Factory**

Distance (ft): **192.7**
Structural Grade: **0**
O&M Grade: **0**
Clock Start/From: **10**
Clock To:
1st Value: **4.000**
2nd Value:
Value Percent:
Continuous Index:
Within 8" of Joint:
Remarks:

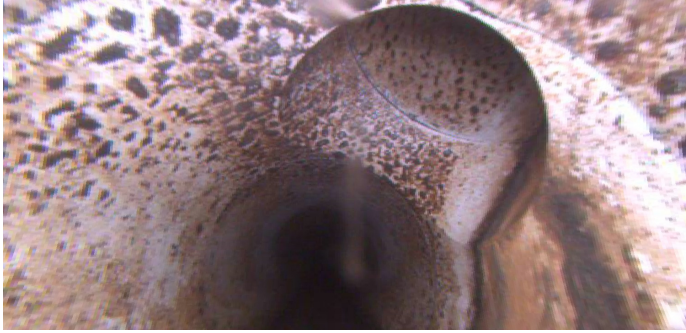
Code: **TF**
Description: **Tap Factory**

Distance (ft): **195.9**
Structural Grade: **0**
O&M Grade: **0**
Clock Start/From: **2**
Clock To:
1st Value: **4.000**
2nd Value:
Value Percent:
Continuous Index:
Within 8" of Joint:
Remarks:

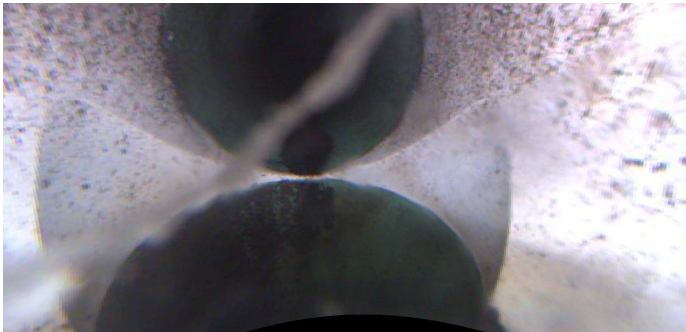
Code: **TF**
Description: **Tap Factory**

Distance (ft): **308.5**
Structural Grade: **0**
O&M Grade: **0**
Clock Start/From: **6**
Clock To:
1st Value: **6.000**
2nd Value:
Value Percent:
Continuous Index:
Within 8" of Joint:
Remarks: **DROP CONNECTION**

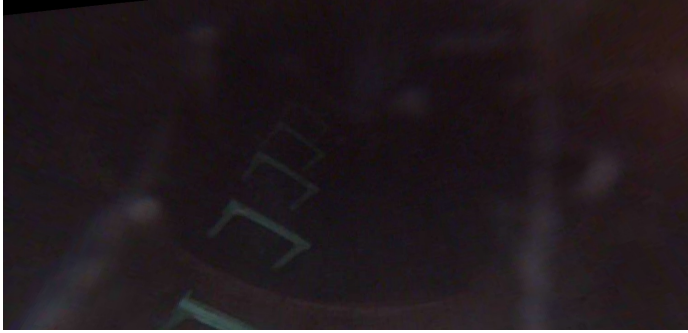
Code:	AMH
Description:	Manhole
Distance (ft):	311.4
Structural Grade:	0
O&M Grade:	0
Clock Start/From:	
Clock To:	
1st Value:	
2nd Value:	
Value Percent:	
Continuous Index:	
Within 8" of Joint:	NO
Remarks:	M-703-006
