## Profile/Photo Observation Report

Street:	<b>EDGEWATER DR</b>	Flow Control:	<b>Not Controlled</b>
City:	<b>Hobart, IN</b>	Year Renewed:	
Location:	<b>Other</b>	Tape/Media #:	
Purpose:	<b>Not Known</b>	Dia/Height:	<b>10"</b>
Use:	<b>Sanitary</b>	Material:	<b>PVC</b>
Drain Area:	<b>NA</b>	Lining:	
Category:	<b>NA</b>		
Comment:

Location Details:		Direction of Survey:	<b>Downstream</b>
US MH:	<b>M-703-006</b>	DS MH:	<b>M-703-007</b>
		Total Length Surveyed (ft):	<b>205.8</b>

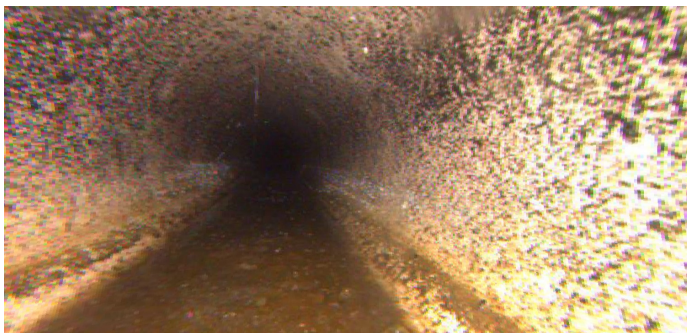
Code: **AMH**  
Description: **Manhole**

Distance (ft): **.0**  
Structural Grade: **0**  
O&M Grade: **0**  
Clock Start/From:  
Clock To:  
1st Value:  
2nd Value:  
Value Percent:  
Continuous Index:  
Within 8" of Joint: **NO**  
Remarks: **M-703-006**

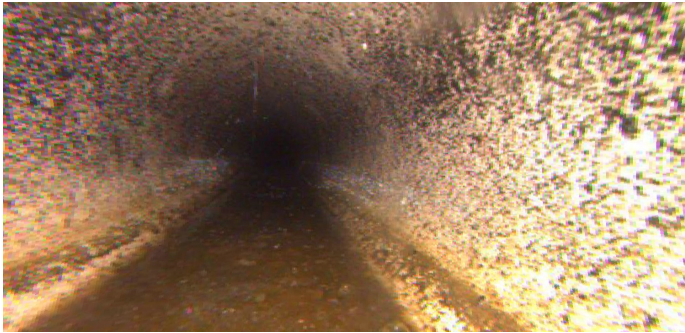
Code:	<b>MWL</b>
Description:	<b>Water Level</b>

Distance (ft):	<b>.0</b>
Structural Grade:	<b>0</b>
O&M Grade:	<b>0</b>
Clock Start/From:	
Clock To:	
1st Value:	
2nd Value:	
Value Percent:	<b>5.000</b>
Continuous Index:	
Within 8" of Joint:	<b>NO</b>
Remarks:

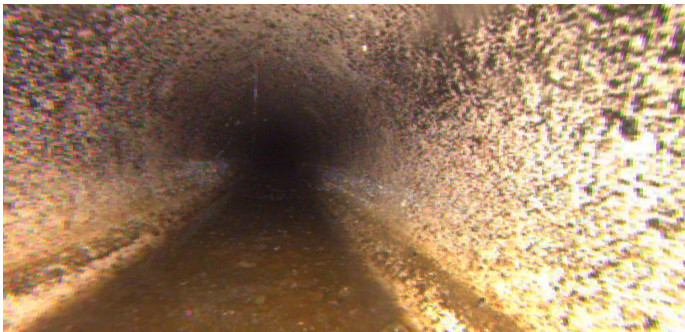
Code:	<b>DAZ</b>
Description:	<b>Deposits Attached Other</b>

Distance (ft):	<b>.0</b>
Structural Grade:	<b>0</b>
O&M Grade:	<b>2</b>
Clock Start/From:	<b>7</b>
Clock To:	<b>5</b>
1st Value:	
2nd Value:	
Value Percent:	<b>5.000</b>
Continuous Index:	<b>S01</b>
Within 8" of Joint:	<b>YES</b>
Remarks:	<b>WANDER</b>

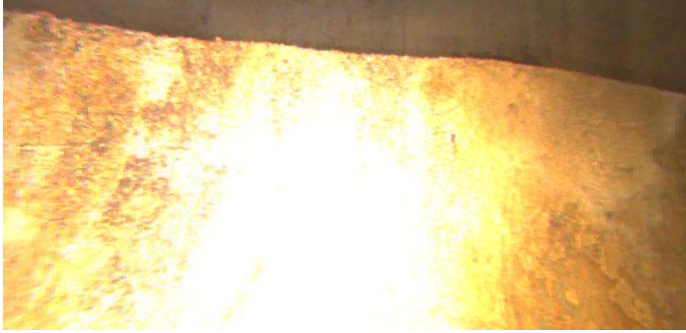
Code: **AMH**  
Description: **Manhole**

Distance (ft): **205.8**  
Structural Grade: **0**  
O&M Grade: **0**  
Clock Start/From:  
Clock To:  
1st Value:  
2nd Value:  
Value Percent:  
Continuous Index:  
Within 8" of Joint: **NO**  
Remarks: **M-703-007**

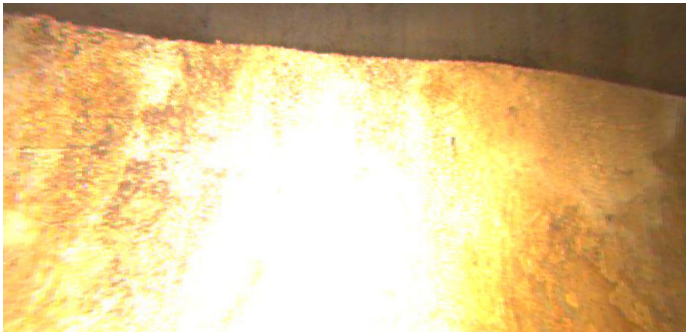
Code: **DAZ**  
Description: **Deposits Attached Other**

Distance (ft): **205.8**  
Structural Grade: **0**  
O&M Grade: **2**  
Clock Start/From: **7**  
Clock To: **5**  
1st Value:  
2nd Value:  
Value Percent: **5.000**  
Continuous Index: **F01**  
Within 8" of Joint: **YES**  
Remarks: **WANDER**
