Profile/Photo Observation Report

Date:	03/26/2018	Weather:		Coding:	PACP 6.0
Pipe Length (ft):	341.7	Owner:	NA	Pre Clean:	Not Known
P.O.#:		Surveyor:	Justin Gonzales	PSR:	P-703-008-006
Customer:		Clean Date:	01/01/1900	Shape:	C

Street:	PHEASANT RUN DR	Flow Control:	Not Controlled
City:	Hobart, IN	Year Renewed:	
Location:	Other	Tape/Media #:	
Purpose:	Not Known	Dia/Height:	10"
Use:	Sanitary	Material:	PVC
Drain Area:	NA	Lining:	
Category:	NA		
Comment:

Location Details:		Direction of Survey:	Downstream
US MH:	M-703-006	DS MH:	M-703-008
		Total Length Surveyed (ft):	332.9

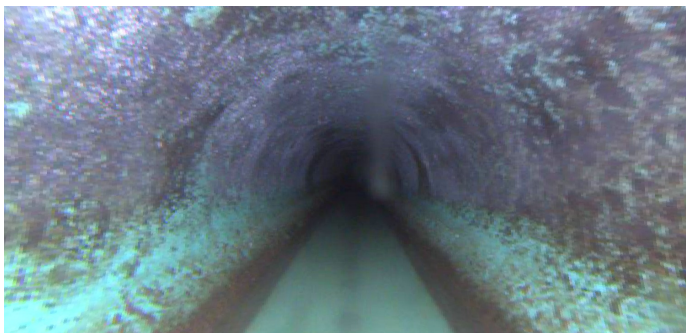
Code: **AMH**
Description: **Manhole**

Distance (ft): **.0**
Structural Grade: **0**
O&M Grade: **0**
Clock Start/From:
Clock To:
1st Value:
2nd Value:
Value Percent:
Continuous Index:
Within 8" of Joint: **NO**
Remarks: **M-703-006**

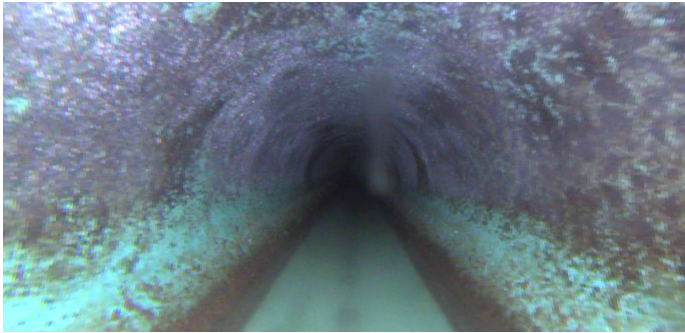
Code:	MWL
Description:	Water Level

Distance (ft):	.0
Structural Grade:	0
O&M Grade:	0
Clock Start/From:	
Clock To:	
1st Value:	
2nd Value:	
Value Percent:	5.000
Continuous Index:	
Within 8" of Joint:	NO
Remarks:

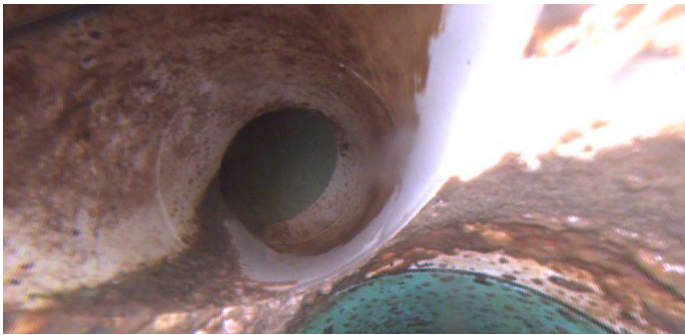
Code:	TF
Description:	Tap Factory

Distance (ft):	45.0
Structural Grade:	0
O&M Grade:	0
Clock Start/From:	11
Clock To:	
1st Value:	4.000
2nd Value:	
Value Percent:	
Continuous Index:	
Within 8" of Joint:	
Remarks:

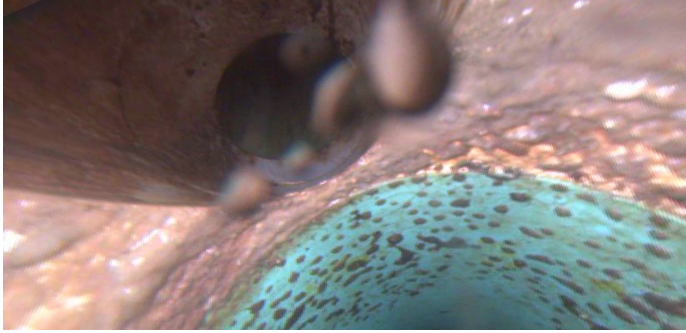
Code: **TF**
Description: **Tap Factory**

Distance (ft): **138.7**
Structural Grade: **0**
O&M Grade: **0**
Clock Start/From: **11**
Clock To:
1st Value: **4.000**
2nd Value:
Value Percent:
Continuous Index:
Within 8" of Joint:
Remarks:

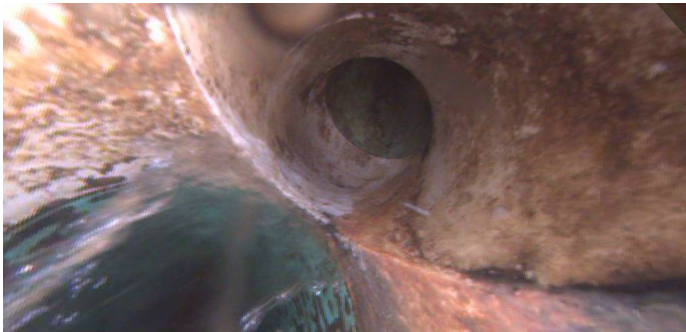
Code: **TFA**
Description: **Tap Factory Active**

Distance (ft): **141.2**
Structural Grade: **0**
O&M Grade: **0**
Clock Start/From: **1**
Clock To:
1st Value: **4.000**
2nd Value:
Value Percent:
Continuous Index:
Within 8" of Joint:
Remarks:

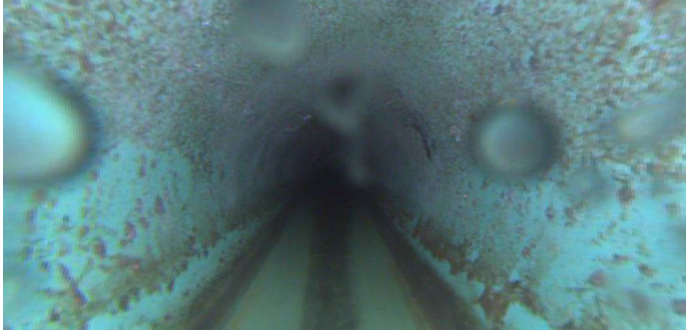
Code: **DSF**
Description: **Deposits Settled Fine**

Distance (ft): **189.1**
Structural Grade: **0**
O&M Grade: **2**
Clock Start/From: **6**
Clock To:
1st Value:
2nd Value:
Value Percent: **5.000**
Continuous Index:
Within 8" of Joint: **YES**
Remarks:

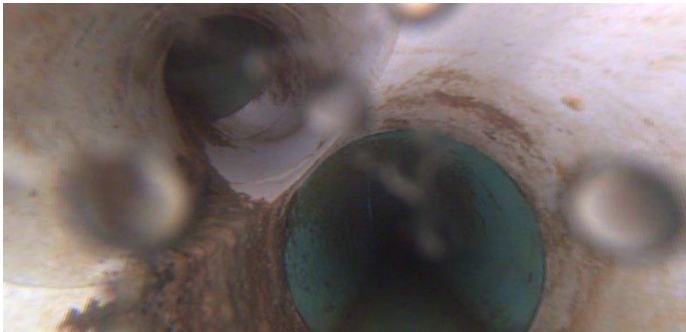
Code: **TF**
Description: **Tap Factory**

Distance (ft): **208.7**
Structural Grade: **0**
O&M Grade: **0**
Clock Start/From: **10**
Clock To:
1st Value: **4.000**
2nd Value:
Value Percent:
Continuous Index:
Within 8" of Joint:
Remarks:

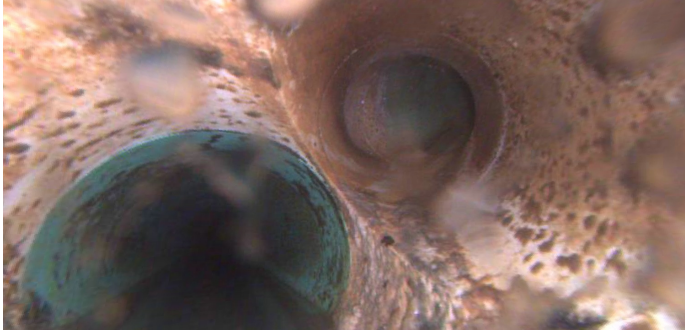
Code: **TF**
Description: **Tap Factory**

Distance (ft): **228.9**
Structural Grade: **0**
O&M Grade: **0**
Clock Start/From: **2**
Clock To:
1st Value: **4.000**
2nd Value:
Value Percent:
Continuous Index:
Within 8" of Joint:
Remarks:

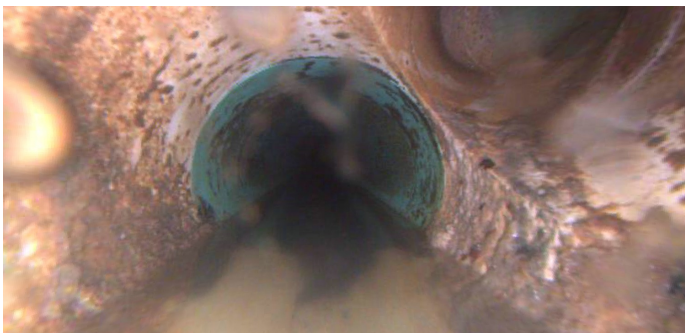
Code: **DAGS**
Description: **Deposits Attached Grease**

Distance (ft): **228.9**
Structural Grade: **0**
O&M Grade: **2**
Clock Start/From: **8**
Clock To: **4**
1st Value:
2nd Value:
Value Percent: **5.000**
Continuous Index:
Within 8" of Joint: **NO**
Remarks:

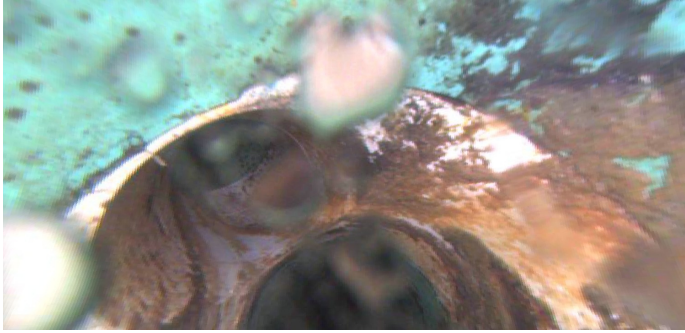
Code: **TF**
Description: **Tap Factory**

Distance (ft): **289.3**
Structural Grade: **0**
O&M Grade: **0**
Clock Start/From: **10**
Clock To:
1st Value: **4.000**
2nd Value:
Value Percent:
Continuous Index:
Within 8" of Joint:
Remarks:

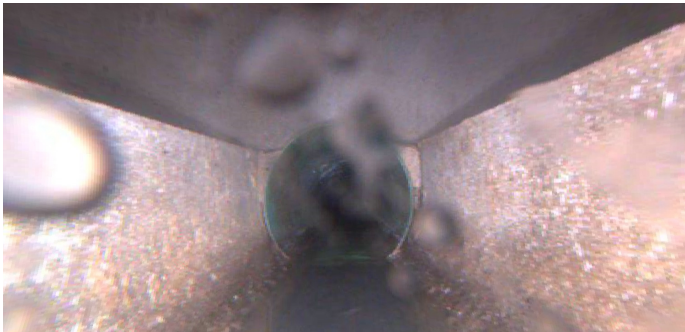
Code: **AMH**
Description: **Manhole**

Distance (ft): **332.9**
Structural Grade: **0**
O&M Grade: **0**
Clock Start/From:
Clock To:
1st Value:
2nd Value:
Value Percent:
Continuous Index:
Within 8" of Joint: **NO**
Remarks: **M-703-008**
