Profile/Photo Observation Report

Street:	PHEASANT RUN DR	Flow Control:	Not Controlled
City:	Hobart, IN	Year Renewed:	
Location:	Other	Tape/Media #:	
Purpose:	Not Known	Dia/Height:	10"
Use:	Sanitary	Material:	PVC
Drain Area:	NA	Lining:	
Category:	NA		
Comment:

Location Details:		Direction of Survey:	Upstream
US MH:	M-703-008	DS MH:	M-703-009
		Total Length Surveyed (ft):	313.5

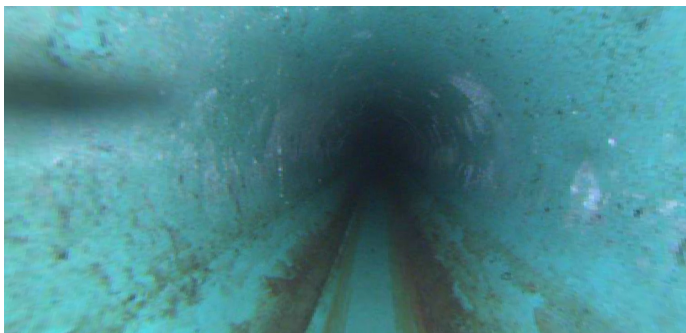
Code: **AMH**
Description: **Manhole**

Distance (ft): **.0**
Structural Grade: **0**
O&M Grade: **0**
Clock Start/From:
Clock To:
1st Value:
2nd Value:
Value Percent:
Continuous Index:
Within 8" of Joint: **NO**
Remarks: **M-703-009**

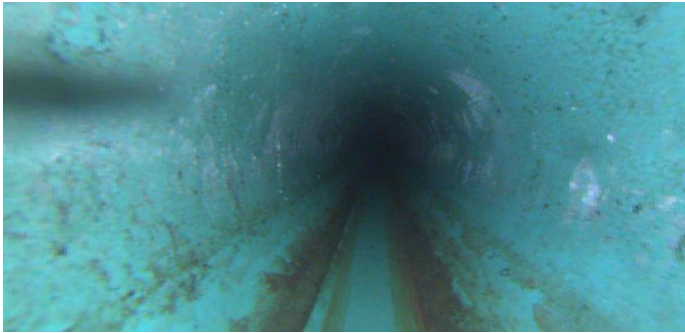
Code:	MWL
Description:	Water Level

Distance (ft):	.0
Structural Grade:	0
O&M Grade:	0
Clock Start/From:	
Clock To:	
1st Value:	
2nd Value:	
Value Percent:	5.000
Continuous Index:	
Within 8" of Joint:	NO
Remarks:

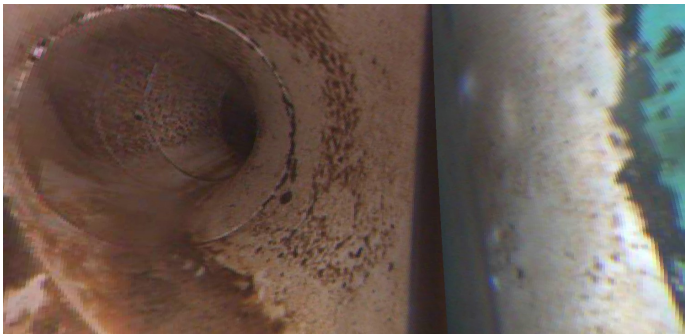
Code:	TF
Description:	Tap Factory

Distance (ft):	34.2
Structural Grade:	0
O&M Grade:	0
Clock Start/From:	9
Clock To:	
1st Value:	4.000
2nd Value:	
Value Percent:	
Continuous Index:	
Within 8" of Joint:	
Remarks:

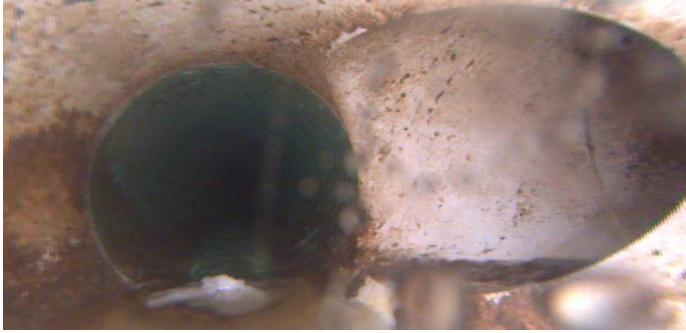
Code: **TF**
Description: **Tap Factory**

Distance (ft): **42.5**
Structural Grade: **0**
O&M Grade: **0**
Clock Start/From: **3**
Clock To:
1st Value: **4.000**
2nd Value:
Value Percent:
Continuous Index:
Within 8" of Joint:
Remarks:

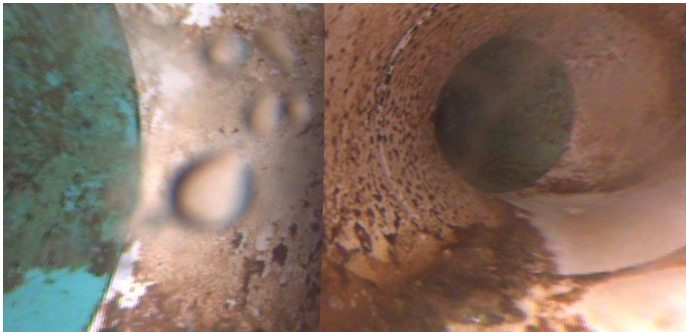
Code: **TF**
Description: **Tap Factory**

Distance (ft): **105.5**
Structural Grade: **0**
O&M Grade: **0**
Clock Start/From: **3**
Clock To:
1st Value: **4.000**
2nd Value:
Value Percent:
Continuous Index:
Within 8" of Joint:
Remarks:

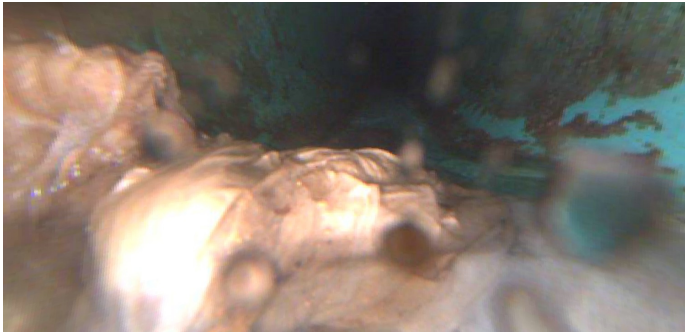
Code: **MGO**
Description: **General Observation**

Distance (ft): **105.5**
Structural Grade: **0**
O&M Grade: **0**
Clock Start/From:
Clock To:
1st Value:
2nd Value:
Value Percent:
Continuous Index:
Within 8" of Joint: **NO**
Remarks: **TOILET TISSUE**

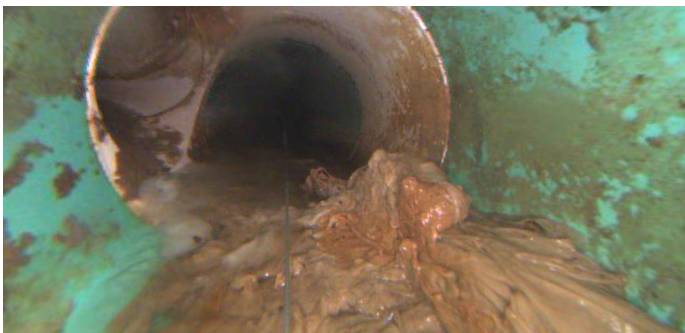
Code: **OBZ**
Description: **Obstacle Other**

Distance (ft): **106.3**
Structural Grade: **0**
O&M Grade: **3**
Clock Start/From: **4**
Clock To: **8**
1st Value:
2nd Value:
Value Percent: **20.000**
Continuous Index:
Within 8" of Joint: **NO**
Remarks: **PAPER PRODUCTS**

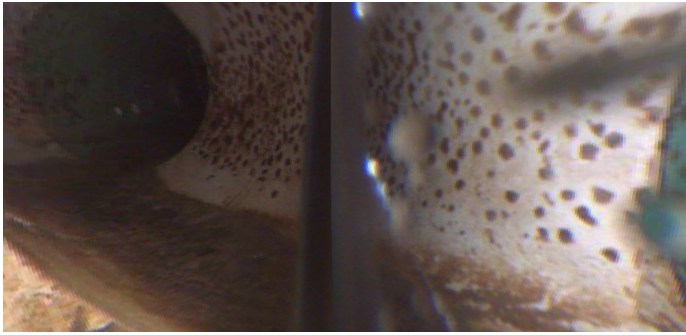
Code: **TF**
Description: **Tap Factory**

Distance (ft): **124.1**
Structural Grade: **0**
O&M Grade: **0**
Clock Start/From: **9**
Clock To:
1st Value: **4.000**
2nd Value:
Value Percent:
Continuous Index:
Within 8" of Joint:
Remarks:

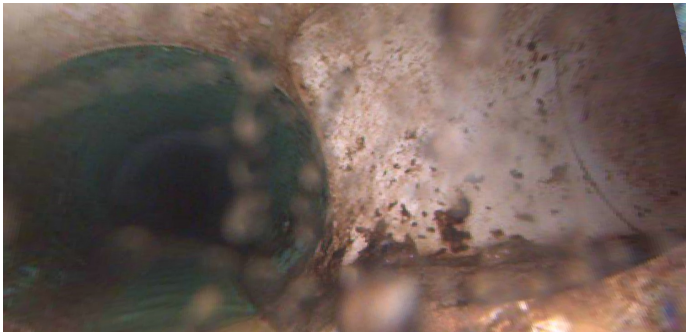
Code: **TF**
Description: **Tap Factory**

Distance (ft): **188.4**
Structural Grade: **0**
O&M Grade: **0**
Clock Start/From: **3**
Clock To:
1st Value: **4.000**
2nd Value:
Value Percent:
Continuous Index:
Within 8" of Joint:
Remarks:

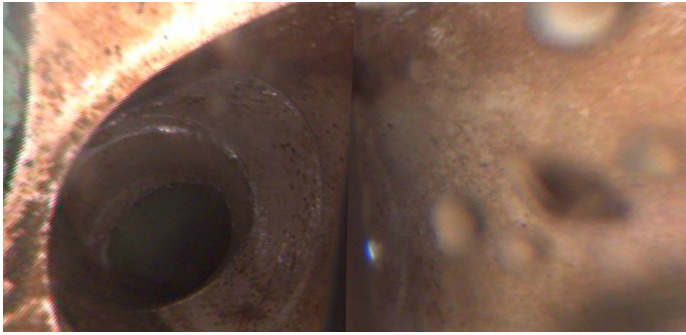
Code: **TF**
Description: **Tap Factory**

Distance (ft): **213.6**
Structural Grade: **0**
O&M Grade: **0**
Clock Start/From: **10**
Clock To:
1st Value: **4.000**
2nd Value:
Value Percent:
Continuous Index:
Within 8" of Joint:
Remarks:

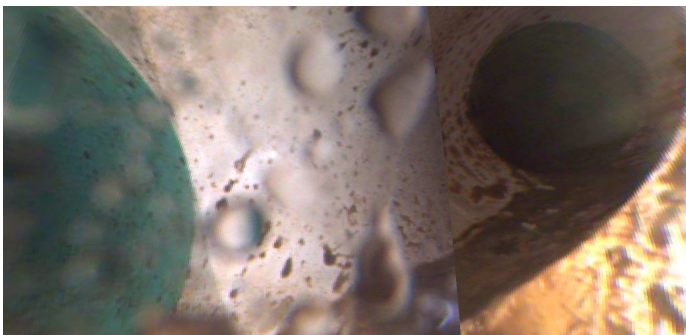
Code: **TF**
Description: **Tap Factory**

Distance (ft): **273.1**
Structural Grade: **0**
O&M Grade: **0**
Clock Start/From: **2**
Clock To:
1st Value: **4.000**
2nd Value:
Value Percent:
Continuous Index:
Within 8" of Joint:
Remarks:

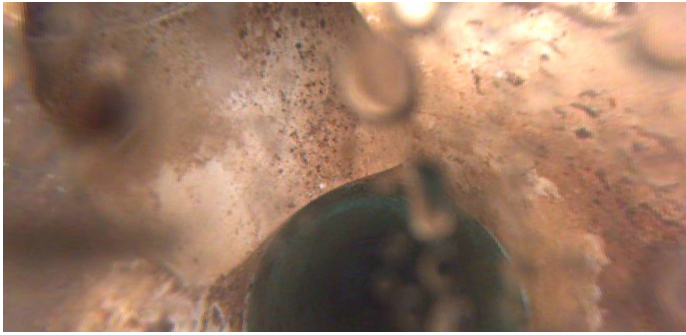
Code: **TF**
Description: **Tap Factory**

Distance (ft): **298.5**
Structural Grade: **0**
O&M Grade: **0**
Clock Start/From: **11**
Clock To:
1st Value: **4.000**
2nd Value:
Value Percent:
Continuous Index:
Within 8" of Joint:
Remarks:

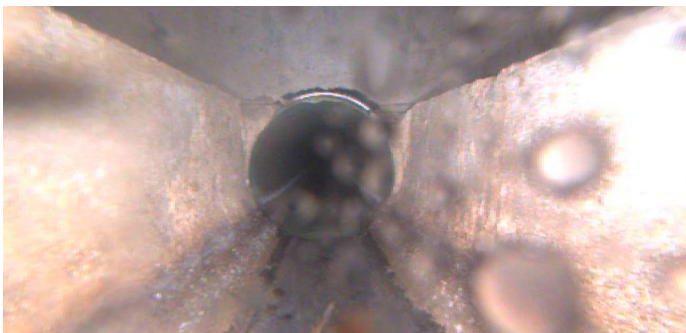
Code: **AMH**
Description: **Manhole**

Distance (ft): **313.5**
Structural Grade: **0**
O&M Grade: **0**
Clock Start/From:
Clock To:
1st Value:
2nd Value:
Value Percent:
Continuous Index:
Within 8" of Joint: **NO**
Remarks: **M-703-008**
