## Profile/Photo Observation Report

Street:	<b>PHEASANT RUN DR</b>	Flow Control:	<b>Not Controlled</b>
City:	<b>Hobart, IN</b>	Year Renewed:	
Location:	<b>Other</b>	Tape/Media #:	
Purpose:	<b>Not Known</b>	Dia/Height:	<b>10"</b>
Use:	<b>Sanitary</b>	Material:	<b>PVC</b>
Drain Area:	<b>NA</b>	Lining:	
Category:	<b>NA</b>		
Comment:

Location Details:		Direction of Survey:	<b>Downstream</b>
US MH:	<b>M-703-009</b>	DS MH:	<b>M-703-010</b>
		Total Length Surveyed (ft):	<b>313.6</b>

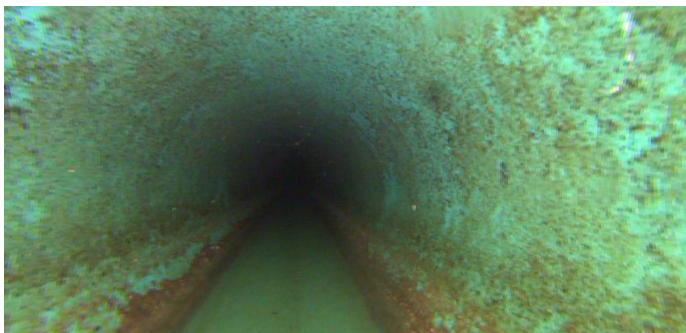
Code: **AMH**  
Description: **Manhole**

Distance (ft): **.0**  
Structural Grade: **0**  
O&M Grade: **0**  
Clock Start/From:  
Clock To:  
1st Value:  
2nd Value:  
Value Percent:  
Continuous Index:  
Within 8" of Joint: **NO**  
Remarks: **M-703-009**

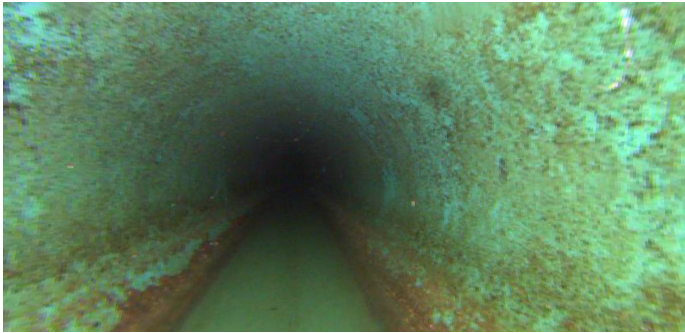
Code:	<b>MWL</b>
Description:	<b>Water Level</b>

Distance (ft):	<b>.0</b>
Structural Grade:	<b>0</b>
O&M Grade:	<b>0</b>
Clock Start/From:	
Clock To:	
1st Value:	
2nd Value:	
Value Percent:	<b>5.000</b>
Continuous Index:	
Within 8" of Joint:	<b>NO</b>
Remarks:

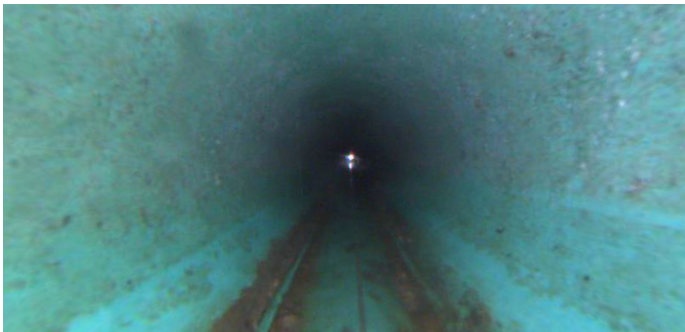
Code:	<b>MGO</b>
Description:	<b>General Observation</b>

Distance (ft):	<b>19.9</b>
Structural Grade:	<b>0</b>
O&M Grade:	<b>0</b>
Clock Start/From:	
Clock To:	
1st Value:	
2nd Value:	
Value Percent:	
Continuous Index:	
Within 8" of Joint:	<b>NO</b>
Remarks:	<b>REAR CAMERA</b>

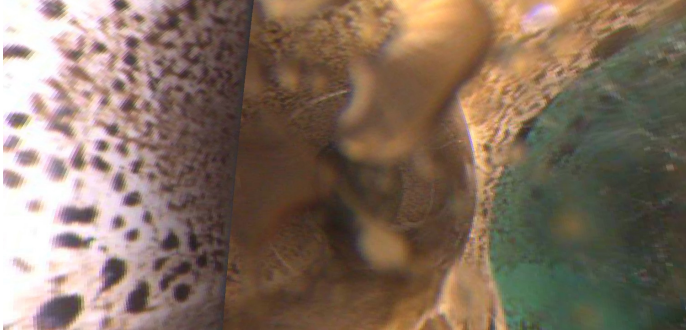
Code: **TF**  
Description: **Tap Factory**

Distance (ft): **33.0**  
Structural Grade: **0**  
O&M Grade: **0**  
Clock Start/From: **9**  
Clock To:  
1st Value: **4.000**  
2nd Value:  
Value Percent:  
Continuous Index:  
Within 8" of Joint:  
Remarks:

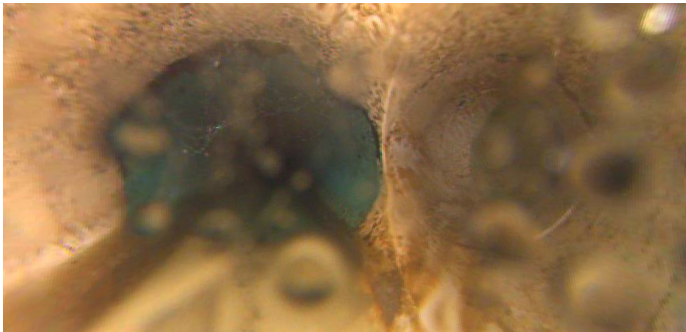
Code: **TF**  
Description: **Tap Factory**

Distance (ft): **57.3**  
Structural Grade: **0**  
O&M Grade: **0**  
Clock Start/From: **3**  
Clock To:  
1st Value: **4.000**  
2nd Value:  
Value Percent:  
Continuous Index:  
Within 8" of Joint:  
Remarks:

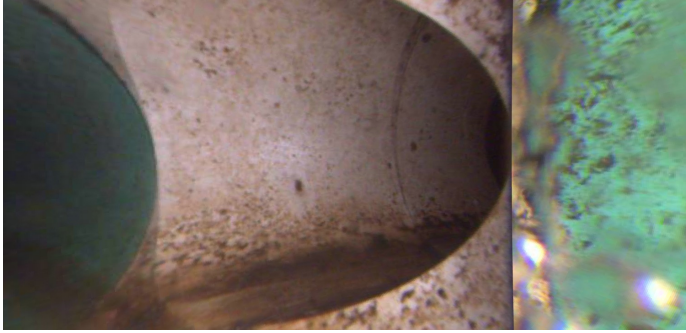
Code: **TFA**  
Description: **Tap Factory Active**

Distance (ft): **123.5**  
Structural Grade: **0**  
O&M Grade: **0**  
Clock Start/From: **9**  
Clock To:  
1st Value: **4.000**  
2nd Value:  
Value Percent:  
Continuous Index:  
Within 8" of Joint:  
Remarks:

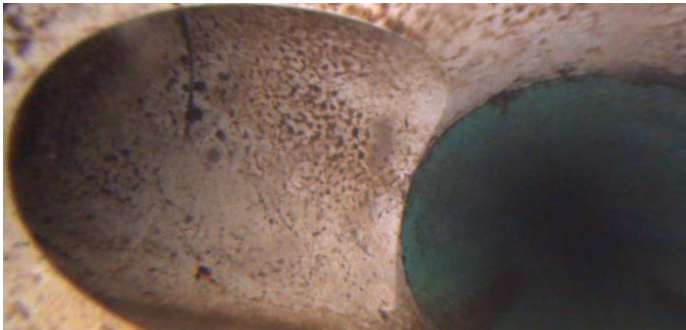
Code: **TFA**  
Description: **Tap Factory Active**

Distance (ft): **196.0**  
Structural Grade: **0**  
O&M Grade: **0**  
Clock Start/From: **3**  
Clock To:  
1st Value: **4.000**  
2nd Value:  
Value Percent:  
Continuous Index:  
Within 8" of Joint:  
Remarks:

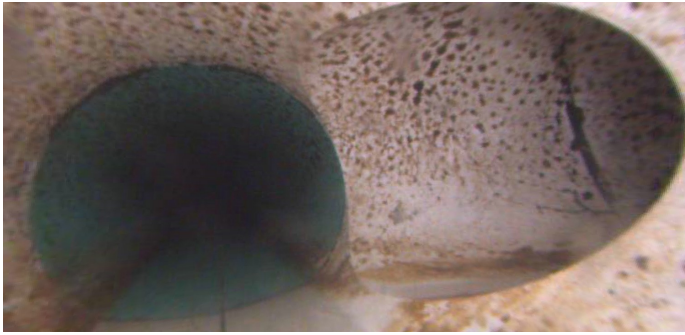
Code: **TFA**  
Description: **Tap Factory Active**

Distance (ft): **201.6**  
Structural Grade: **0**  
O&M Grade: **0**  
Clock Start/From: **9**  
Clock To:  
1st Value: **4.000**  
2nd Value:  
Value Percent:  
Continuous Index:  
Within 8" of Joint:  
Remarks:

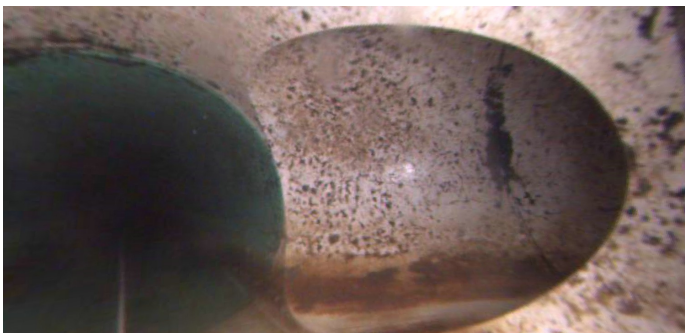
Code: **TFA**  
Description: **Tap Factory Active**

Distance (ft): **274.9**  
Structural Grade: **0**  
O&M Grade: **0**  
Clock Start/From: **9**  
Clock To:  
1st Value: **4.000**  
2nd Value:  
Value Percent:  
Continuous Index:  
Within 8" of Joint:  
Remarks:

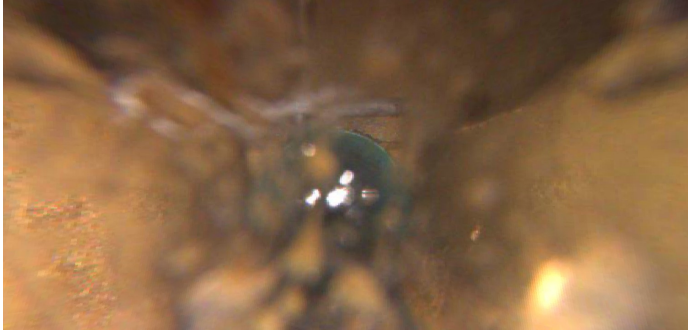
Code:	AMH
Description:	Manhole
Distance (ft):	313.6
Structural Grade:	0
O&M Grade:	0
Clock Start/From:	
Clock To:	
1st Value:	
2nd Value:	
Value Percent:	
Continuous Index:	
Within 8" of Joint:	NO
Remarks:	M-703-010
