Profile/Photo Observation Report

Street:	pheasant run dr	Flow Control:	Not Controlled
City:	Hobart, IN	Year Renewed:	
Location:	Other	Tape/Media #:	
Purpose:	Not Known	Dia/Height:	10"
Use:	Sanitary	Material:	PVC
Drain Area:	NA	Lining:	
Category:	NA		
Comment:

Location Details:		Direction of Survey:	Downstream
US MH:	M-703-010	DS MH:	M-703-011
		Total Length Surveyed (ft):	216.9

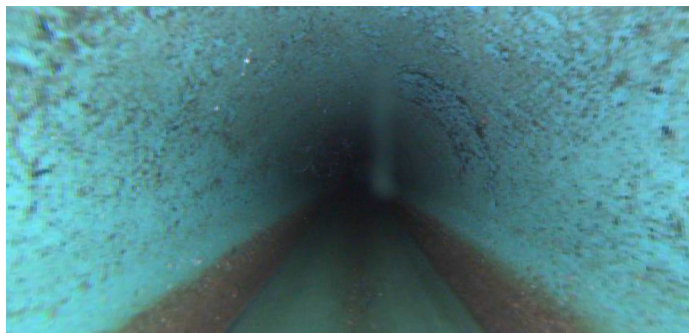
Code: **AMH**
Description: **Manhole**

Distance (ft): **.0**
Structural Grade: **0**
O&M Grade: **0**
Clock Start/From:
Clock To:
1st Value:
2nd Value:
Value Percent:
Continuous Index:
Within 8" of Joint: **NO**
Remarks: **M-703-010**

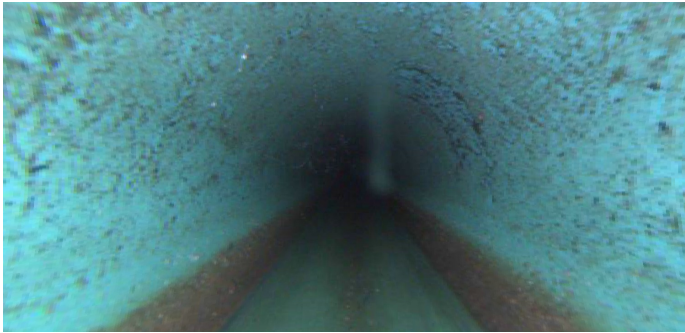
Code:	MWL
Description:	Water Level

Distance (ft):	.0
Structural Grade:	0
O&M Grade:	0
Clock Start/From:	
Clock To:	
1st Value:	
2nd Value:	
Value Percent:	5.000
Continuous Index:	
Within 8" of Joint:	NO
Remarks:

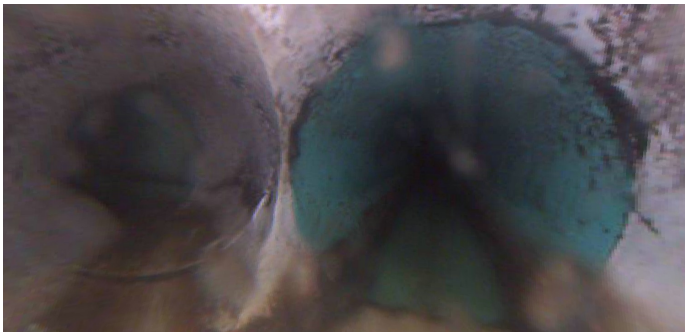
Code:	TF
Description:	Tap Factory

Distance (ft):	28.7
Structural Grade:	0
O&M Grade:	0
Clock Start/From:	9
Clock To:	
1st Value:	6.000
2nd Value:	
Value Percent:	
Continuous Index:	
Within 8" of Joint:	
Remarks:

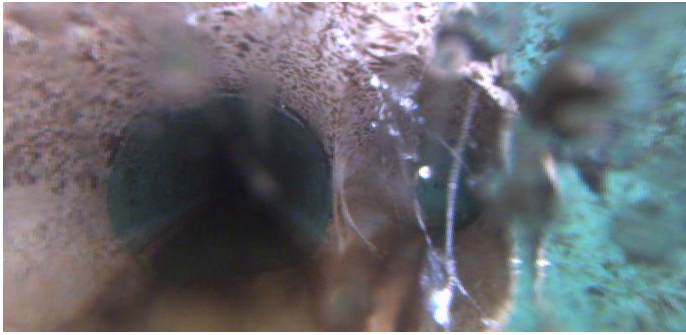
Code: **TF**
Description: **Tap Factory**

Distance (ft): **35.2**
Structural Grade: **0**
O&M Grade: **0**
Clock Start/From: **3**
Clock To:
1st Value: **4.000**
2nd Value:
Value Percent:
Continuous Index:
Within 8" of Joint:
Remarks:

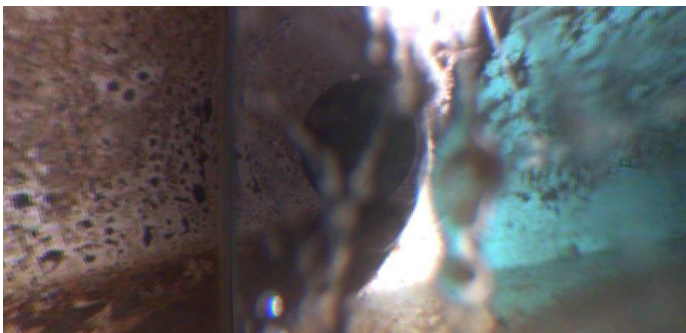
Code: **TF**
Description: **Tap Factory**

Distance (ft): **116.5**
Structural Grade: **0**
O&M Grade: **0**
Clock Start/From: **9**
Clock To:
1st Value: **4.000**
2nd Value:
Value Percent:
Continuous Index:
Within 8" of Joint:
Remarks:

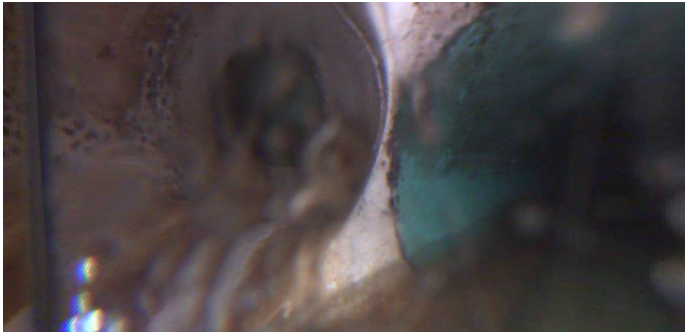
Code: **TF**
Description: **Tap Factory**

Distance (ft): **179.5**
Structural Grade: **0**
O&M Grade: **0**
Clock Start/From: **9**
Clock To:
1st Value: **4.000**
2nd Value:
Value Percent:
Continuous Index:
Within 8" of Joint:
Remarks:

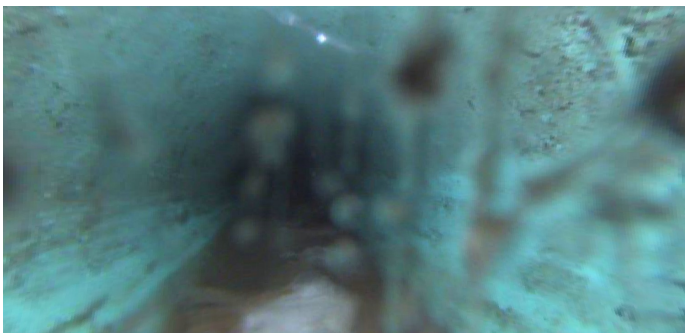
Code: **MGO**
Description: **General Observation**

Distance (ft): **189.6**
Structural Grade: **0**
O&M Grade: **0**
Clock Start/From:
Clock To:
1st Value:
2nd Value:
Value Percent:
Continuous Index:
Within 8" of Joint: **NO**
Remarks: **TOILET TISSUE**

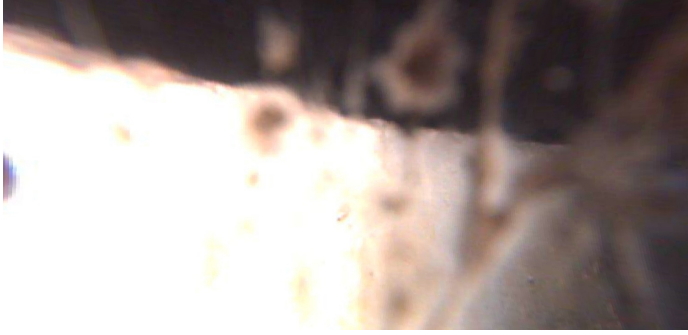
Code:	AMH
Description:	Manhole
Distance (ft):	216.9
Structural Grade:	0
O&M Grade:	0
Clock Start/From:	
Clock To:	
1st Value:	
2nd Value:	
Value Percent:	
Continuous Index:	
Within 8" of Joint:	NO
Remarks:	M-703-011
