Profile/Photo Observation Report

Street:	Pheasant Run Dr.	Flow Control:	Not Controlled
City:	Hobart, IN	Year Renewed:	
Location:	Light Highway	Tape/Media #:	
Purpose:	Routine Assessment	Dia/Height:	8"
Use:	Sanitary	Material:	PVC
Drain Area:	NA	Lining:	
Category:	NA		
Comment:

Location Details:		Direction of Survey:	Downstream
US MH:	M-703-011	DS MH:	M-703-012
		Total Length Surveyed (ft):	43.1

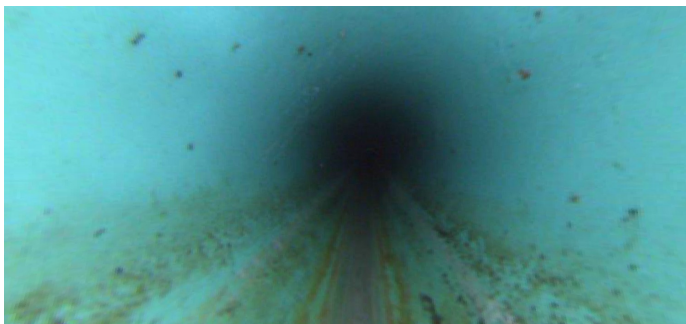
Code: **AMH**
Description: **Manhole**

Distance (ft): **.0**
Structural Grade: **0**
O&M Grade: **0**
Clock Start/From:
Clock To:
1st Value:
2nd Value:
Value Percent:
Continuous Index:
Within 8" of Joint: **NO**
Remarks: **M-703-011**

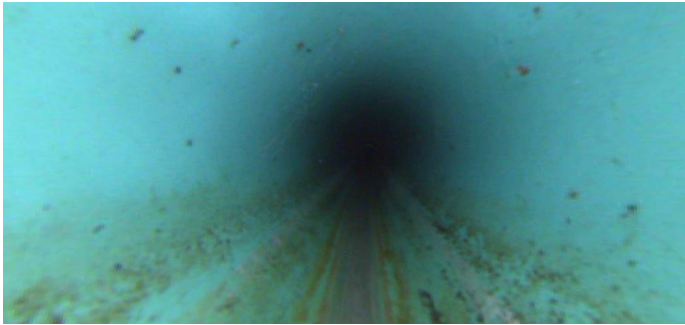
Code:	MWL
Description:	Water Level

Distance (ft):	.0
Structural Grade:	0
O&M Grade:	0
Clock Start/From:	
Clock To:	
1st Value:	
2nd Value:	
Value Percent:	5.000
Continuous Index:	
Within 8" of Joint:	NO
Remarks:

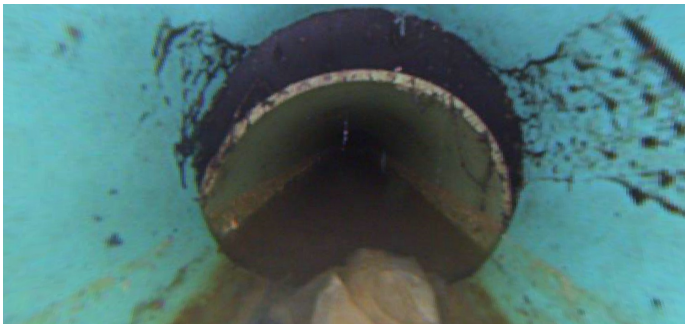
Code:	JOL
Description:	Joint Offset Large

Distance (ft):	8.4
Structural Grade:	2
O&M Grade:	0
Clock Start/From:	
Clock To:	
1st Value:	
2nd Value:	
Value Percent:	
Continuous Index:	
Within 8" of Joint:	NO
Remarks:

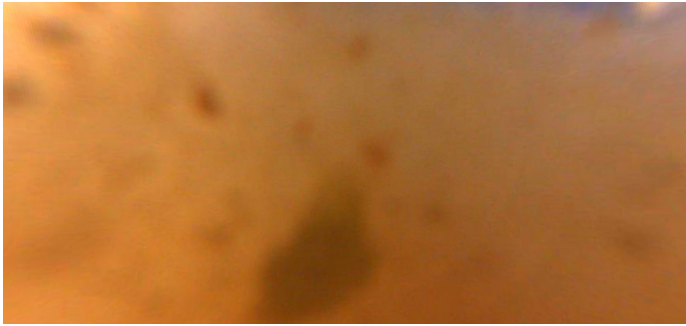
Code: **MWLS**
Description: **Water Level Sag**

Distance (ft): **10.2**
Structural Grade: **2**
O&M Grade: **3**
Clock Start/From:
Clock To:
1st Value:
2nd Value:
Value Percent: **20.000**
Continuous Index:
Within 8" of Joint: **NO**
Remarks:

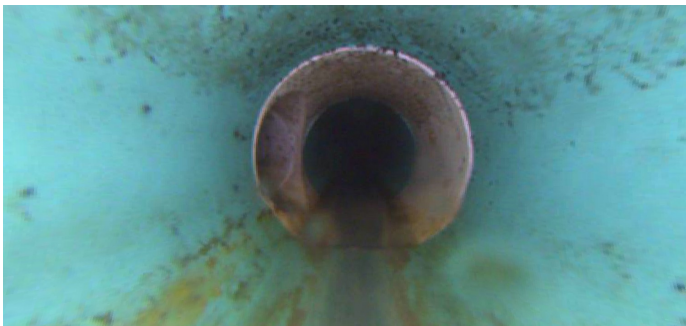
Code: **TF**
Description: **Tap Factory**

Distance (ft): **18.7**
Structural Grade: **0**
O&M Grade: **0**
Clock Start/From: **9**
Clock To:
1st Value: **4.000**
2nd Value:
Value Percent:
Continuous Index:
Within 8" of Joint:
Remarks:

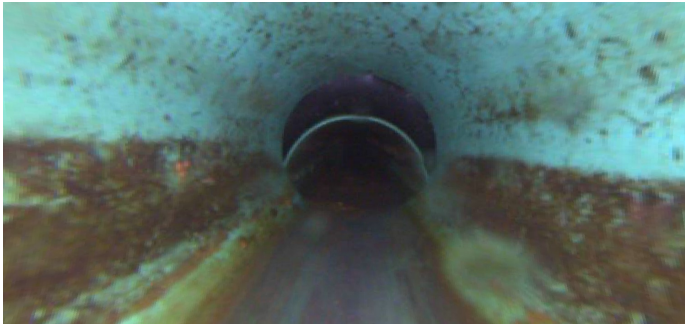
Code: **JOL**
Description: **Joint Offset Large**

Distance (ft): **41.6**
Structural Grade: **2**
O&M Grade: **0**
Clock Start/From:
Clock To:
1st Value:
2nd Value:
Value Percent:
Continuous Index:
Within 8" of Joint: **NO**
Remarks:

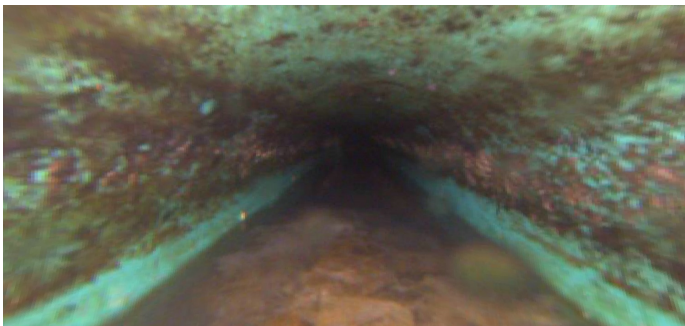
Code: **MSA**
Description: **Abandoned Survey**

Distance (ft): **43.1**
Structural Grade: **0**
O&M Grade: **0**
Clock Start/From:
Clock To:
1st Value:
2nd Value:
Value Percent:
Continuous Index:
Within 8" of Joint: **NO**
Remarks: **joint offset large**
