Profile/Photo Observation Report

Street:	PHEASANT RUN DR	Flow Control:	Not Controlled
City:	Hobart, IN	Year Renewed:	
Location:	Light Highway	Tape/Media #:	
Purpose:	Routine Assessment	Dia/Height:	8"
Use:	Sanitary	Material:	PVC
Drain Area:	NA	Lining:	
Category:	NA		
Comment:

Location Details:		Direction of Survey:	Upstream
US MH:	M-703-011	DS MH:	M-703-012
		Total Length Surveyed (ft):	8.6

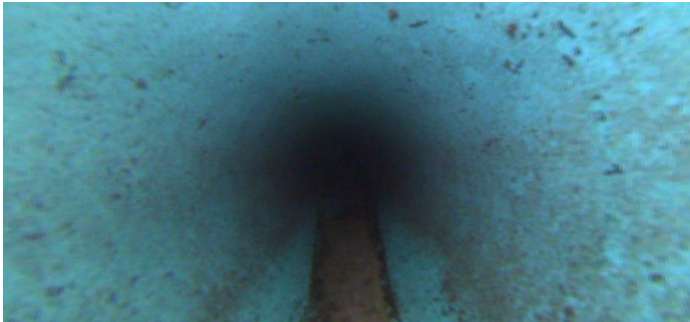
Code: AMH

Description: Manhole

Distance (ft): .0

Structural Grade: 0

O&M Grade: 0

Remarks: M-703-012

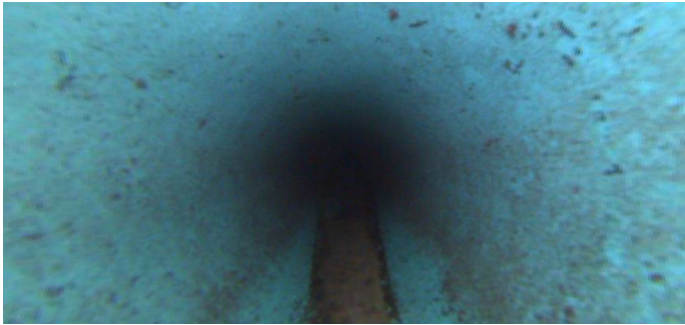
Code:	MWL
Description:	Water Level

Distance (ft):	.0
Structural Grade:	0
O&M Grade:	0
Clock Start/From:	
Clock To:	
1st Value:	
2nd Value:	
Value Percent:	5.000
Continuous Index:	
Within 8" of Joint:	NO
Remarks:
