Profile/Photo Observation Report

Date:	09/30/2018	Weather:		Coding:	PACP 6.0
Pipe Length (ft):	96.8	Owner:	NA	Pre Clean:	Not Known
P.O.#:		Surveyor:	Selasie Honu	PSR:	P-703-012-011
Customer:		Clean Date:	01/01/1900	Shape:	C

Street:	Pheasant Run Dr.	Flow Control:	Not Controlled
City:	Hobart, IN	Year Renewed:	
Location:	Light Highway	Tape/Media #:	
Purpose:	Routine Assessment	Dia/Height:	8"
Use:	Sanitary	Material:	PVC
Drain Area:	NA	Lining:	
Category:	NA		
Comment:

Location Details:		Direction of Survey:	Upstream
US MH:	M-703-011	DS MH:	M-703-012
		Total Length Surveyed (ft):	8.6

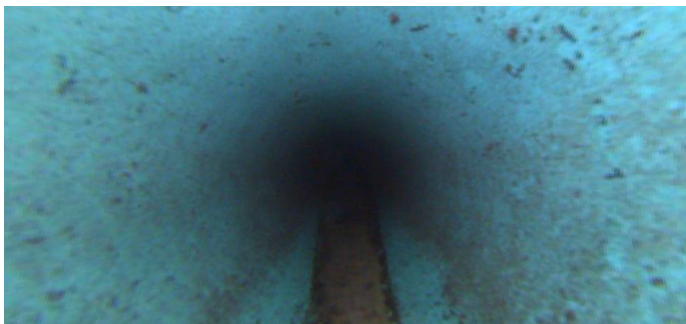
Code: **AMH**
Description: **Manhole**

Distance (ft): **.0**
Structural Grade: **0**
O&M Grade: **0**
Clock Start/From:
Clock To:
1st Value:
2nd Value:
Value Percent:
Continuous Index:
Within 8" of Joint: **NO**
Remarks: **M-703-012**

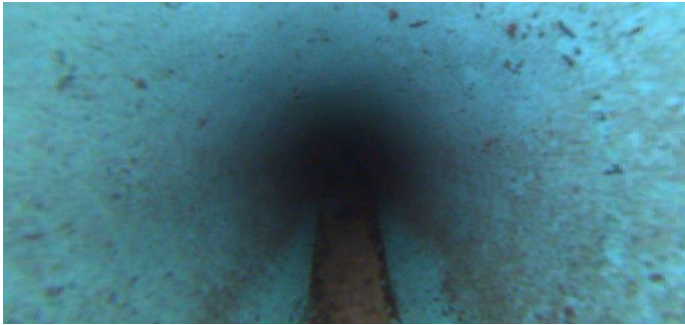
Code:	MWL
Description:	Water Level

Distance (ft):	.0
Structural Grade:	0
O&M Grade:	0
Clock Start/From:	
Clock To:	
1st Value:	
2nd Value:	
Value Percent:	5.000
Continuous Index:	
Within 8" of Joint:	NO
Remarks:
