Profile/Photo Observation Report

Street:	QUAIL DR	Flow Control:	Not Controlled
City:	Hobart, IN	Year Renewed:	
Location:	Light Highway	Tape/Media #:	
Purpose:	Routine Assessment	Dia/Height:	8"
Use:	Sanitary	Material:	PVC
Drain Area:	NA	Lining:	
Category:	NA		
Comment:

Location Details:		Direction of Survey:	Downstream
US MH:	M-703-014	DS MH:	M-703-013
		Total Length Surveyed (ft):	354.0

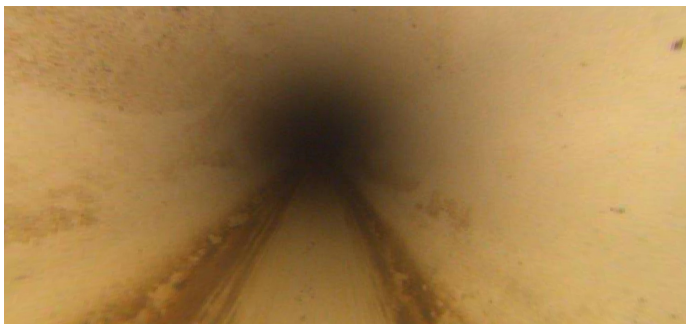
Code: **AMH**
Description: **Manhole**

Distance (ft): **.0**
Structural Grade: **0**
O&M Grade: **0**
Clock Start/From:
Clock To:
1st Value:
2nd Value:
Value Percent:
Continuous Index:
Within 8" of Joint: **NO**
Remarks: **M-703-014**

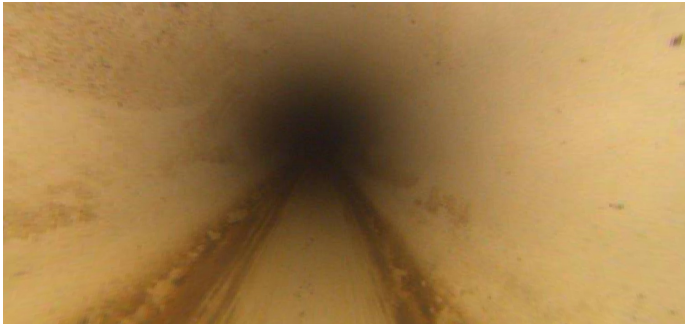
Code:	MWL
Description:	Water Level

Distance (ft):	.0
Structural Grade:	0
O&M Grade:	0
Clock Start/From:	
Clock To:	
1st Value:	
2nd Value:	
Value Percent:	5.000
Continuous Index:	
Within 8" of Joint:	NO
Remarks:

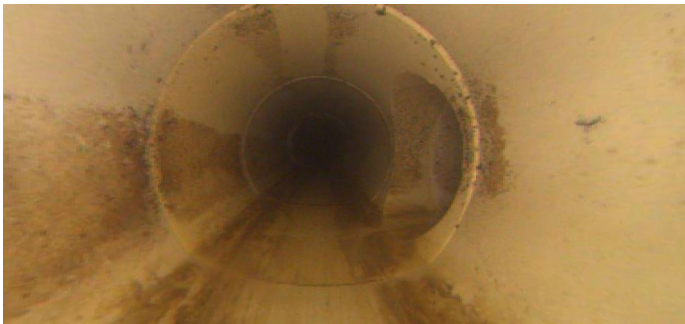
Code:	TF
Description:	Tap Factory

Distance (ft):	34.8
Structural Grade:	0
O&M Grade:	0
Clock Start/From:	3
Clock To:	
1st Value:	4.000
2nd Value:	
Value Percent:	
Continuous Index:	
Within 8" of Joint:	
Remarks:

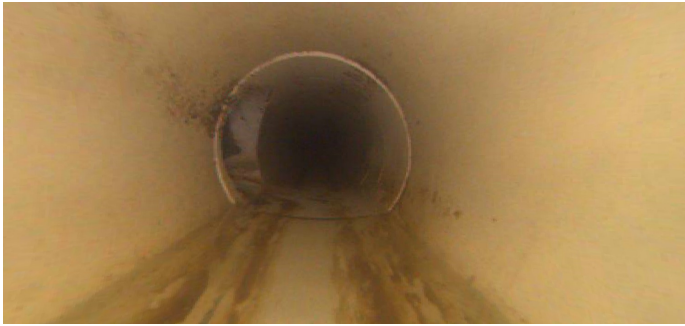
Code: **TF**
Description: **Tap Factory**

Distance (ft): **140.9**
Structural Grade: **0**
O&M Grade: **0**
Clock Start/From: **9**
Clock To:
1st Value: **4.000**
2nd Value:
Value Percent:
Continuous Index:
Within 8" of Joint:
Remarks:

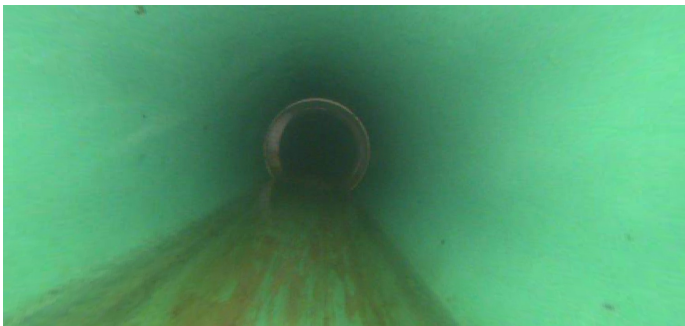
Code: **TF**
Description: **Tap Factory**

Distance (ft): **250.1**
Structural Grade: **0**
O&M Grade: **0**
Clock Start/From: **9**
Clock To:
1st Value: **4.000**
2nd Value:
Value Percent:
Continuous Index:
Within 8" of Joint:
Remarks:

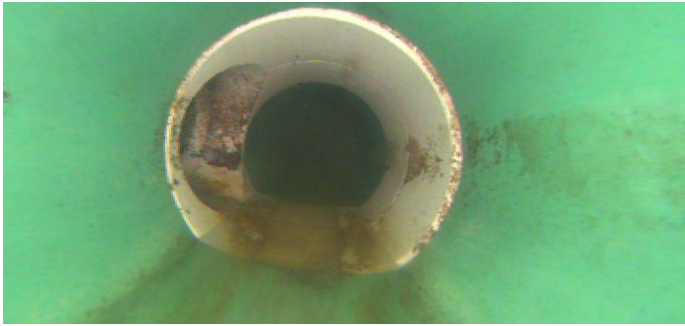
Code: **TF**
Description: **Tap Factory**

Distance (ft): **308.6**
Structural Grade: **0**
O&M Grade: **0**
Clock Start/From: **9**
Clock To:
1st Value: **4.000**
2nd Value:
Value Percent:
Continuous Index:
Within 8" of Joint:
Remarks:

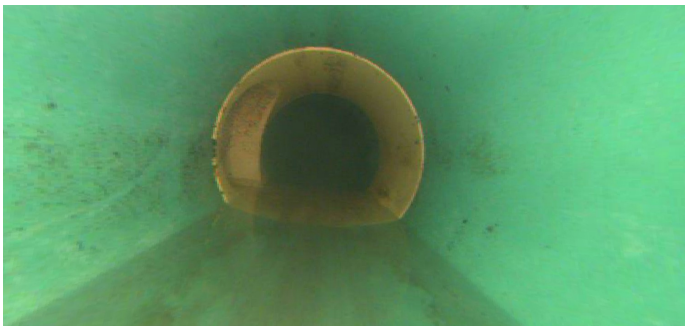
Code: **TF**
Description: **Tap Factory**

Distance (ft): **340.5**
Structural Grade: **0**
O&M Grade: **0**
Clock Start/From: **9**
Clock To:
1st Value: **4.000**
2nd Value:
Value Percent:
Continuous Index:
Within 8" of Joint:
Remarks:

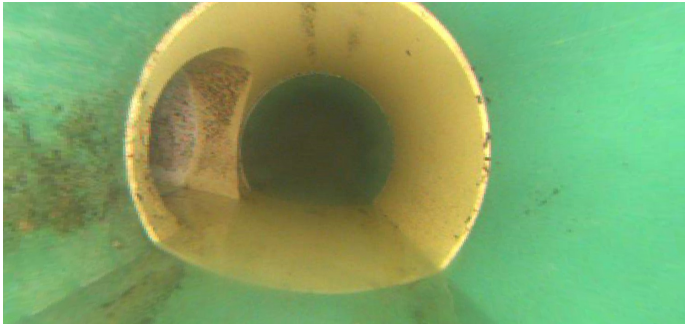
Code: **TF**
Description: **Tap Factory**

Distance (ft): **346.6**
Structural Grade: **0**
O&M Grade: **0**
Clock Start/From: **9**
Clock To:
1st Value: **4.000**
2nd Value:
Value Percent:
Continuous Index:
Within 8" of Joint:
Remarks:

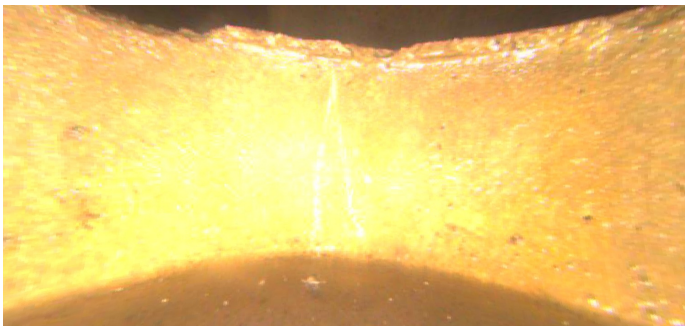
Code: **AMH**
Description: **Manhole**

Distance (ft): **354.0**
Structural Grade: **0**
O&M Grade: **0**
Clock Start/From:
Clock To:
1st Value:
2nd Value:
Value Percent:
Continuous Index:
Within 8" of Joint: **NO**
Remarks: **M-703-013**
