Profile/Photo Observation Report

| Street: | Quail Dr. | Flow Control: | Not Controlled |
| City: | Hobart, IN | Year Renewed: | |

| US MH: | M-703-014 | DS MH: | M-703-013 |

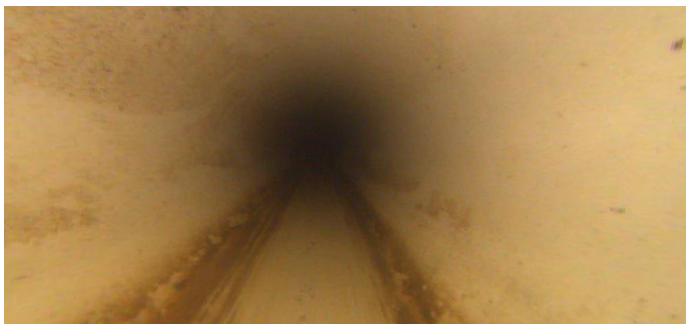
Code: **AMH**
Description: **Manhole**

Distance (ft): **.0**
Structural Grade: **0**
O&M Grade: **0**
Clock Start/From:
Clock To:
1st Value:
2nd Value:
Value Percent:
Continuous Index:
Within 8" of Joint: **NO**
Remarks: **M-703-014**

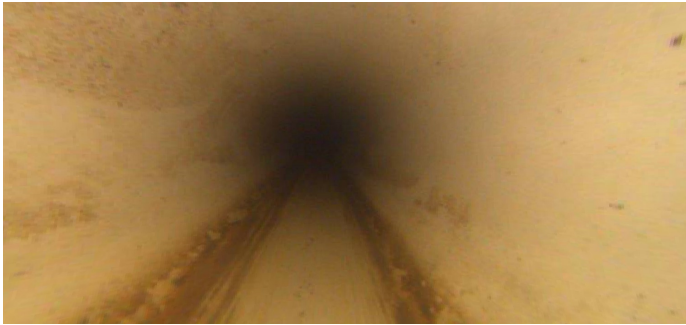
| Code: | MWL |
| Description: | Water Level |

| Distance (ft): | .0 |
| Value Percent: | 5.000 |

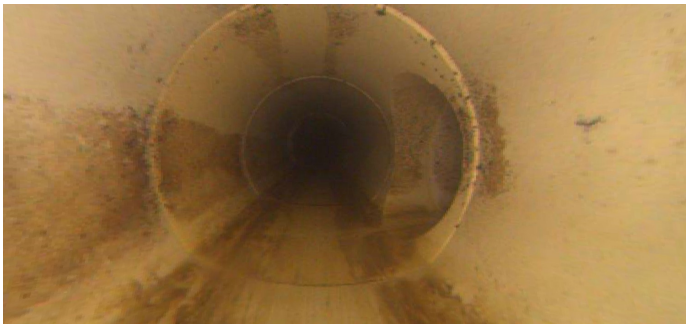
| Code: | TF |
| Description: | Tap Factory |

| Distance (ft): | 34.8 |
| Clock Start/From: | 3 |
| 1st Value: | 4.000 |

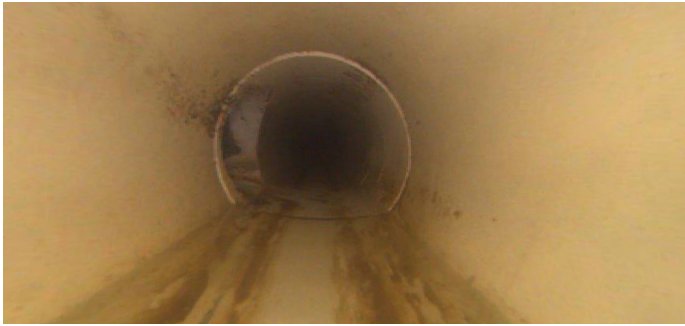
Code: **TF**
Description: **Tap Factory**

Distance (ft): **140.9**
Structural Grade: **0**
O&M Grade: **0**
Clock Start/From: **9**
Clock To:
1st Value: **4.000**
2nd Value:
Value Percent:
Continuous Index:
Within 8" of Joint:
Remarks:

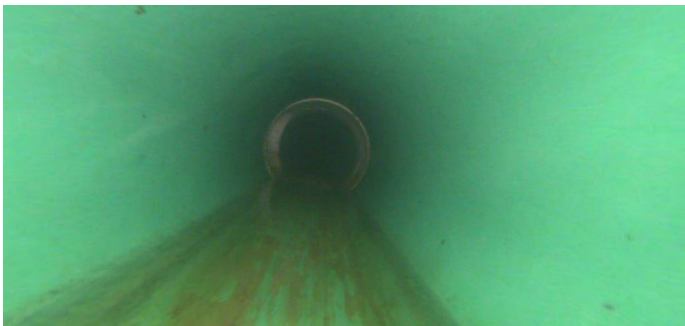
Code: **TF**
Description: **Tap Factory**

Distance (ft): **250.1**
Structural Grade: **0**
O&M Grade: **0**
Clock Start/From: **9**
Clock To:
1st Value: **4.000**
2nd Value:
Value Percent:
Continuous Index:
Within 8" of Joint:
Remarks:

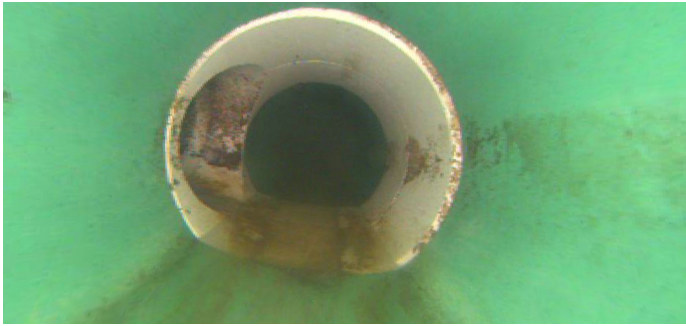
Code: **TF**
Description: **Tap Factory**

Distance (ft): **308.6**
Structural Grade: **0**
O&M Grade: **0**
Clock Start/From: **9**
Clock To:
1st Value: **4.000**
2nd Value:
Value Percent:
Continuous Index:
Within 8" of Joint:
Remarks:

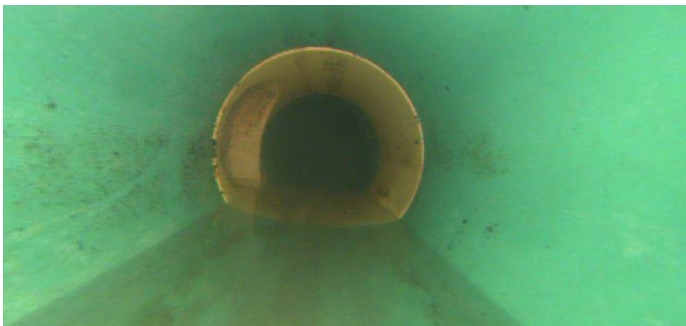
Code: **TF**
Description: **Tap Factory**

Distance (ft): **340.5**
Structural Grade: **0**
O&M Grade: **0**
Clock Start/From: **9**
Clock To:
1st Value: **4.000**
2nd Value:
Value Percent:
Continuous Index:
Within 8" of Joint:
Remarks:

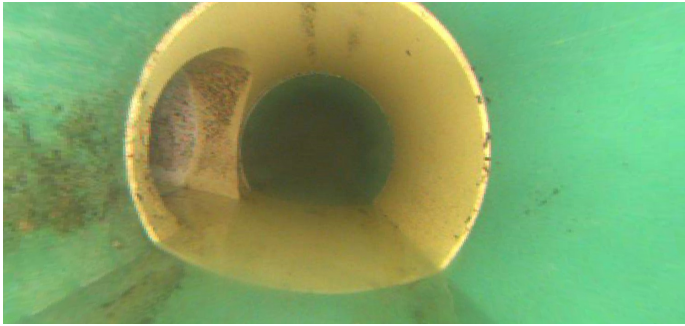
Code: **TF**
Description: **Tap Factory**

Distance (ft): **346.6**
Structural Grade: **0**
O&M Grade: **0**
Clock Start/From: **9**
Clock To:
1st Value: **4.000**
2nd Value:
Value Percent:
Continuous Index:
Within 8" of Joint:
Remarks:

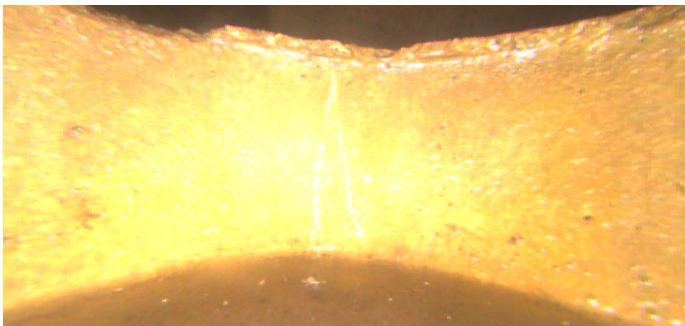
Code: **AMH**
Description: **Manhole**

Distance (ft): **354.0**
Structural Grade: **0**
O&M Grade: **0**
Clock Start/From:
Clock To:
1st Value:
2nd Value:
Value Percent:
Continuous Index:
Within 8" of Joint: **NO**
Remarks: **M-703-013**
