Profile/Photo Observation Report

Street:	quail dr	Flow Control:	Not Controlled
City:	Hobart, IN	Year Renewed:	
Location:	Other	Tape/Media #:	
Purpose:	Not Known	Dia/Height:	10"
Use:	Sanitary	Material:	PVC
Drain Area:	NA	Lining:	
Category:	NA		
Comment:

Location Details:		Direction of Survey:	Downstream
US MH:	M-703-015	DS MH:	M-703-014
		Total Length Surveyed (ft):	282.4

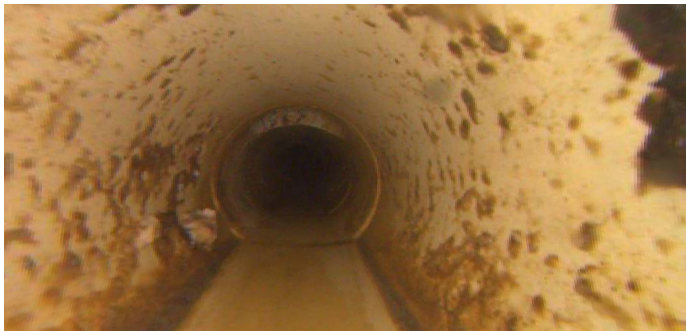
Code: **AMH**
Description: **Manhole**

Distance (ft): **.0**
Structural Grade: **0**
O&M Grade: **0**
Clock Start/From:
Clock To:
1st Value:
2nd Value:
Value Percent:
Continuous Index:
Within 8" of Joint: **NO**
Remarks: **M-703-015**

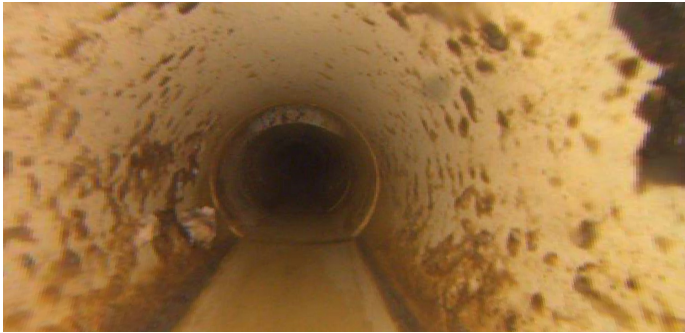
Code:	MWL
Description:	Water Level

Distance (ft):	.0
Structural Grade:	0
O&M Grade:	0
Clock Start/From:	
Clock To:	
1st Value:	
2nd Value:	
Value Percent:	5.000
Continuous Index:	
Within 8" of Joint:	NO
Remarks:

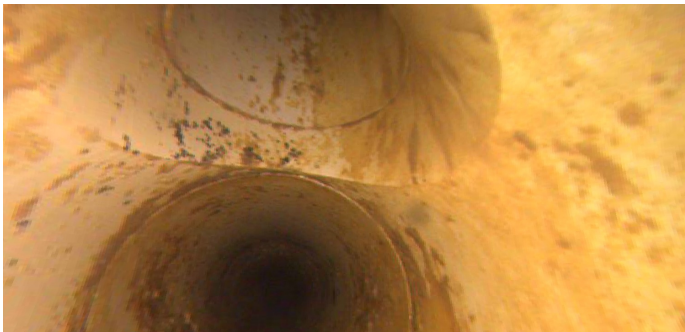
Code:	TF
Description:	Tap Factory

Distance (ft):	2.5
Structural Grade:	0
O&M Grade:	0
Clock Start/From:	12
Clock To:	
1st Value:	4.000
2nd Value:	
Value Percent:	
Continuous Index:	
Within 8" of Joint:	
Remarks:

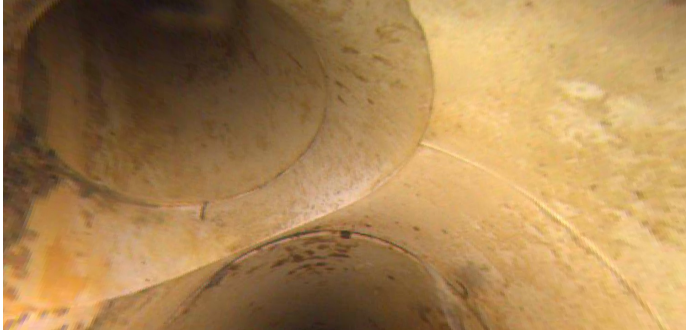
Code: **TF**
Description: **Tap Factory**

Distance (ft): **56.6**
Structural Grade: **0**
O&M Grade: **0**
Clock Start/From: **10**
Clock To:
1st Value: **4.000**
2nd Value:
Value Percent:
Continuous Index:
Within 8" of Joint:
Remarks:

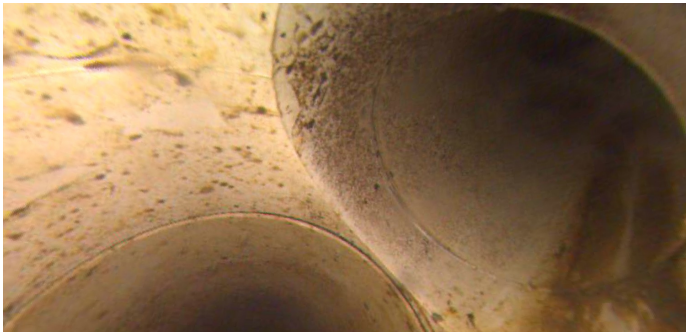
Code: **TF**
Description: **Tap Factory**

Distance (ft): **74.7**
Structural Grade: **0**
O&M Grade: **0**
Clock Start/From: **2**
Clock To:
1st Value: **4.000**
2nd Value:
Value Percent:
Continuous Index:
Within 8" of Joint:
Remarks:

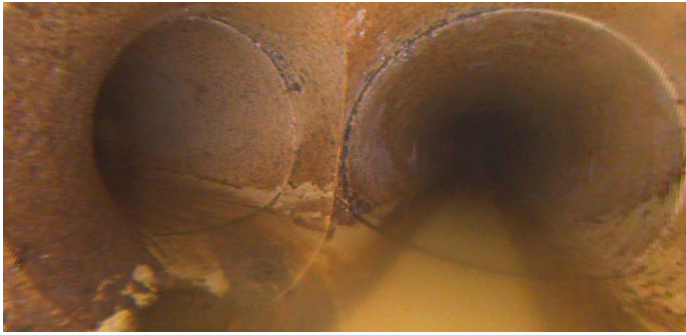
Code: **TF**
Description: **Tap Factory**

Distance (ft): **131.9**
Structural Grade: **0**
O&M Grade: **0**
Clock Start/From: **9**
Clock To:
1st Value: **4.000**
2nd Value:
Value Percent:
Continuous Index:
Within 8" of Joint:
Remarks:

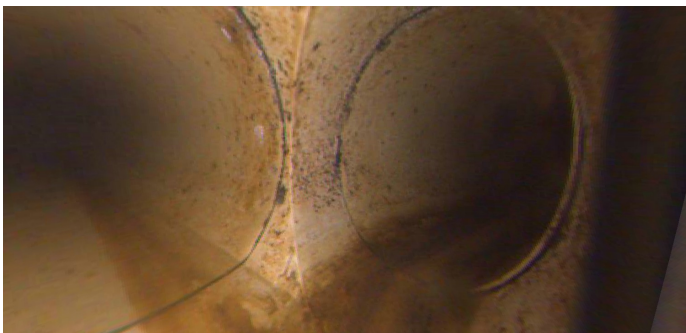
Code: **TF**
Description: **Tap Factory**

Distance (ft): **152.8**
Structural Grade: **0**
O&M Grade: **0**
Clock Start/From: **3**
Clock To:
1st Value: **4.000**
2nd Value:
Value Percent:
Continuous Index:
Within 8" of Joint:
Remarks:

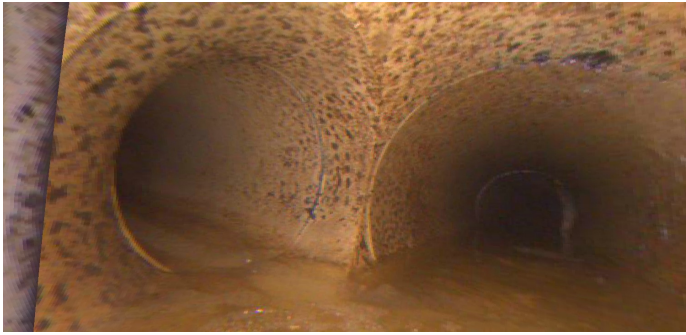
Code: **TFA**
Description: **Tap Factory Active**

Distance (ft): **233.1**
Structural Grade: **0**
O&M Grade: **0**
Clock Start/From: **9**
Clock To:
1st Value: **4.000**
2nd Value:
Value Percent:
Continuous Index:
Within 8" of Joint:
Remarks:

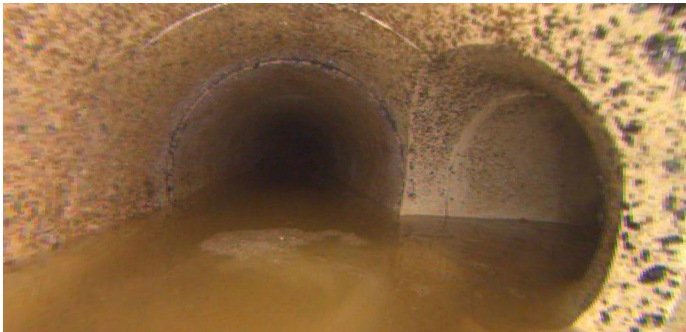
Code: **TFA**
Description: **Tap Factory Active**

Distance (ft): **235.6**
Structural Grade: **0**
O&M Grade: **0**
Clock Start/From: **3**
Clock To:
1st Value: **4.000**
2nd Value:
Value Percent:
Continuous Index:
Within 8" of Joint:
Remarks:

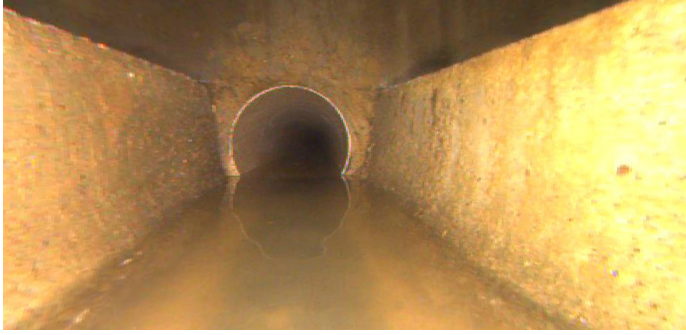
Code:	AMH
Description:	Manhole
Distance (ft):	282.4
Structural Grade:	0
O&M Grade:	0
Clock Start/From:	
Clock To:	
1st Value:	
2nd Value:	
Value Percent:	
Continuous Index:	
Within 8" of Joint:	NO
Remarks:	M-703-014
