## Profile/Photo Observation Report

Street:	<b>PHEASANT RUN DR &amp; EDGEWATER</b>	Flow Control:	<b>Not Controlled</b>
City:	<b>Hobart, IN</b>	Year Renewed:	
Location:	<b>Other</b>	Tape/Media #:	
Purpose:	<b>Not Known</b>	Dia/Height:	<b>10"</b>
Use:	<b>Sanitary</b>	Material:	<b>PVC</b>
Drain Area:	<b>NA</b>	Lining:	
Category:	<b>NA</b>		
Comment:

Location Details:		Direction of Survey:	<b>Upstream</b>
US MH:	<b>M-703-016</b>	DS MH:	<b>M-703-006</b>
		Total Length Surveyed (ft):	<b>302.9</b>

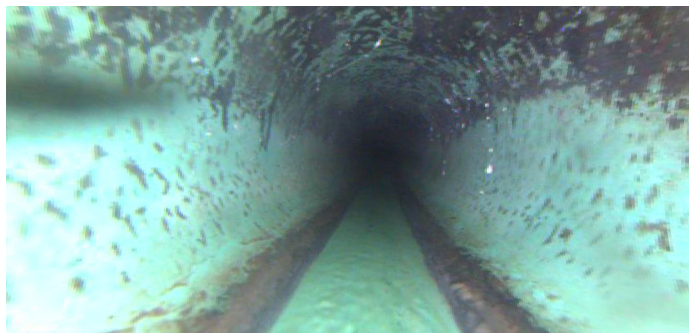
Code: **AMH**  
Description: **Manhole**

Distance (ft): **.0**  
Structural Grade: **0**  
O&M Grade: **0**  
Clock Start/From:  
Clock To:  
1st Value:  
2nd Value:  
Value Percent:  
Continuous Index:  
Within 8" of Joint: **NO**  
Remarks: **M-703-006**

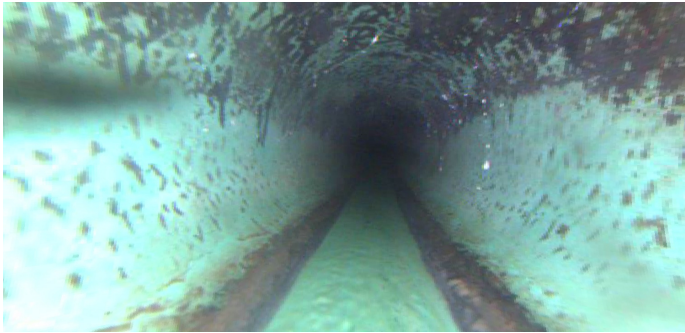
Code:	<b>MWL</b>
Description:	<b>Water Level</b>

Distance (ft):	<b>.0</b>
Structural Grade:	<b>0</b>
O&M Grade:	<b>0</b>
Clock Start/From:	
Clock To:	
1st Value:	
2nd Value:	
Value Percent:	<b>5.000</b>
Continuous Index:	
Within 8" of Joint:	<b>NO</b>
Remarks:

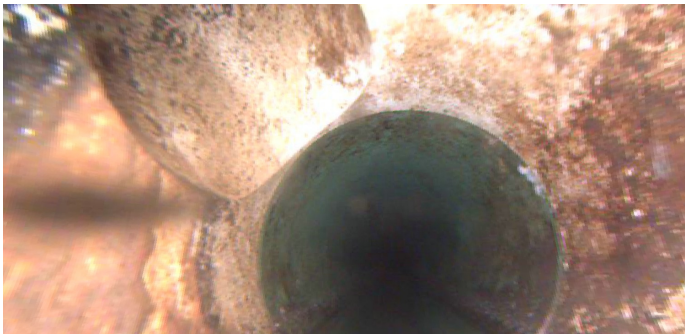
Code:	<b>TF</b>
Description:	<b>Tap Factory</b>

Distance (ft):	<b>83.9</b>
Structural Grade:	<b>0</b>
O&M Grade:	<b>0</b>
Clock Start/From:	<b>10</b>
Clock To:	
1st Value:	<b>4.000</b>
2nd Value:	
Value Percent:	
Continuous Index:	
Within 8" of Joint:	
Remarks:

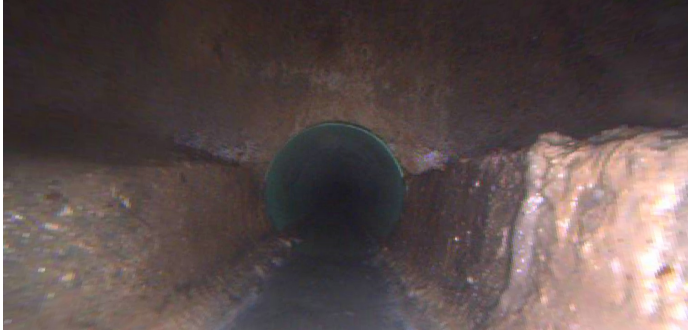
Code:	<b>AMH</b>
Description:	<b>Manhole</b>
Distance (ft):	<b>302.9</b>
Structural Grade:	<b>0</b>
O&M Grade:	<b>0</b>
Clock Start/From:	
Clock To:	
1st Value:	
2nd Value:	
Value Percent:	
Continuous Index:	
Within 8" of Joint:	<b>NO</b>
Remarks:	<b>M-703-016</b>
