Profile/Photo Observation Report

Street:	EDGEWATER DR	Flow Control:	Not Controlled
City:	Hobart, IN	Year Renewed:	
Location:	Other	Tape/Media #:	
Purpose:	Not Known	Dia/Height:	10"
Use:	Sanitary	Material:	PVC
Drain Area:	NA	Lining:	
Category:	NA		
Comment:

Location Details:		Direction of Survey:	Upstream
US MH:	M-703-016	DS MH:	M-703-006
		Total Length Surveyed (ft):	302.9

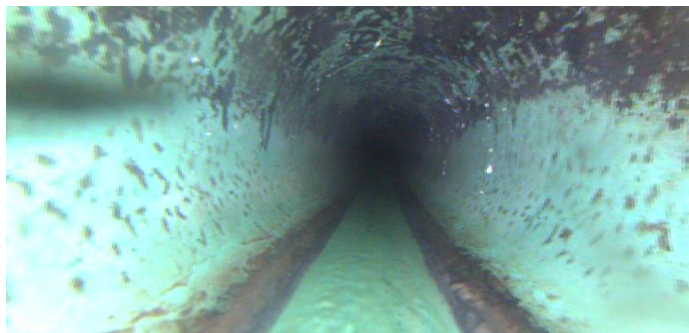
Code: **AMH**
 Description: **Manhole**
 Distance (ft): **.0**
 Structural Grade: **0**
 O&M Grade: **0**
 Clock Start/From:
 Clock To:
 1st Value:
 2nd Value:
 Value Percent:
 Continuous Index:
 Within 8" of Joint: **NO**
 Remarks: **M-703-006**

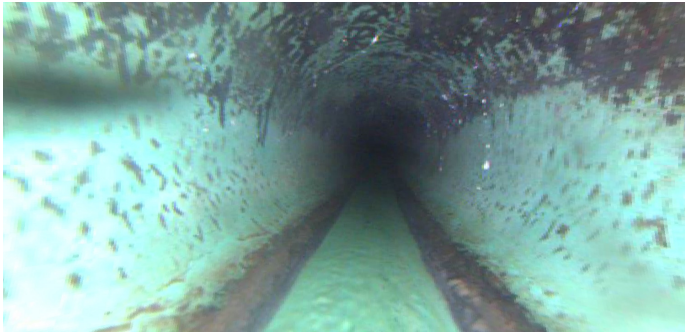
Code:	MWL
Description:	Water Level

Distance (ft):	.0
Structural Grade:	0
O&M Grade:	0
Clock Start/From:	
Clock To:	
1st Value:	
2nd Value:	
Value Percent:	5.000
Continuous Index:	
Within 8" of Joint:	NO
Remarks:

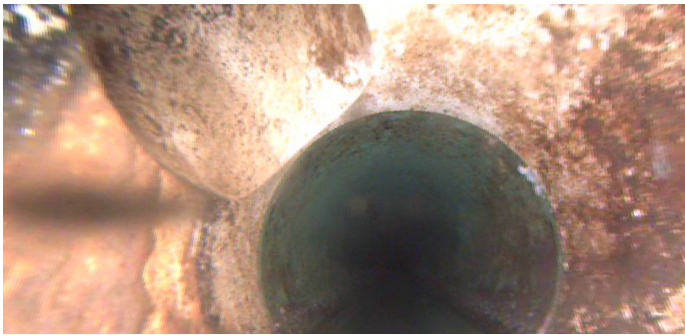
Code:	TF
Description:	Tap Factory

Distance (ft):	83.9
Structural Grade:	0
O&M Grade:	0
Clock Start/From:	10
Clock To:	
1st Value:	4.000
2nd Value:	
Value Percent:	
Continuous Index:	
Within 8" of Joint:	
Remarks:

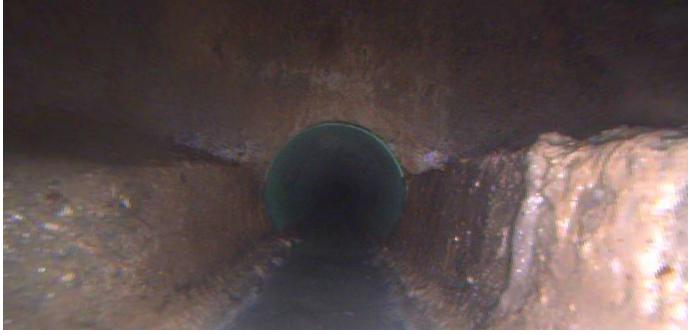
Code:	AMH
Description:	Manhole
Distance (ft):	302.9
Structural Grade:	0
O&M Grade:	0
Clock Start/From:	
Clock To:	
1st Value:	
2nd Value:	
Value Percent:	
Continuous Index:	
Within 8" of Joint:	NO
Remarks:	M-703-016
