Profile/Photo Observation Report

Street:	EDGEWATER DR & QUAIL DR	Flow Control:	Not Controlled
City:	Hobart, IN	Year Renewed:	
Location:	Other	Tape/Media #:	
Purpose:	Not Known	Dia/Height:	10"
Use:	Sanitary	Material:	PVC
Drain Area:	NA	Lining:	
Category:	NA		
Comment:

Location Details:		Direction of Survey:	Downstream
US MH:	M-703-017	DS MH:	M-703-016
		Total Length Surveyed (ft):	306.3

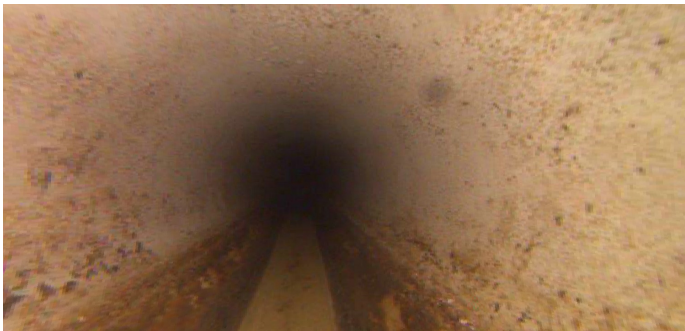
Code: **AMH**
Description: **Manhole**

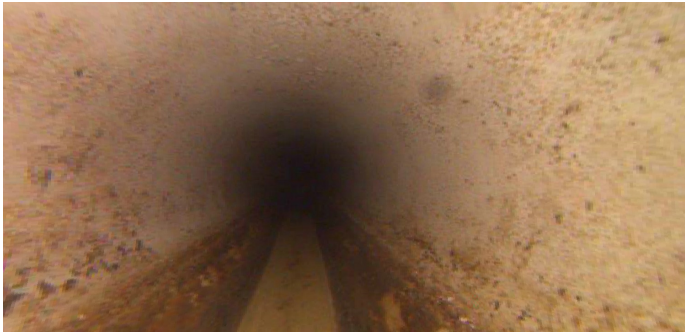
Code:	MWL
Description:	Water Level

Distance (ft):	.0
Structural Grade:	0
O&M Grade:	0
Clock Start/From:	
Clock To:	
1st Value:	
2nd Value:	
Value Percent:	5.000
Continuous Index:	
Within 8" of Joint:	NO
Remarks:

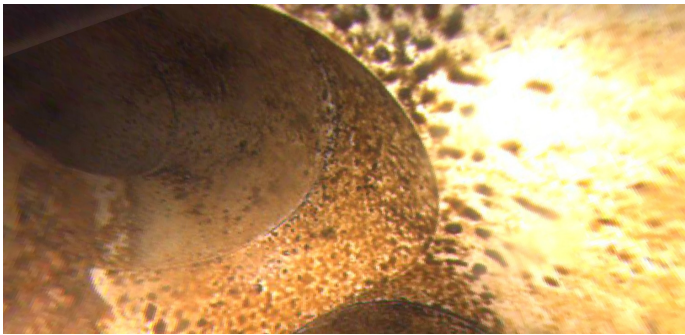
Code:	TF
Description:	Tap Factory

Distance (ft):	36.6
Structural Grade:	0
O&M Grade:	0
Clock Start/From:	10
Clock To:	
1st Value:	4.000
2nd Value:	
Value Percent:	
Continuous Index:	
Within 8" of Joint:	
Remarks:

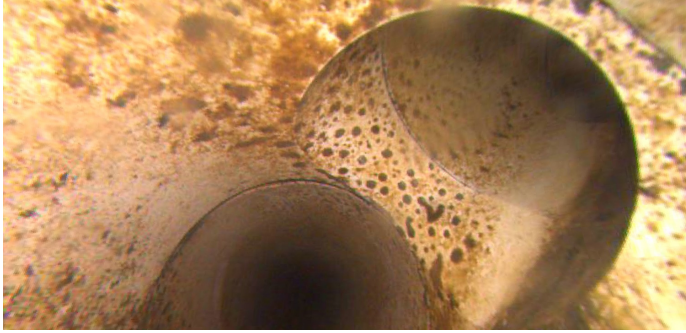
Code: **TF**
Description: **Tap Factory**

Distance (ft): **39.1**
Structural Grade: **0**
O&M Grade: **0**
Clock Start/From: **2**
Clock To:
1st Value: **4.000**
2nd Value:
Value Percent:
Continuous Index:
Within 8" of Joint:
Remarks:

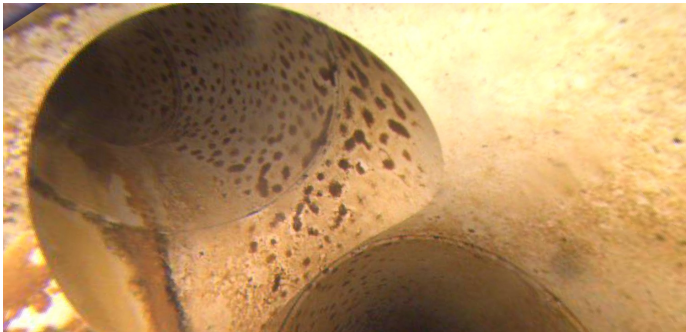
Code: **TF**
Description: **Tap Factory**

Distance (ft): **116.6**
Structural Grade: **0**
O&M Grade: **0**
Clock Start/From: **11**
Clock To:
1st Value: **4.000**
2nd Value:
Value Percent:
Continuous Index:
Within 8" of Joint:
Remarks:

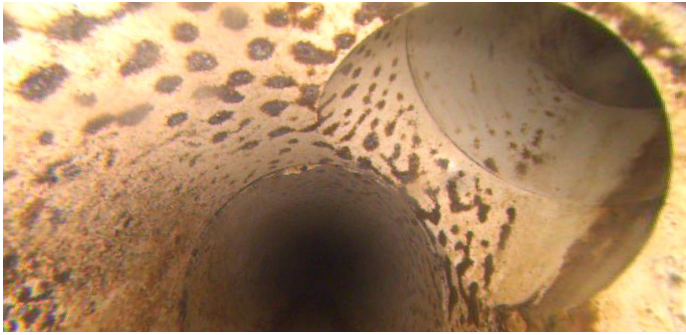
Code: **TF**
Description: **Tap Factory**

Distance (ft): **119.1**
Structural Grade: **0**
O&M Grade: **0**
Clock Start/From: **2**
Clock To:
1st Value: **4.000**
2nd Value:
Value Percent:
Continuous Index:
Within 8" of Joint:
Remarks:

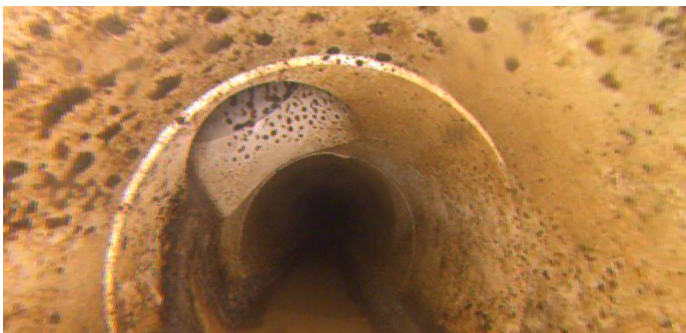
Code: **TF**
Description: **Tap Factory**

Distance (ft): **207.1**
Structural Grade: **0**
O&M Grade: **0**
Clock Start/From: **10**
Clock To:
1st Value: **4.000**
2nd Value:
Value Percent:
Continuous Index:
Within 8" of Joint:
Remarks:

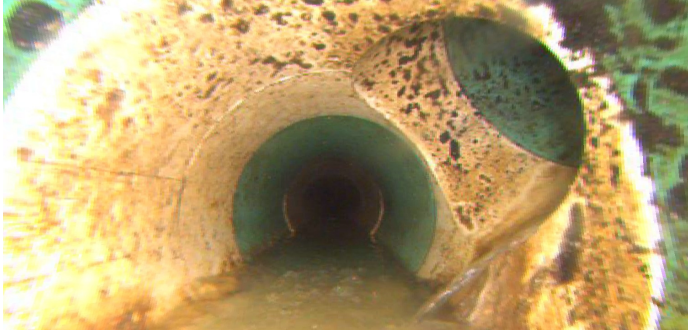
Code: **TFA**
Description: **Tap Factory Active**

Distance (ft): **222.7**
Structural Grade: **0**
O&M Grade: **0**
Clock Start/From: **2**
Clock To:
1st Value: **4.000**
2nd Value:
Value Percent:
Continuous Index:
Within 8" of Joint:
Remarks:

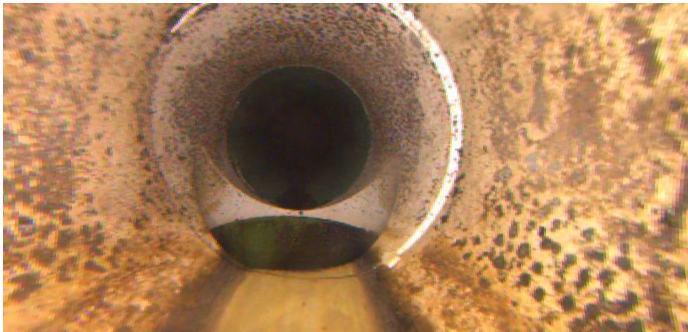
Code: **TF**
Description: **Tap Factory**

Distance (ft): **302.7**
Structural Grade: **0**
O&M Grade: **0**
Clock Start/From: **6**
Clock To:
1st Value: **6.000**
2nd Value:
Value Percent:
Continuous Index:
Within 8" of Joint:
Remarks: **DROP CONNECTION**

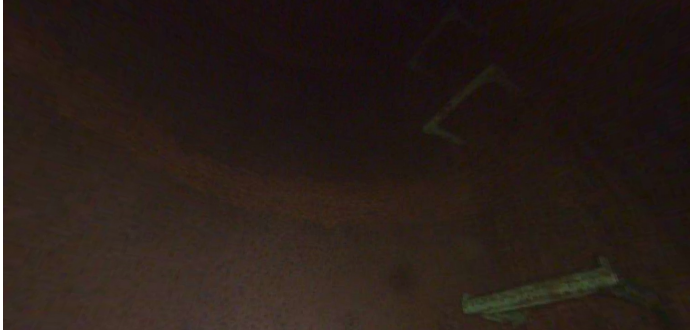
Code:	AMH
Description:	Manhole
Distance (ft):	306.3
Structural Grade:	0
O&M Grade:	0
Clock Start/From:	
Clock To:	
1st Value:	
2nd Value:	
Value Percent:	
Continuous Index:	
Within 8" of Joint:	NO
Remarks:	M-703-016
