## Profile/Photo Observation Report

Street:	<b>quail dr</b>	Flow Control:	<b>Not Controlled</b>
City:	<b>Hobart, IN</b>	Year Renewed:	
Location:	<b>Other</b>	Tape/Media #:	
Purpose:	<b>Not Known</b>	Dia/Height:	<b>10"</b>
Use:	<b>Sanitary</b>	Material:	<b>PVC</b>
Drain Area:	<b>NA</b>	Lining:	
Category:	<b>NA</b>		
Comment:

Location Details:		Direction of Survey:	<b>Downstream</b>
US MH:	<b>M-703-017</b>	DS MH:	<b>M-703-016</b>
		Total Length Surveyed (ft):	<b>306.3</b>

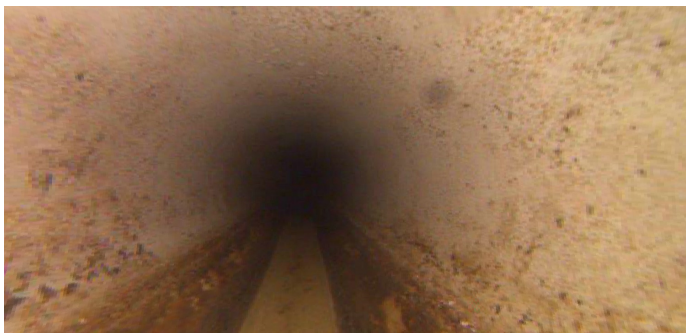
Code: **AMH**  
Description: **Manhole**

Distance (ft): **.0**  
Structural Grade: **0**  
O&M Grade: **0**  
Clock Start/From:  
Clock To:  
1st Value:  
2nd Value:  
Value Percent:  
Continuous Index:  
Within 8" of Joint: **NO**  
Remarks: **M-703-017**

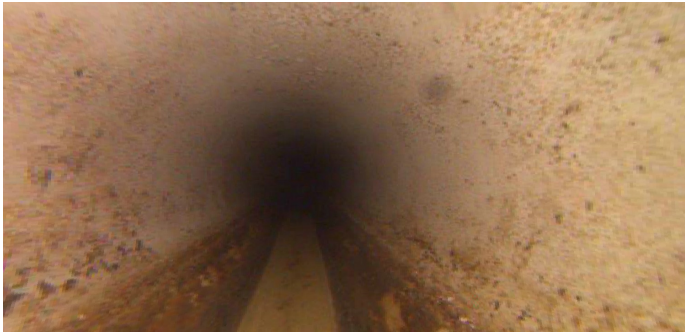
Code:	<b>MWL</b>
Description:	<b>Water Level</b>

Distance (ft):	<b>.0</b>
Structural Grade:	<b>0</b>
O&M Grade:	<b>0</b>
Clock Start/From:	
Clock To:	
1st Value:	
2nd Value:	
Value Percent:	<b>5.000</b>
Continuous Index:	
Within 8" of Joint:	<b>NO</b>
Remarks:

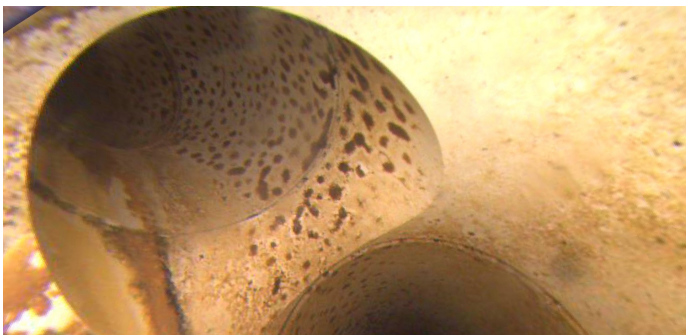
Code: **TF**  
Description: **Tap Factory**

Distance (ft): **116.6**  
Structural Grade: **0**  
O&M Grade: **0**  
Clock Start/From: **11**  
Clock To:  
1st Value: **4.000**  
2nd Value:  
Value Percent:  
Continuous Index:  
Within 8" of Joint:  
Remarks:

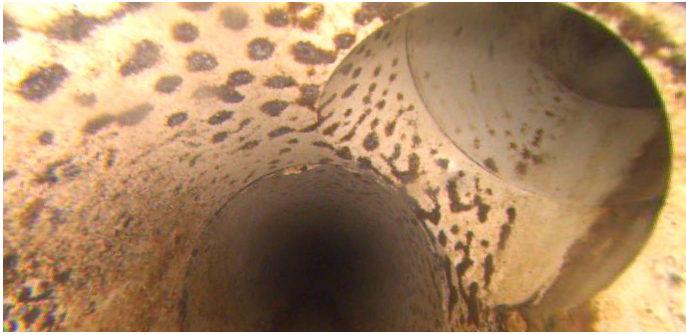
Code: **TF**  
Description: **Tap Factory**

Distance (ft): **119.1**  
Structural Grade: **0**  
O&M Grade: **0**  
Clock Start/From: **2**  
Clock To:  
1st Value: **4.000**  
2nd Value:  
Value Percent:  
Continuous Index:  
Within 8" of Joint:  
Remarks:

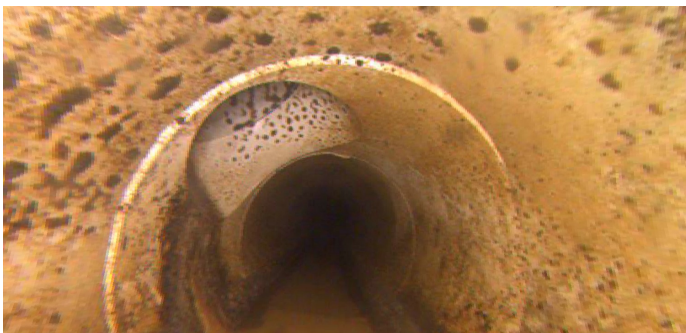
Code: **TF**  
Description: **Tap Factory**

Distance (ft): **207.1**  
Structural Grade: **0**  
O&M Grade: **0**  
Clock Start/From: **10**  
Clock To:  
1st Value: **4.000**  
2nd Value:  
Value Percent:  
Continuous Index:  
Within 8" of Joint:  
Remarks:

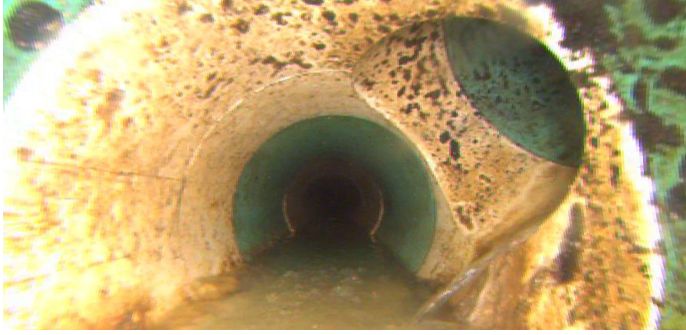
Code: **TFA**  
Description: **Tap Factory Active**

Distance (ft): **222.7**  
Structural Grade: **0**  
O&M Grade: **0**  
Clock Start/From: **2**  
Clock To:  
1st Value: **4.000**  
2nd Value:  
Value Percent:  
Continuous Index:  
Within 8" of Joint:  
Remarks:

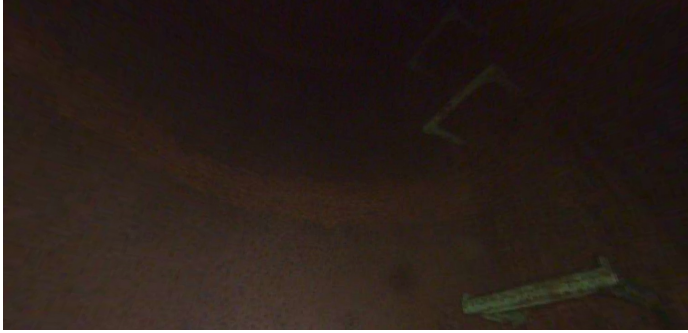
Code:	AMH
Description:	Manhole
Distance (ft):	306.3
Structural Grade:	0
O&M Grade:	0
Clock Start/From:	
Clock To:	
1st Value:	
2nd Value:	
Value Percent:	
Continuous Index:	
Within 8" of Joint:	NO
Remarks:	M-703-016
