## Profile/Photo Observation Report

Street:	<b>QUAIL DR</b>	Flow Control:	<b>Not Controlled</b>
City:	<b>Hobart, IN</b>	Year Renewed:	
Location:	<b>Other</b>	Tape/Media #:	
Purpose:	<b>Not Known</b>	Dia/Height:	<b>10"</b>
Use:	<b>Sanitary</b>	Material:	<b>PVC</b>
Drain Area:	<b>NA</b>	Lining:	
Category:	<b>NA</b>		
Comment:

Location Details:		Direction of Survey:	<b>Downstream</b>
US MH:	<b>M-703-017</b>	DS MH:	<b>M-703-018</b>
		Total Length Surveyed (ft):	<b>234.2</b>

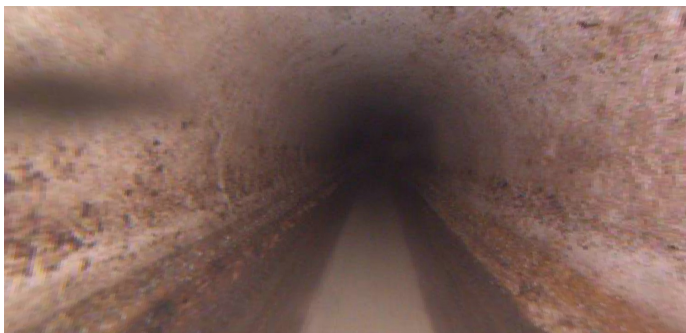
Code: **AMH**  
Description: **Manhole**

Distance (ft): **.0**  
Structural Grade: **0**  
O&M Grade: **0**  
Clock Start/From:  
Clock To:  
1st Value:  
2nd Value:  
Value Percent:  
Continuous Index:  
Within 8" of Joint: **NO**  
Remarks: **M-703-017**

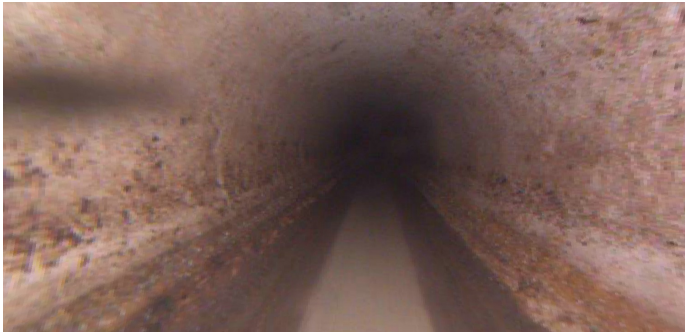
Code:	<b>MWL</b>
Description:	<b>Water Level</b>

Distance (ft):	<b>.0</b>
Structural Grade:	<b>0</b>
O&M Grade:	<b>0</b>
Clock Start/From:	
Clock To:	
1st Value:	
2nd Value:	
Value Percent:	<b>5.000</b>
Continuous Index:	
Within 8" of Joint:	<b>NO</b>
Remarks:

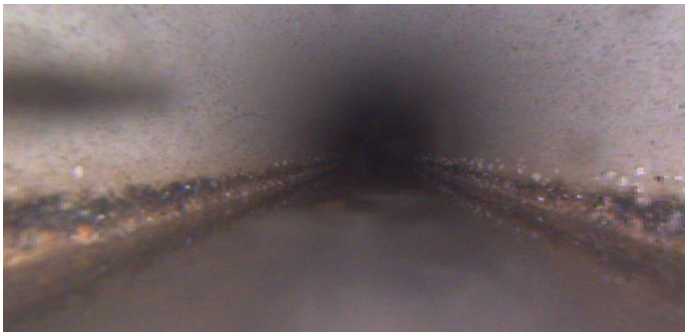
Code:	<b>MGO</b>
Description:	<b>General Observation</b>

Distance (ft):	<b>30.6</b>
Structural Grade:	<b>0</b>
O&M Grade:	<b>0</b>
Clock Start/From:	
Clock To:	
1st Value:	
2nd Value:	
Value Percent:	
Continuous Index:	
Within 8" of Joint:	<b>NO</b>
Remarks:	<b>TOILE TISSUE</b>

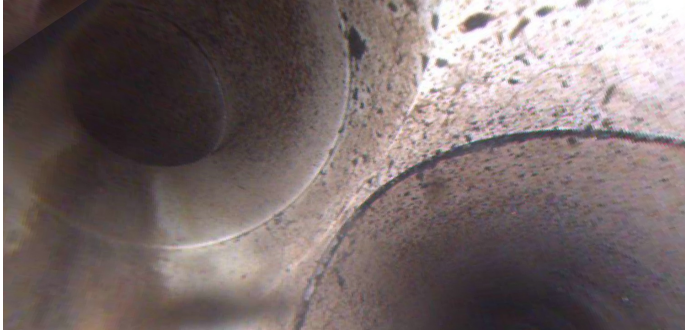
Code: **TF**  
Description: **Tap Factory**

Distance (ft): **36.0**  
Structural Grade: **0**  
O&M Grade: **0**  
Clock Start/From: **10**  
Clock To:  
1st Value: **4.000**  
2nd Value:  
Value Percent:  
Continuous Index:  
Within 8" of Joint:  
Remarks:

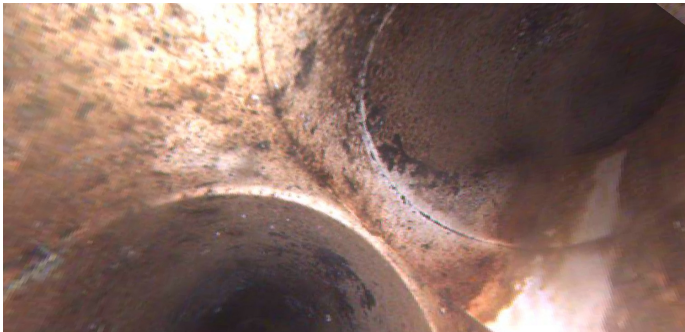
Code: **TF**  
Description: **Tap Factory**

Distance (ft): **40.5**  
Structural Grade: **0**  
O&M Grade: **0**  
Clock Start/From: **2**  
Clock To:  
1st Value: **4.000**  
2nd Value:  
Value Percent:  
Continuous Index:  
Within 8" of Joint:  
Remarks:

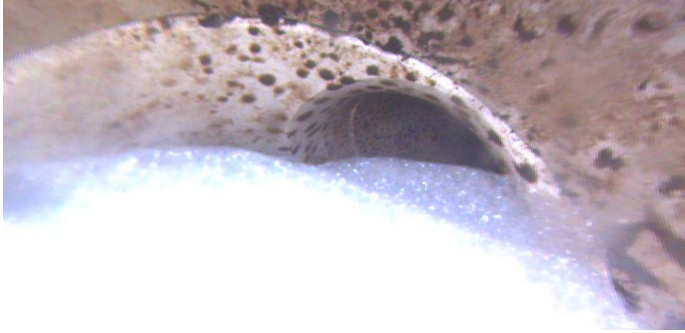
Code: **MGO**  
Description: **General Observation**

Distance (ft): **115.9**  
Structural Grade: **0**  
O&M Grade: **0**  
Clock Start/From:  
Clock To:  
1st Value:  
2nd Value:  
Value Percent:  
Continuous Index:  
Within 8" of Joint: **NO**  
Remarks: **SOAP SUDS**

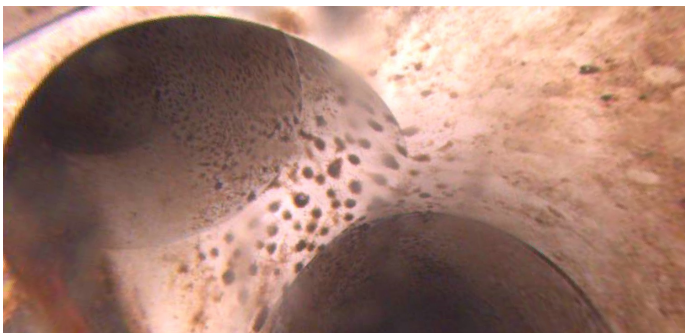
Code: **TF**  
Description: **Tap Factory**

Distance (ft): **116.8**  
Structural Grade: **0**  
O&M Grade: **0**  
Clock Start/From: **2**  
Clock To:  
1st Value: **4.000**  
2nd Value:  
Value Percent:  
Continuous Index:  
Within 8" of Joint:  
Remarks:

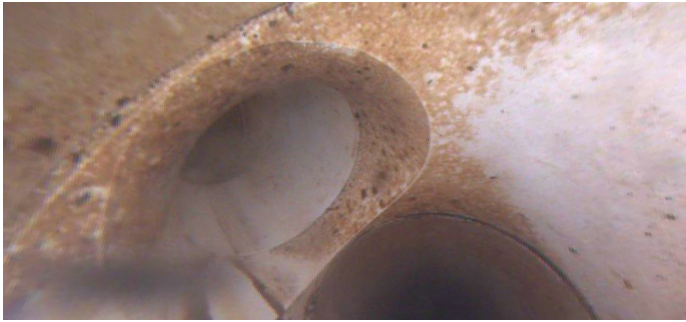
Code: **TF**  
Description: **Tap Factory**

Distance (ft): **159.1**  
Structural Grade: **0**  
O&M Grade: **0**  
Clock Start/From: **10**  
Clock To:  
1st Value: **4.000**  
2nd Value:  
Value Percent:  
Continuous Index:  
Within 8" of Joint:  
Remarks:

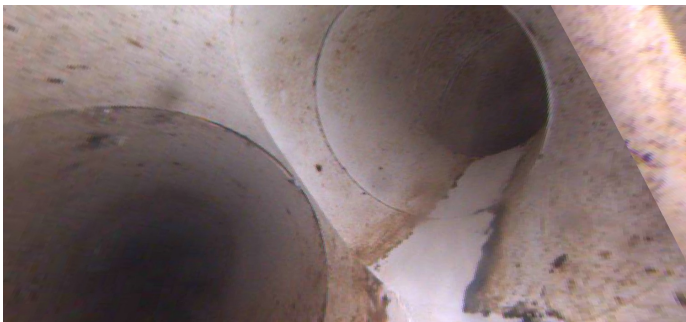
Code: **TF**  
Description: **Tap Factory**

Distance (ft): **190.3**  
Structural Grade: **0**  
O&M Grade: **0**  
Clock Start/From: **2**  
Clock To:  
1st Value: **4.000**  
2nd Value:  
Value Percent:  
Continuous Index:  
Within 8" of Joint:  
Remarks:

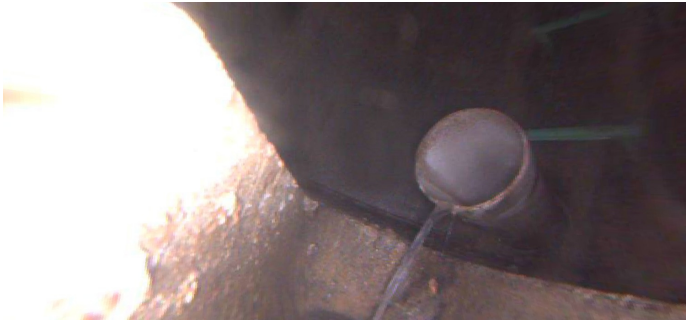
Code:	AMH
Description:	Manhole
Distance (ft):	234.2
Structural Grade:	0
O&M Grade:	0
Clock Start/From:	
Clock To:	
1st Value:	
2nd Value:	
Value Percent:	
Continuous Index:	
Within 8" of Joint:	NO
Remarks:	M-703-018
