## Profile/Photo Observation Report

Street:	<b>quail dr</b>	Flow Control:	<b>Not Controlled</b>
City:	<b>Hobart, IN</b>	Year Renewed:	
Location:	<b>Other</b>	Tape/Media #:	
Purpose:	<b>Not Known</b>	Dia/Height:	<b>10"</b>
Use:	<b>Sanitary</b>	Material:	<b>PVC</b>
Drain Area:	<b>NA</b>	Lining:	
Category:	<b>NA</b>		
Comment:

Location Details:		Direction of Survey:	<b>Downstream</b>
US MH:	<b>M-703-017</b>	DS MH:	<b>M-703-018</b>
		Total Length Surveyed (ft):	<b>234.2</b>

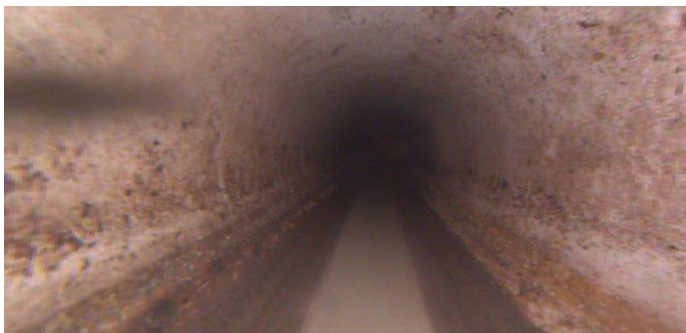
Code: **AMH**  
Description: **Manhole**

Distance (ft): **.0**  
Structural Grade: **0**  
O&M Grade: **0**  
Clock Start/From:  
Clock To:  
1st Value:  
2nd Value:  
Value Percent:  
Continuous Index:  
Within 8" of Joint: **NO**  
Remarks: **M-703-017**

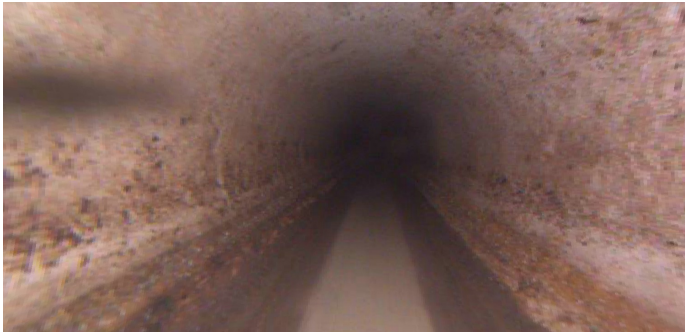
Code:	<b>MWL</b>
Description:	<b>Water Level</b>

Distance (ft):	<b>.0</b>
Structural Grade:	<b>0</b>
O&M Grade:	<b>0</b>
Clock Start/From:	
Clock To:	
1st Value:	
2nd Value:	
Value Percent:	<b>5.000</b>
Continuous Index:	
Within 8" of Joint:	<b>NO</b>
Remarks:

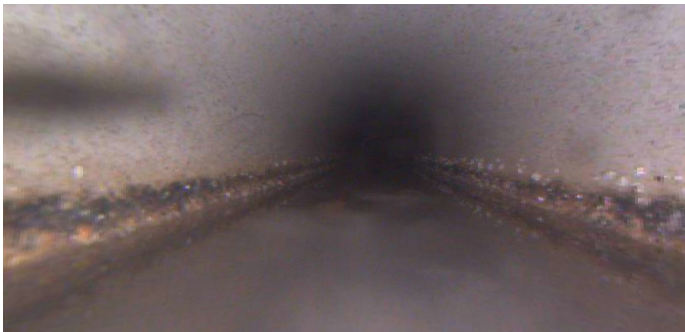
Code:	<b>MGO</b>
Description:	<b>General Observation</b>

Distance (ft):	<b>30.6</b>
Structural Grade:	<b>0</b>
O&M Grade:	<b>0</b>
Clock Start/From:	
Clock To:	
1st Value:	
2nd Value:	
Value Percent:	
Continuous Index:	
Within 8" of Joint:	<b>NO</b>
Remarks:	<b>TOILE TISSUE</b>

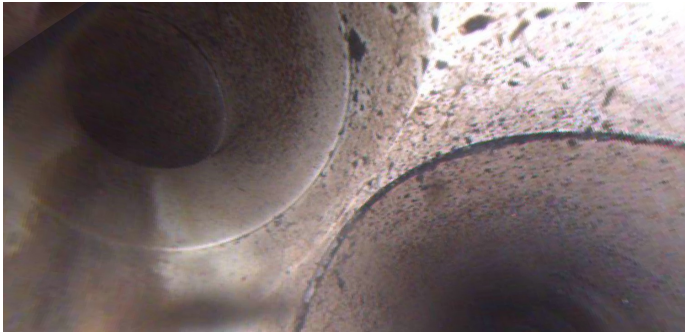
Code: **TF**  
Description: **Tap Factory**

Distance (ft): **36.0**  
Structural Grade: **0**  
O&M Grade: **0**  
Clock Start/From: **10**  
Clock To:  
1st Value: **4.000**  
2nd Value:  
Value Percent:  
Continuous Index:  
Within 8" of Joint:  
Remarks:

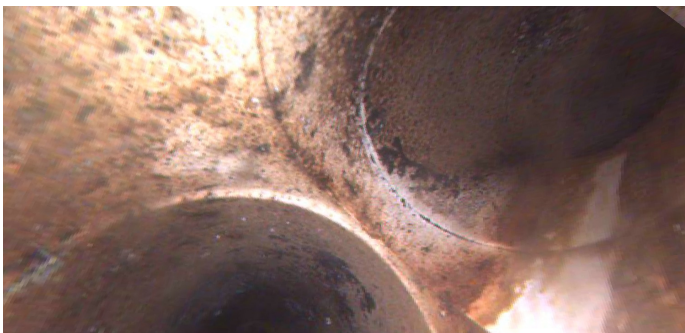
Code: **TF**  
Description: **Tap Factory**

Distance (ft): **40.5**  
Structural Grade: **0**  
O&M Grade: **0**  
Clock Start/From: **2**  
Clock To:  
1st Value: **4.000**  
2nd Value:  
Value Percent:  
Continuous Index:  
Within 8" of Joint:  
Remarks:

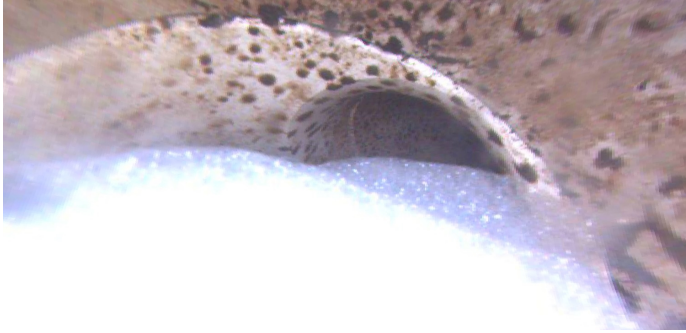
Code: **MGO**  
Description: **General Observation**

Distance (ft): **115.9**  
Structural Grade: **0**  
O&M Grade: **0**  
Clock Start/From:  
Clock To:  
1st Value:  
2nd Value:  
Value Percent:  
Continuous Index:  
Within 8" of Joint: **NO**  
Remarks: **SOAP SUDS**

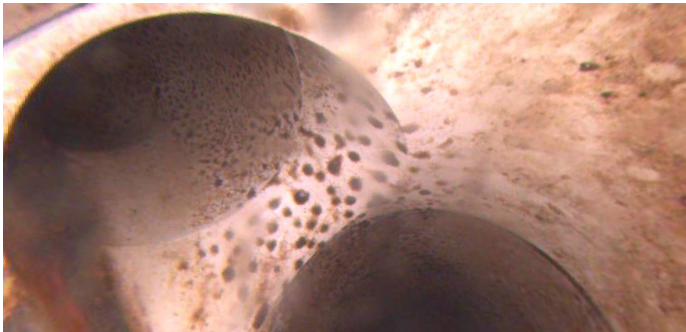
Code: **TF**  
Description: **Tap Factory**

Distance (ft): **116.8**  
Structural Grade: **0**  
O&M Grade: **0**  
Clock Start/From: **2**  
Clock To:  
1st Value: **4.000**  
2nd Value:  
Value Percent:  
Continuous Index:  
Within 8" of Joint:  
Remarks:

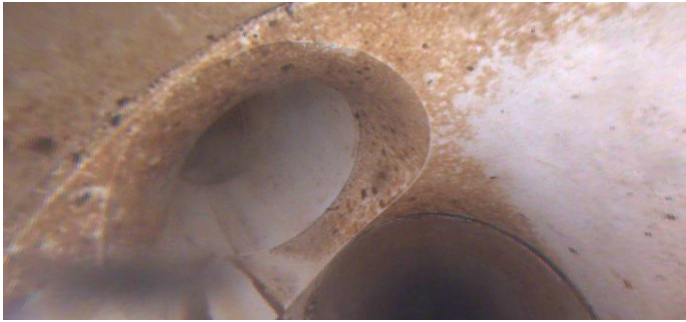
Code: **TF**  
Description: **Tap Factory**

Distance (ft): **159.1**  
Structural Grade: **0**  
O&M Grade: **0**  
Clock Start/From: **10**  
Clock To:  
1st Value: **4.000**  
2nd Value:  
Value Percent:  
Continuous Index:  
Within 8" of Joint:  
Remarks:

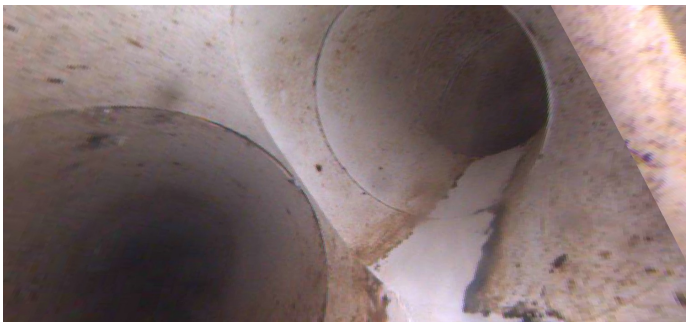
Code: **TF**  
Description: **Tap Factory**

Distance (ft): **190.3**  
Structural Grade: **0**  
O&M Grade: **0**  
Clock Start/From: **2**  
Clock To:  
1st Value: **4.000**  
2nd Value:  
Value Percent:  
Continuous Index:  
Within 8" of Joint:  
Remarks:

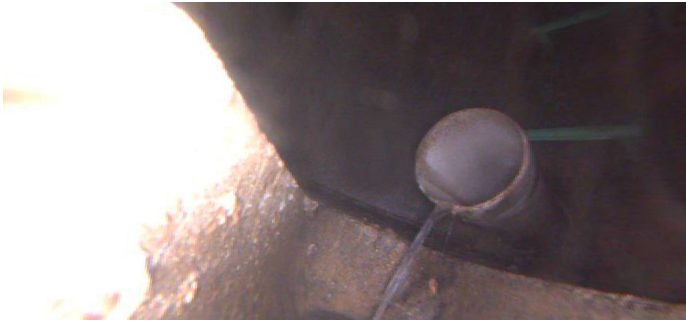
Code:	<b>AMH</b>
Description:	<b>Manhole</b>
Distance (ft):	<b>234.2</b>
Structural Grade:	<b>0</b>
O&M Grade:	<b>0</b>
Clock Start/From:	
Clock To:	
1st Value:	
2nd Value:	
Value Percent:	
Continuous Index:	
Within 8" of Joint:	<b>NO</b>
Remarks:	<b>M-703-018</b>
