Profile/Photo Observation Report

Street:	Quail Dr.	Flow Control:	Not Controlled
City:	Hobart, IN	Year Renewed:	
Location:	Light Highway	Tape/Media #:	
Purpose:	Routine Assessment	Dia/Height:	10"
Use:	Sanitary	Material:	PVC
Drain Area:	NA	Lining:	
Category:	NA		
Comment:

Location Details:		Direction of Survey:	Downstream
US MH:	M-703-019	DS MH:	M-703-033
		Total Length Surveyed (ft):	284.0

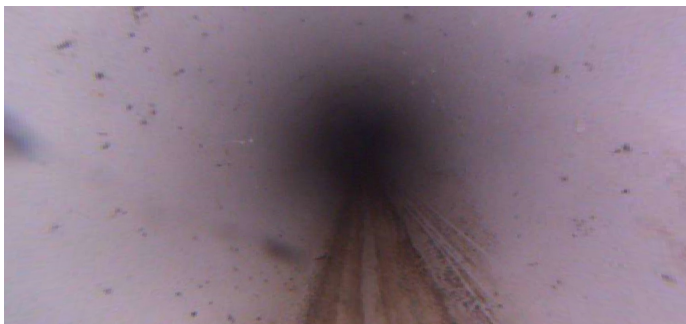
Code: **AMH**
Description: **Manhole**

Distance (ft): **.0**
Structural Grade: **0**
O&M Grade: **0**
Clock Start/From:
Clock To:
1st Value:
2nd Value:
Value Percent:
Continuous Index:
Within 8" of Joint: **NO**
Remarks: **M-703-019**

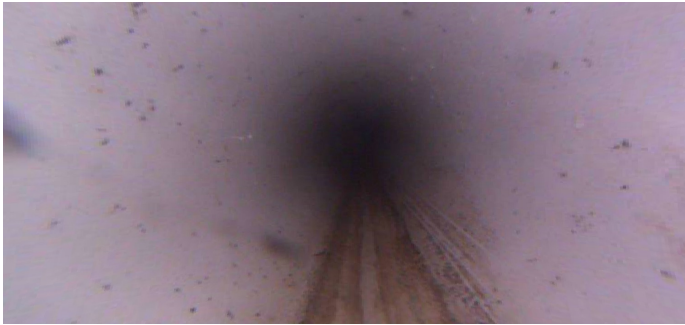
Code:	MWL
Description:	Water Level

Distance (ft):	.0
Structural Grade:	0
O&M Grade:	0
Clock Start/From:	
Clock To:	
1st Value:	
2nd Value:	
Value Percent:	5.000
Continuous Index:	
Within 8" of Joint:	NO
Remarks:

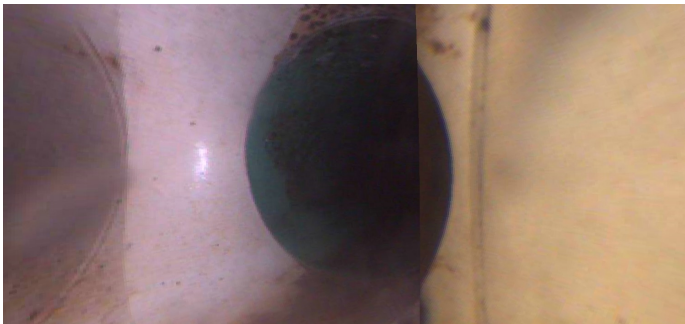
Code:	TF
Description:	Tap Factory

Distance (ft):	44.4
Structural Grade:	0
O&M Grade:	0
Clock Start/From:	3
Clock To:	
1st Value:	4.000
2nd Value:	
Value Percent:	
Continuous Index:	
Within 8" of Joint:	
Remarks:

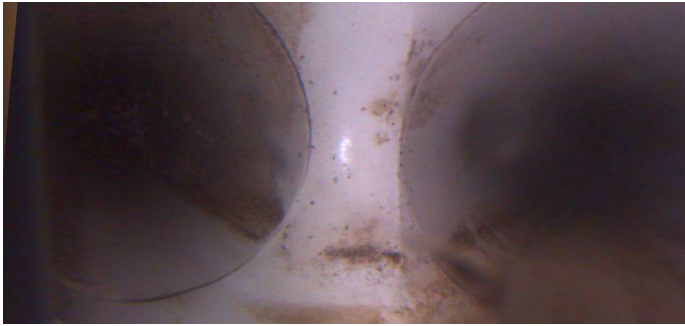
Code: **TF**
Description: **Tap Factory**

Distance (ft): **108.3**
Structural Grade: **0**
O&M Grade: **0**
Clock Start/From: **9**
Clock To:
1st Value: **4.000**
2nd Value:
Value Percent:
Continuous Index:
Within 8" of Joint:
Remarks:

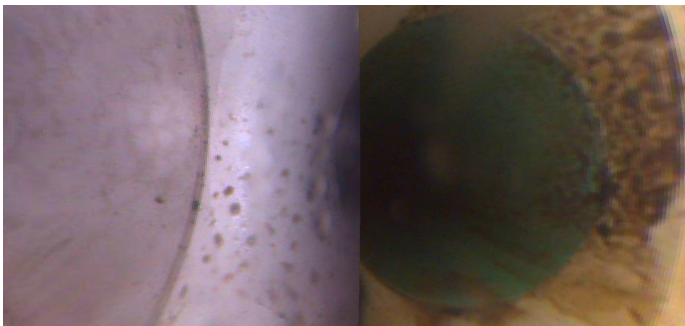
Code: **TF**
Description: **Tap Factory**

Distance (ft): **113.6**
Structural Grade: **0**
O&M Grade: **0**
Clock Start/From: **3**
Clock To:
1st Value: **4.000**
2nd Value:
Value Percent:
Continuous Index:
Within 8" of Joint:
Remarks:

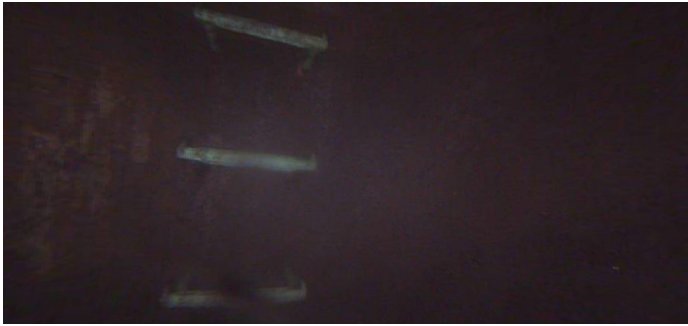
Code:	AMH
Description:	Manhole
Distance (ft):	284.0
Structural Grade:	0
O&M Grade:	0
Clock Start/From:	
Clock To:	
1st Value:	
2nd Value:	
Value Percent:	
Continuous Index:	
Within 8" of Joint:	NO
Remarks:	M-703-033
