Profile/Photo Observation Report

Street:	HIDDEN LAKE DR	Flow Control:	Not Controlled
City:	Hobart, IN	Year Renewed:	
Location:	Other	Tape/Media #:	
Purpose:	Not Known	Dia/Height:	10"
Use:	Sanitary	Material:	PVC
Drain Area:	NA	Lining:	
Category:	NA		
Comment:

Location Details:		Direction of Survey:	Downstream
US MH:	M-703-020	DS MH:	M-703-022
		Total Length Surveyed (ft):	329.6

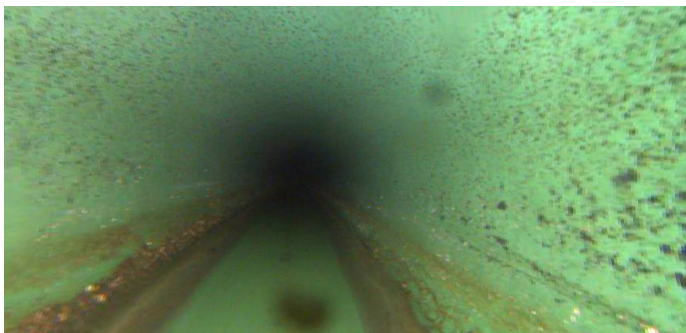
Code: **AMH**
Description: **Manhole**

Distance (ft): **.0**
Structural Grade: **0**
O&M Grade: **0**
Clock Start/From:
Clock To:
1st Value:
2nd Value:
Value Percent:
Continuous Index:
Within 8" of Joint: **NO**
Remarks: **M-703-020**

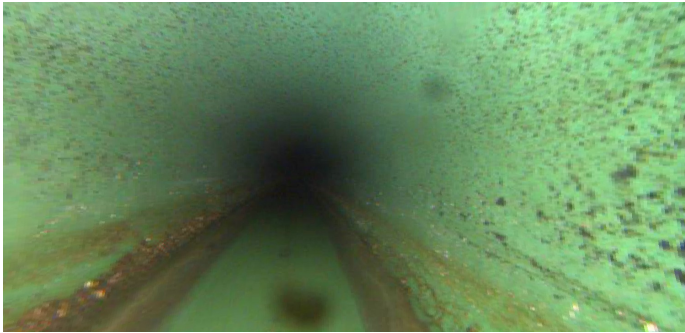
Code:	MWL
Description:	Water Level

Distance (ft):	.0
Structural Grade:	0
O&M Grade:	0
Clock Start/From:	
Clock To:	
1st Value:	
2nd Value:	
Value Percent:	5.000
Continuous Index:	
Within 8" of Joint:	NO
Remarks:

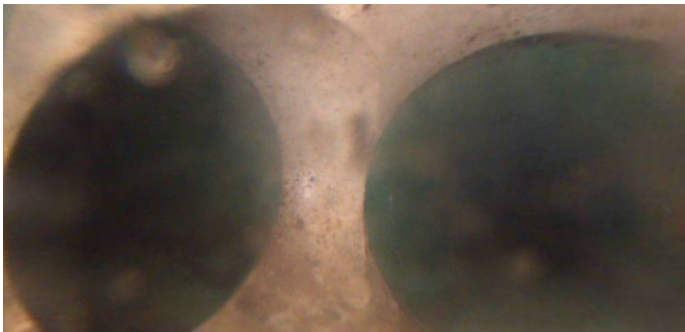
Code:	TF
Description:	Tap Factory

Distance (ft):	25.5
Structural Grade:	0
O&M Grade:	0
Clock Start/From:	3
Clock To:	
1st Value:	4.000
2nd Value:	
Value Percent:	
Continuous Index:	
Within 8" of Joint:	
Remarks:

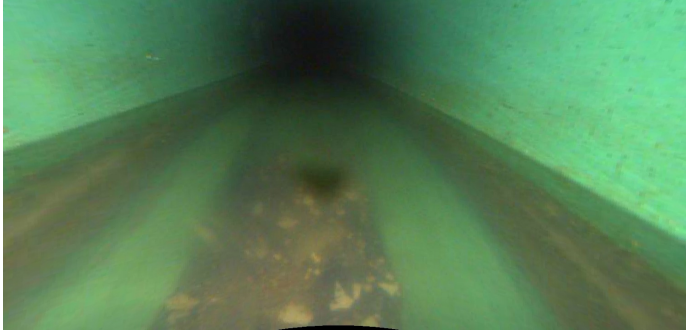
Code: **DSF**
Description: **Deposits Settled Fine**

Distance (ft): **27.7**
Structural Grade: **0**
O&M Grade: **2**
Clock Start/From: **6**
Clock To:
1st Value:
2nd Value:
Value Percent: **5.000**
Continuous Index:
Within 8" of Joint: **NO**
Remarks:

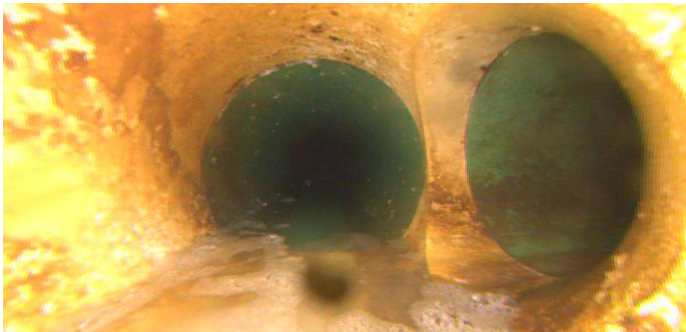
Code: **TF**
Description: **Tap Factory**

Distance (ft): **96.3**
Structural Grade: **0**
O&M Grade: **0**
Clock Start/From: **3**
Clock To:
1st Value: **4.000**
2nd Value:
Value Percent:
Continuous Index:
Within 8" of Joint:
Remarks:

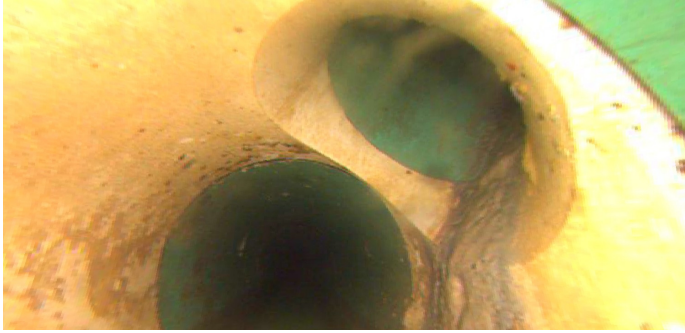
Code: **TF**
Description: **Tap Factory**

Distance (ft): **175.4**
Structural Grade: **0**
O&M Grade: **0**
Clock Start/From: **2**
Clock To:
1st Value: **4.000**
2nd Value:
Value Percent:
Continuous Index:
Within 8" of Joint:
Remarks:

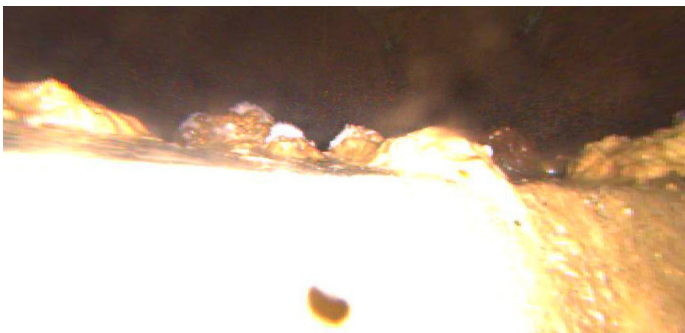
Code: **AMH**
Description: **Manhole**

Distance (ft): **329.6**
Structural Grade: **0**
O&M Grade: **0**
Clock Start/From:
Clock To:
1st Value:
2nd Value:
Value Percent:
Continuous Index:
Within 8" of Joint: **NO**
Remarks: **M-703-022**
