Profile/Photo Observation Report

Date:	04/12/2018	Weather:		Coding:	PACP 6.0
Pipe Length (ft):	347.5	Owner:	NA	Pre Clean:	Not Known
P.O.#:		Surveyor:	Jen Costello	PSR:	P-703-023-022
Customer:		Clean Date:	01/01/1900	Shape:	C

Street:	PHEASANT RUN DR	Flow Control:	Not Controlled
City:	Hobart, IN	Year Renewed:	
Location:	Other	Tape/Media #:	
Purpose:	Not Known	Dia/Height:	8"
Use:	Sanitary	Material:	PVC
Drain Area:	NA	Lining:	
Category:	NA		
Comment:

Location Details:		Direction of Survey:	Downstream
US MH:	M-703-022	DS MH:	M-703-023
		Total Length Surveyed (ft):	345.5

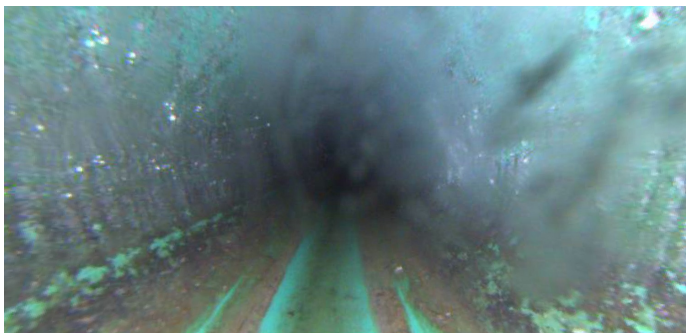
Code: **AMH**
Description: **Manhole**

Distance (ft): **.0**
Structural Grade: **0**
O&M Grade: **0**
Clock Start/From:
Clock To:
1st Value:
2nd Value:
Value Percent:
Continuous Index:
Within 8" of Joint: **NO**
Remarks: **M-703-022**

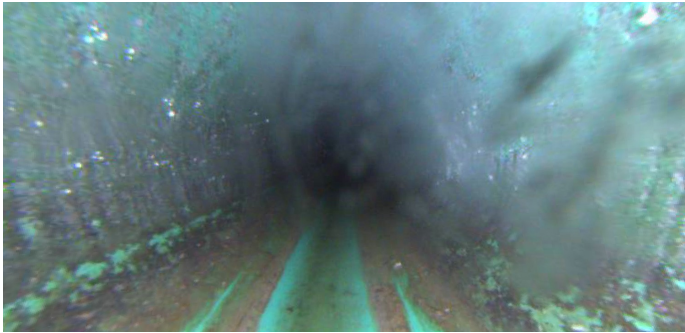
Code:	MWL
Description:	Water Level

Distance (ft):	.0
Structural Grade:	0
O&M Grade:	0
Clock Start/From:	
Clock To:	
1st Value:	
2nd Value:	
Value Percent:	5.000
Continuous Index:	
Within 8" of Joint:	NO
Remarks:

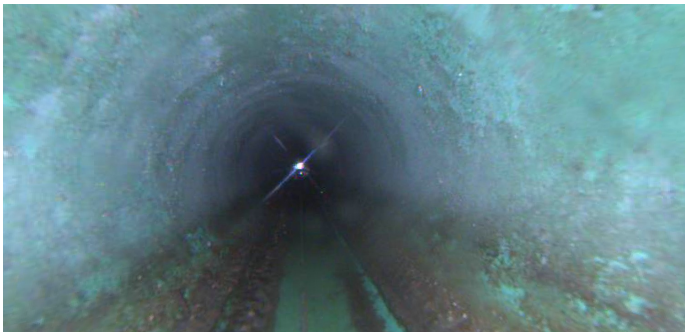
Code:	MGO
Description:	General Observation

Distance (ft):	30.2
Structural Grade:	0
O&M Grade:	0
Clock Start/From:	
Clock To:	
1st Value:	
2nd Value:	
Value Percent:	
Continuous Index:	
Within 8" of Joint:	NO
Remarks:	REAR CAMERA

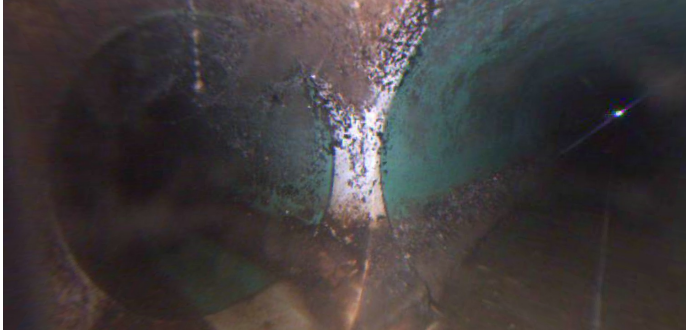
Code: **TFA**
Description: **Tap Factory Active**

Distance (ft): **45.5**
Structural Grade: **0**
O&M Grade: **0**
Clock Start/From: **3**
Clock To:
1st Value: **4.000**
2nd Value:
Value Percent:
Continuous Index:
Within 8" of Joint:
Remarks:

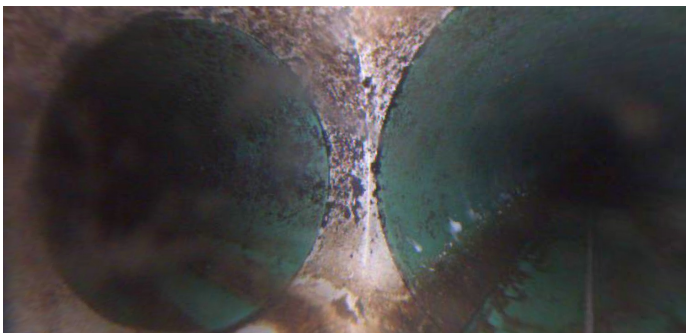
Code: **TFA**
Description: **Tap Factory Active**

Distance (ft): **193.3**
Structural Grade: **0**
O&M Grade: **0**
Clock Start/From: **3**
Clock To:
1st Value: **4.000**
2nd Value:
Value Percent:
Continuous Index:
Within 8" of Joint:
Remarks:

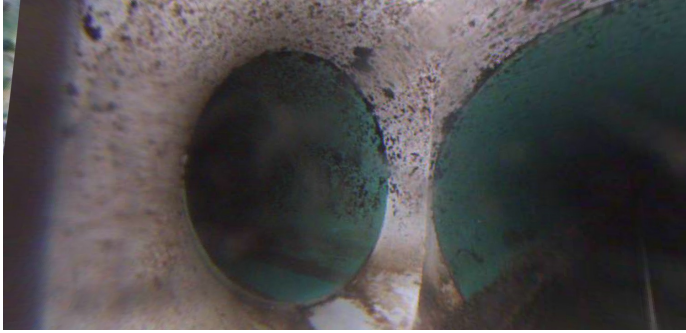
Code: **TF**
Description: **Tap Factory**

Distance (ft): **284.3**
Structural Grade: **0**
O&M Grade: **0**
Clock Start/From: **3**
Clock To:
1st Value: **4.000**
2nd Value:
Value Percent:
Continuous Index:
Within 8" of Joint:
Remarks:

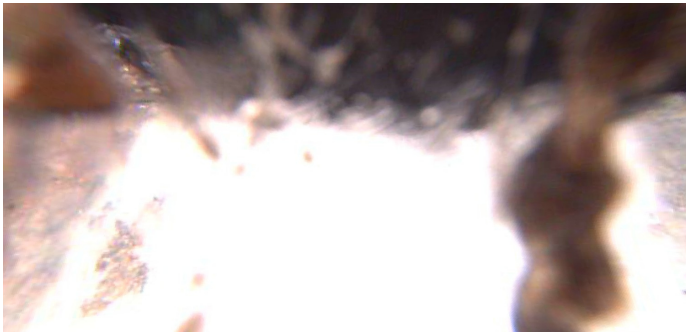
Code: **AMH**
Description: **Manhole**

Distance (ft): **345.5**
Structural Grade: **0**
O&M Grade: **0**
Clock Start/From:
Clock To:
1st Value:
2nd Value:
Value Percent:
Continuous Index:
Within 8" of Joint: **NO**
Remarks: **M-703-023**
