Profile/Photo Observation Report

Date:	04/12/2018	Weather:		Coding:	PACP 6.0
Pipe Length (ft):	347.5	Owner:	NA	Pre Clean:	Not Known
P.O.#:		Surveyor:	Jen Costello	PSR:	P-703-023-022
Customer:		Clean Date:	01/01/1900	Shape:	C

Street:	W 40th ave	Flow Control:	Not Controlled
City:	Hobart, IN	Year Renewed:	
Location:	Other	Tape/Media #:	
Purpose:	Not Known	Dia/Height:	8"
Use:	Sanitary	Material:	PVC
Drain Area:	NA	Lining:	
Category:	NA		
Comment:

Location Details:		Direction of Survey:	Downstream
US MH:	M-703-022	DS MH:	M-703-023
		Total Length Surveyed (ft):	345.5

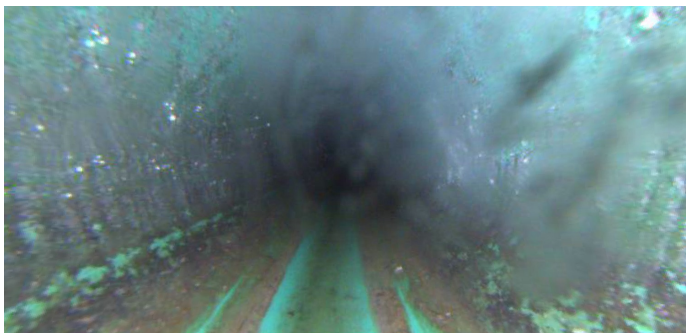
Code: **AMH**
Description: **Manhole**

Distance (ft): **.0**
Structural Grade: **0**
O&M Grade: **0**
Clock Start/From:
Clock To:
1st Value:
2nd Value:
Value Percent:
Continuous Index:
Within 8" of Joint: **NO**
Remarks: **M-703-022**

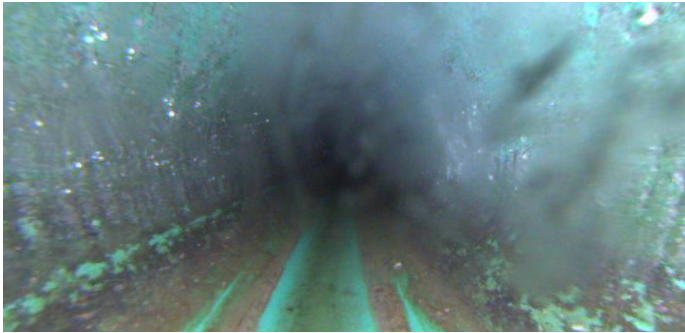
Code:	MWL
Description:	Water Level

Distance (ft):	.0
Structural Grade:	0
O&M Grade:	0
Clock Start/From:	
Clock To:	
1st Value:	
2nd Value:	
Value Percent:	5.000
Continuous Index:	
Within 8" of Joint:	NO
Remarks:

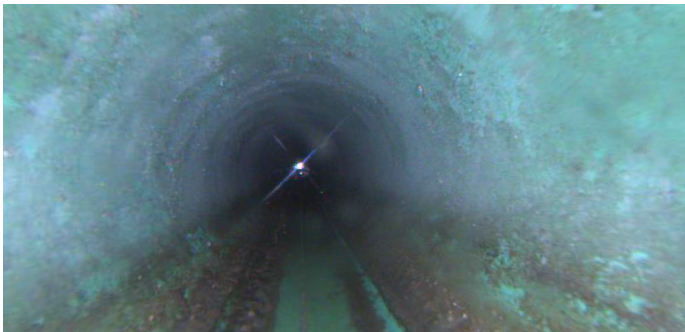
Code:	MGO
Description:	General Observation

Distance (ft):	30.2
Structural Grade:	0
O&M Grade:	0
Clock Start/From:	
Clock To:	
1st Value:	
2nd Value:	
Value Percent:	
Continuous Index:	
Within 8" of Joint:	NO
Remarks:	REAR CAMERA

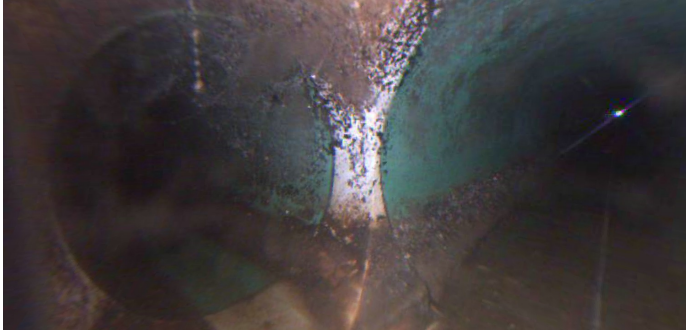
Code: **TFA**
Description: **Tap Factory Active**

Distance (ft): **45.5**
Structural Grade: **0**
O&M Grade: **0**
Clock Start/From: **3**
Clock To:
1st Value: **4.000**
2nd Value:
Value Percent:
Continuous Index:
Within 8" of Joint:
Remarks:

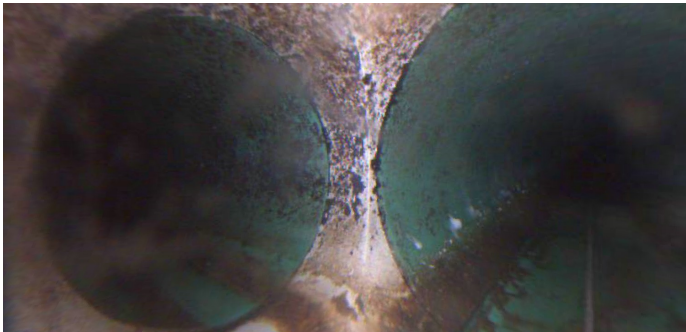
Code: **TFA**
Description: **Tap Factory Active**

Distance (ft): **193.3**
Structural Grade: **0**
O&M Grade: **0**
Clock Start/From: **3**
Clock To:
1st Value: **4.000**
2nd Value:
Value Percent:
Continuous Index:
Within 8" of Joint:
Remarks:

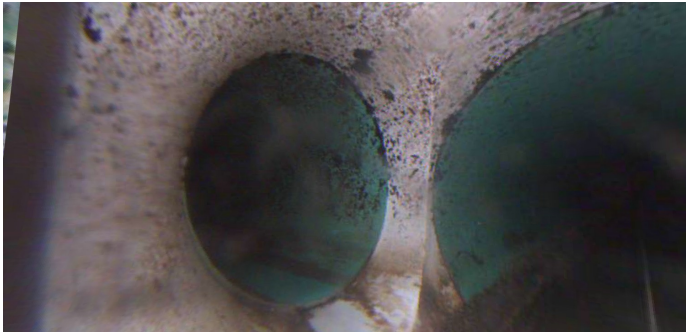
Code: **TF**
Description: **Tap Factory**

Distance (ft): **284.3**
Structural Grade: **0**
O&M Grade: **0**
Clock Start/From: **3**
Clock To:
1st Value: **4.000**
2nd Value:
Value Percent:
Continuous Index:
Within 8" of Joint:
Remarks:

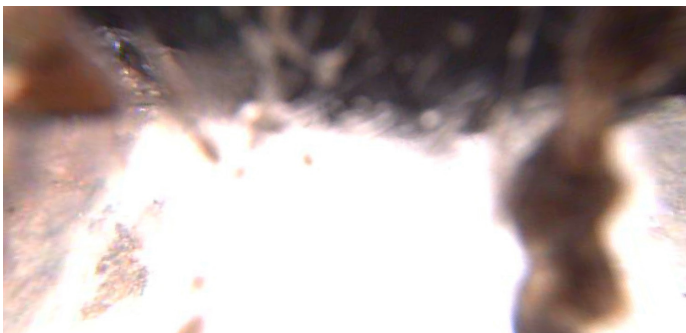
Code: **AMH**
Description: **Manhole**

Distance (ft): **345.5**
Structural Grade: **0**
O&M Grade: **0**
Clock Start/From:
Clock To:
1st Value:
2nd Value:
Value Percent:
Continuous Index:
Within 8" of Joint: **NO**
Remarks: **M-703-023**
