Profile/Photo Observation Report

Street:	MANOR DR	Flow Control:	Not Controlled
City:	Hobart, IN	Year Renewed:	
Location:	Other	Tape/Media #:	
Purpose:	Not Known	Dia/Height:	8"
Use:	Sanitary	Material:	PVC
Drain Area:	NA	Lining:	
Category:	NA		
Comment:

Location Details:		Direction of Survey:	Downstream
US MH:	M-703-022	DS MH:	M-703-026
		Total Length Surveyed (ft):	152.9

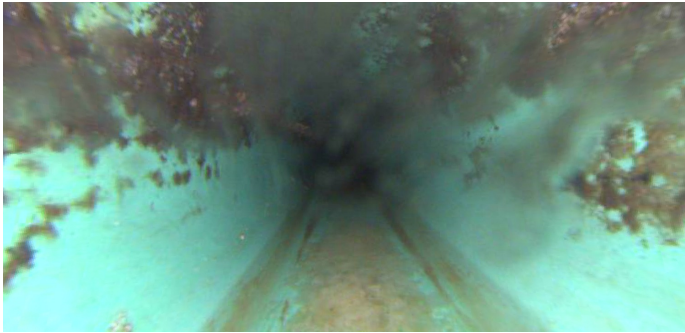
Code:	MWL
Description:	Water Level

Distance (ft):	.0
Structural Grade:	0
O&M Grade:	0
Clock Start/From:	
Clock To:	
1st Value:	
2nd Value:	
Value Percent:	5.000
Continuous Index:	
Within 8" of Joint:	NO
Remarks:

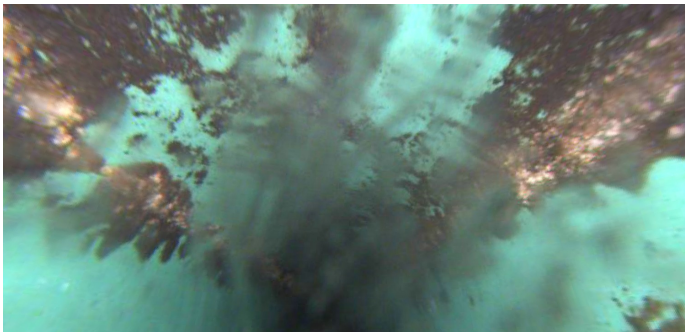
Code:	DAGS
Description:	Deposits Attached Grease

Distance (ft):	2.0
Structural Grade:	0
O&M Grade:	2
Clock Start/From:	10
Clock To:	2
1st Value:	
2nd Value:	
Value Percent:	5.000
Continuous Index:	S01
Within 8" of Joint:	NO
Remarks:

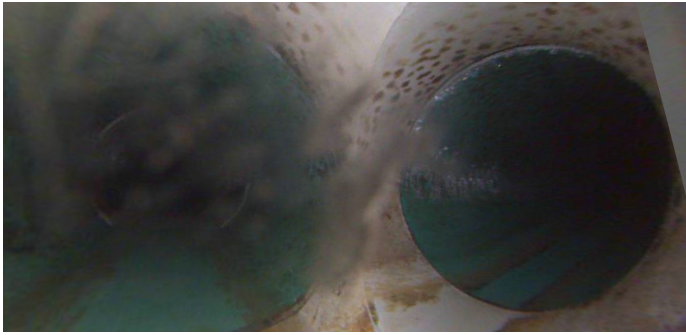
Code: **TF**
Description: **Tap Factory**

Distance (ft): **109.1**
Structural Grade: **0**
O&M Grade: **0**
Clock Start/From: **3**
Clock To:
1st Value: **4.000**
2nd Value:
Value Percent:
Continuous Index:
Within 8" of Joint:
Remarks:

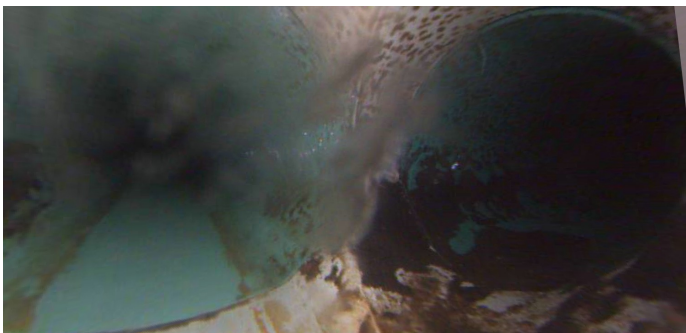
Code: **TF**
Description: **Tap Factory**

Distance (ft): **110.8**
Structural Grade: **0**
O&M Grade: **0**
Clock Start/From: **3**
Clock To:
1st Value: **4.000**
2nd Value:
Value Percent:
Continuous Index:
Within 8" of Joint:
Remarks:

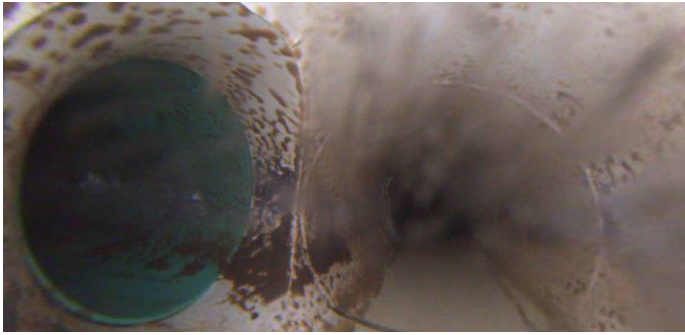
Code: **TF**
Description: **Tap Factory**

Distance (ft): **119.3**
Structural Grade: **0**
O&M Grade: **0**
Clock Start/From: **9**
Clock To:
1st Value: **4.000**
2nd Value:
Value Percent:
Continuous Index:
Within 8" of Joint:
Remarks:

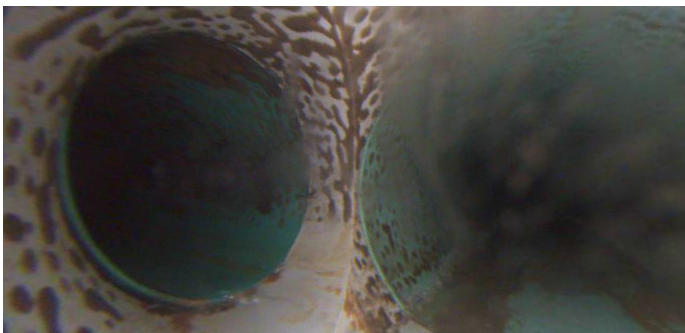
Code: **TF**
Description: **Tap Factory**

Distance (ft): **121.1**
Structural Grade: **0**
O&M Grade: **0**
Clock Start/From: **9**
Clock To:
1st Value: **4.000**
2nd Value:
Value Percent:
Continuous Index:
Within 8" of Joint:
Remarks:

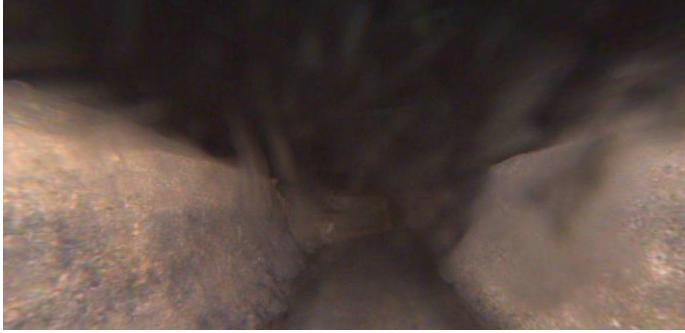
Code: **DAGS**
Description: **Deposits Attached Grease**

Distance (ft): **151.1**
Structural Grade: **0**
O&M Grade: **2**
Clock Start/From: **10**
Clock To: **2**
1st Value:
2nd Value:
Value Percent: **5.000**
Continuous Index: **F01**
Within 8" of Joint: **NO**
Remarks:

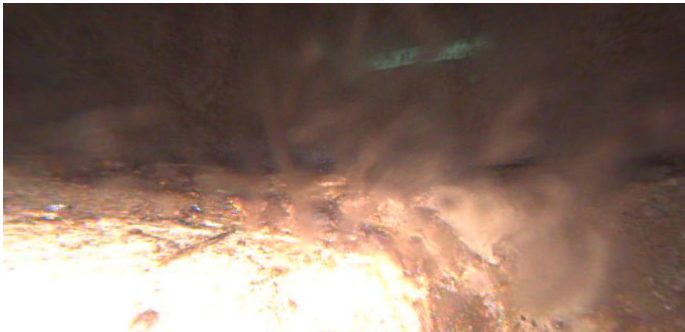
Code: **AMH**
Description: **Manhole**

Distance (ft): **152.9**
Structural Grade: **0**
O&M Grade: **0**
Clock Start/From:
Clock To:
1st Value:
2nd Value:
Value Percent:
Continuous Index:
Within 8" of Joint: **NO**
Remarks: **M-703-026**
